LISEGA SPRING MATERIAL AND COATING

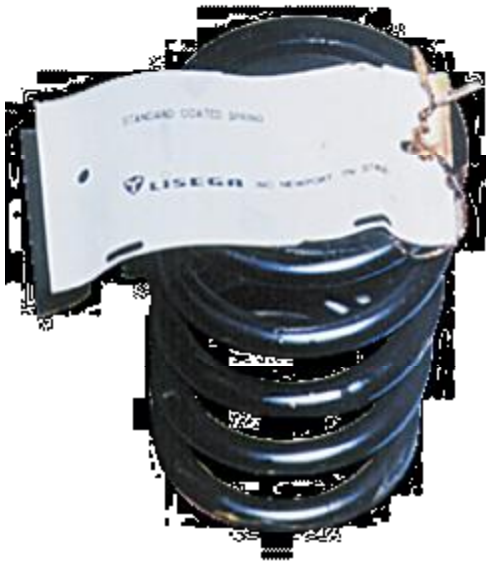
LISEGA spring with electrophoretic paint system

Preceded by technical and economical feasibility studies we have introduced in 1987 the so called cathodic immersion enamelling coating for springs only. The process itself is known under the collective term of electrophoresic paint system.

The goods are first cleaned in a degreasing alkali bath, subsequently activated in a Titanium-crystal solution to condition the size of zinc crystals on the surface. A further bath treatment with zinc-phosphates, called phosphatisation, creates an even surface with a good conductivity.

The workpiece that shall be enameled is immersed in the lacquer bath for about 60 - 120 seconds. Then the electrical current is applied between the workpiece and the lacquer, similar to a galvanic bath, so that the lacquer is separated on the surface of the coil. The coating thickness of this process lies in the area of 12 - 20 my.

Subsequent thermal treatment polymerizes (interlaces) the paint, creating a very durable surface.

The advantages of this process lie in the even coat-formation, in the coating of hollow spaces and locations with difficult access, and no drops or formation of runs.

Salt spray tests carried out by an independent laboratory - results are available on request - have proven our superior spring surface protection compared with the neoprene coating.

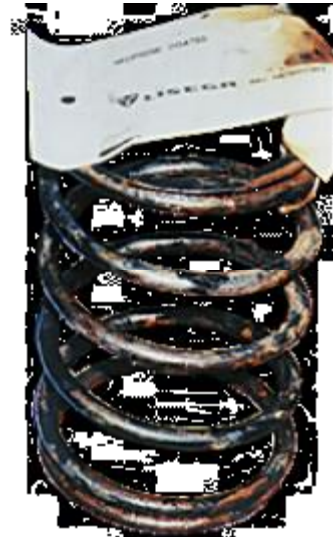
Common hanger spring coated with Neopren

The disadvantage of plastic coating (e.g. neoprene) is that a possible scratch enables moisture to penetrate. This creates severe corrosion, which is not visible, as the coil is covered by the plastic. The consequence might be a spring crack.
