SYNCHRONOUS BELT FAILURE ANALYSIS GUIDE

> Introduction

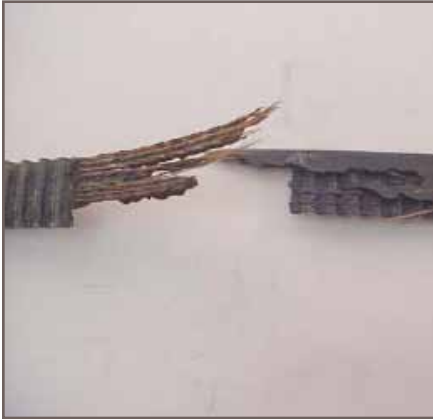
A failure that occurs when a belt reaches its ultimate tensile cord fatigue life, after running for a period of two to three years may be considered to be normal. Belt tensile failure due to cord fatigue after a long running period is considered to be ideal. Figure 1 illustrates a jagged 45-degree belt fracture that is typical of tensile cord at the end of its fatigue life.

Figure 1 – Normal fatigue failure

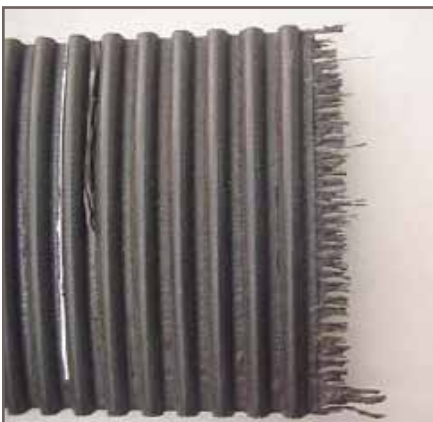
A “crimp” type belt failure often resembles a straight tensile failure as illustrated in Figure 3. A straight type of break like this may occur when belt tensile cords are bent around an excessively small diameter. A sharp bend may result in large compressive forces within the tensile members causing individual fibers to buckle or crimp, reducing the overall ultimate tensile strength of the belt. Belt crimping damage is most commonly associated with belt mishandling, inadequate belt installation tension, sub-minimal sprocket diameters, and/or entry of foreign objects within the belt drive.

Figure 3 – Crimp failure

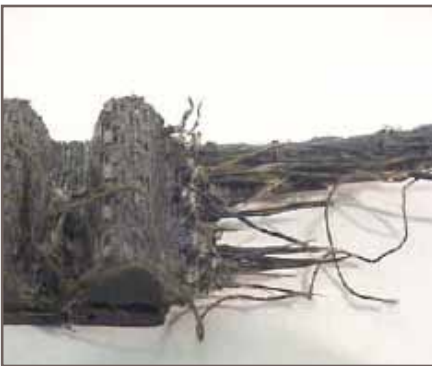
Severe shock loads can result in belt tensile breaks with a ragged and uneven appearance as illustrated in Figure 4. The particular belt teeth engaged in the sprocket at the instant of the shock load may also develop root cracks and/or exhibit tooth shear. If the shock load occurred only once, or was cyclical and repetitious at one specific location around the belt, the remaining belt teeth may appear normal. Figure 5 illustrates how root cracks caused by shock loading can propagate through the teeth. Cracks forming at the tooth roots sometimes move towards the tooth tips. Teeth containing multiple cracks may then shear, leaving only a portion of the tooth behind.

Figure 4 – Typical shock load failure

The shock loads generated by the driven equipment may be an inherent part of system operation or may result from an occasional harsh condition such as jamming. If the drive shock loads cannot be eliminated, the belt tensile strength may need to be increased or the synchronous belt drive replaced with a more forgiving V-belt drive system capable of intermittent slip.

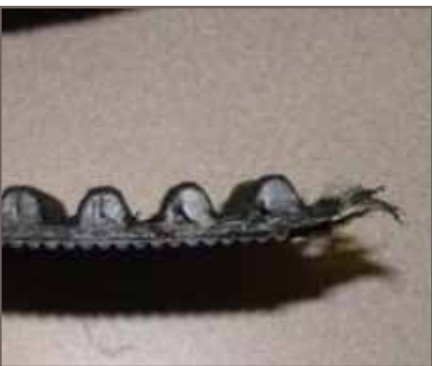
Figure 5 – Tooth root crack propagation

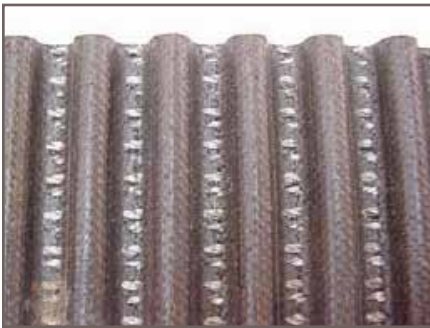
Figure 7 - Excessive land area wear

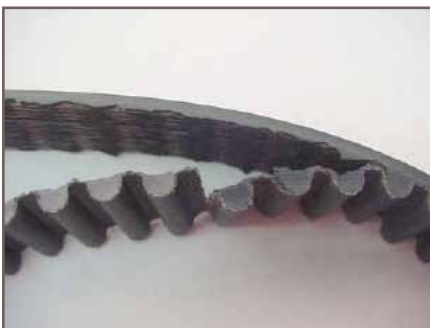
Figure 8 – Tooth separation failure

Applying insufficient installation tension to belts operating on moderately to heavily loaded drive systems may also result in premature failures. A common belt failure mode resulting from insufficient belt installation tension is referred to as tooth rotation. Belt tooth rotation can occur as belt teeth climb out of their respective sprocket grooves (self tensioning) and drive loads are no longer applied at their roots. Drive loads applied further down the belt tooth flanks cause the belt teeth to bend (like a diving board) and “rotate.” Belt tooth rotation can result in rubber tearing at the base of the belt teeth along the tensile member. As rubber tearing propagates, belt teeth often begin to separate from the belt body in strips, as illustrated in Figure 8. Failures due to excessive tooth rotation may resemble failures caused by insufficient rubber adhesion to the tensile cords. Unlike tooth rotation failures, failures from insufficient rubber adhesion leave the exposed tensile members clean where the belt teeth were once located.

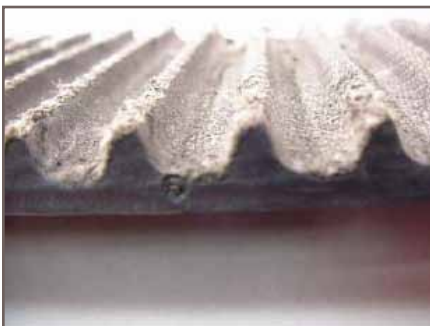
Figure 9 – Excessive tooth wear

As belt teeth climb out of their respective sprocket grooves to self tension, belt ratcheting or tooth jumping may occur before rubber tearing and belt tooth separation occurs. Belt tensile cord damage resulting from ratcheting can cause premature belt tensile failures. These tensile failures may resemble crimp type breaks (straight and clean) as well as shock load type breaks (jagged and angled). If belt ratcheting does not occur and belts continue to operate while self tensioning, excessive belt tooth wear often occurs. This tooth wear is referred to as “hook wear” and results from improper belt tooth meshing with the sprockets, as shown in Figure 9. Hook wear type belt failures result from

Increasing belt installation tension levels generally prevents premature belt failures due to tooth rotation and hook wear. If increasing the belt installation tension level does not prevent this type of failure, the drive structure may not be rigid enough to prevent deflection. Added structural support may be necessary to improve belt performance. If it is not practical to increase belt installation tension levels, increasing the sprocket diameters will allow higher drive loads to be transmitted with less belt tension.

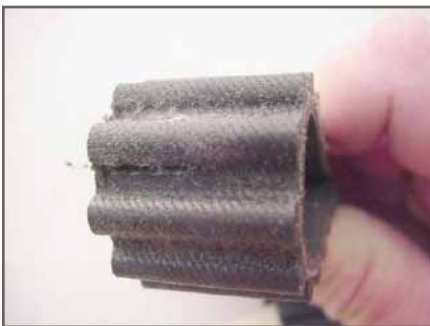
Figure 11 - Uneven belt wear

Belts operating on drives with angular shaft misalignment or tapered sprockets often exhibit an uneven wear pattern across the belt tooth flanks and uneven compaction in the land areas (in between belt teeth) due to the uneven application of load to the belt. Belt failures often occur from tooth root cracks or tears initiating on the side of the belt that is carrying the highest tension and propagating across the belt width, ultimately resulting in tooth shear. One edge of the belt may also show significant wear due to high tracking force and may even roll up or attempt to climb the sprocket flange(s). Figure 10 shows extreme belt edge wear from a high tracking force.

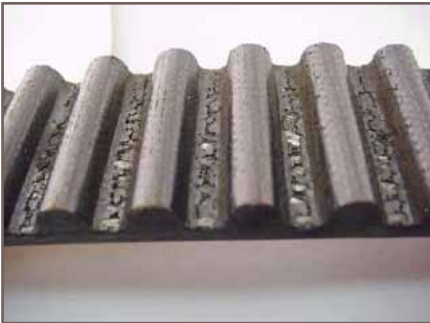
Figure 13 - Land disintegration

Curvilinear (HTD and GT) belts operating on sub-minimal sprocket diameters usually fail by land disintegration, illustrated in Figure 13, and tensile breaks. Trapezoidal (XL, L, H) belts will usually fail by tooth root cracks and tooth shear; however, tensile breaks are not uncommon.

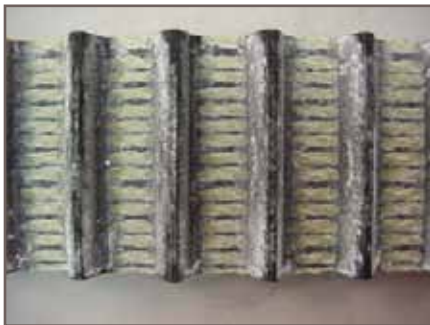
Figure 16 - Extreme wear from abrasion

Belts operating in abrasive atmospheres on applications like foundry shakers, taconite processing equipment, and phosphate mining conveyors often exhibit a high degree of belt land and tooth flank wear. Worn areas frequently have a polished appearance. Figure 16 illustrates a severely worn Gates Poly Chain® GT®2 belt that ran in a highly abrasive environment. Sprocket wear is generally rapid in abrasive environments; therefore, sprockets should be replaced along with belts. To extend the life of belts and sprockets, a sealed guard that is pressurized with clean air can be installed to help keep out abrasive dust and contaminants.

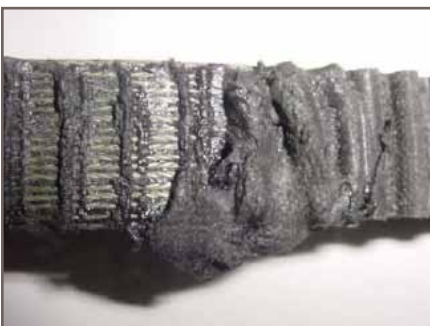
Figure 18 - Melting from high temperature operation, polyurethane

The body material used in urethane belts such as Poly Chain® GT® Carbon® belts is thermoplastic, meaning it has a melting point. When subjected to environmental temperatures in excess of 185°F, the teeth may begin to soften and deform. In addition, the tensile cord to urethane adhesion loses its integrity. Figure 18 illustrates a Poly Chain® GT®2

belt that was exposed to a high environmental temperature.

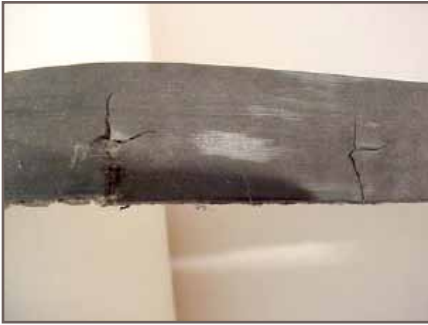
Figure 19 - Tensile cord failure from debris

The introduction of foreign objects between a belt and sprocket often damages both belt teeth and tensile cords. Tensile cords often fracture internally (see Figure 19) or fail later due to crimping, as shown in Figure 20. Once a portion of the tensile cords have fractured, the remaining tensile strength of the belt has been reduced considerably. This often results in a dramatic reduction in belt life. If belt damage from debris is noticeable, the belt should be replaced and the sprockets checked for damage. Damaged sprockets should also be replaced.

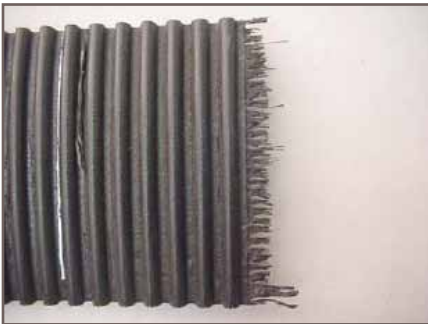
Figure 20 - Crimp failure due to debris
