# Uniform Mitigation Verification Inspection Form

Inspection Date: 8/1/2015		
<b>Owner Information</b>		
Owner Name: EASTWOOD PINES TOWNHOMES		Contact Person:
Address: 1851-1869 PINE CONE CIR		Home Phone:
City: CLEARWATER	Zip: 33760	Work Phone:
County: PINELLAS		Cell Phone:
Insurance Company:		Policy #:
Year of Home: 1973	# of Stories: 2	Email:

**INSURED NAME:  
EASTWOOD PINES TOWNHOMES**

**ADDRESS:  
1851-1869 PINE CONE CIRCLE  
CLEARWATER FL 33760**

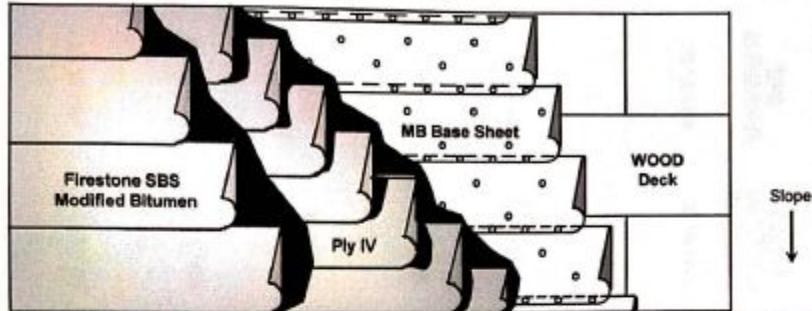
Typical Assembly

**Slope:** Positive drainage up to 1 inch per foot. For slopes above 1 inch per foot, backnailing of the Ply IV sheets and cap sheet is required.

**Deck:**  
Min. 1/2" plywood/OSB

**Base Sheet:**  
Firestone MB Base: Mechanically fasten in accordance with Firestone Technical Specifications or Florida code which ever is more stringent.

**Interply:**  
2 plies Firestone Type IV Glass Ply. Apply in a continuous mopping of hot steep asphalt.

**Cap Sheet:**  
1 ply Firestone SBS Modified Bitumen cap sheet: Apply in a continuous mopping of hot steep asphalt.

**Flashing:**  
Firestone SBS cap sheet over SBS base sheet. Apply in a continuous mopping of hot steep asphalt.

**Surfacing:**  
None required for mineral surfaced membrane.

**Asphalt:**  
ASTM D-312. Type IV asphalt by Anchor-Matcon.
