*Blue Sky*  
Window &  
Gutter Cleaning LTD.

# Fall Cleaning

## GUTTER CLEANING & REPAIR

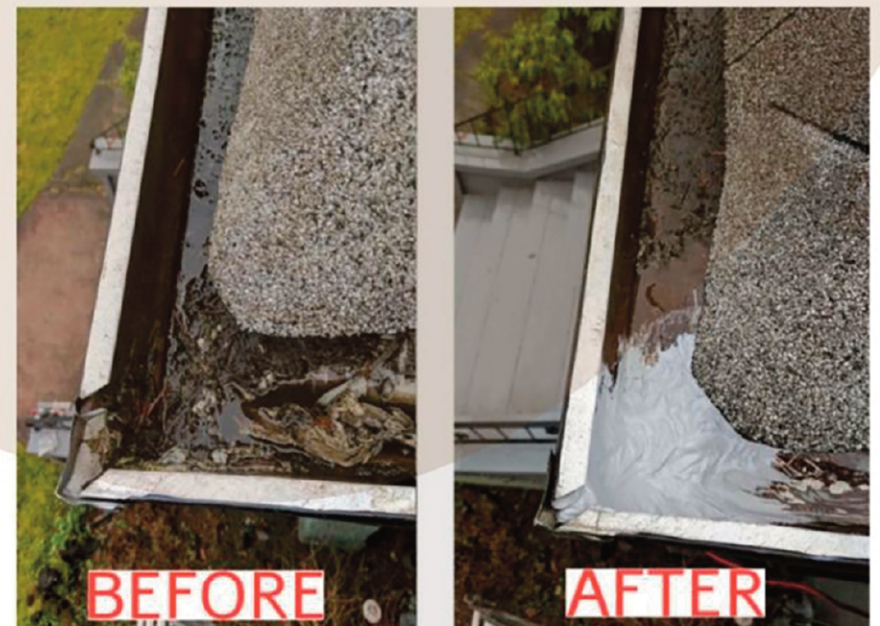
When a corner's sealant (caulking) has failed water and moisture will get behind it, to the wooden structure:

fascia board or rafters (to which the gutter is attached to) will get rotten resulting in the gutter to detach despite proper fasteners in place; moisture will seep up to the rafters and further up into the roofing structure causing water damage there.
