STC SA02798SE

Absolute Solutions LLC

DOCUMENT NUMBER: GWUPA34-IM-000

TITLE: Installation manual
for PA-34 Gear Warning Upgrade

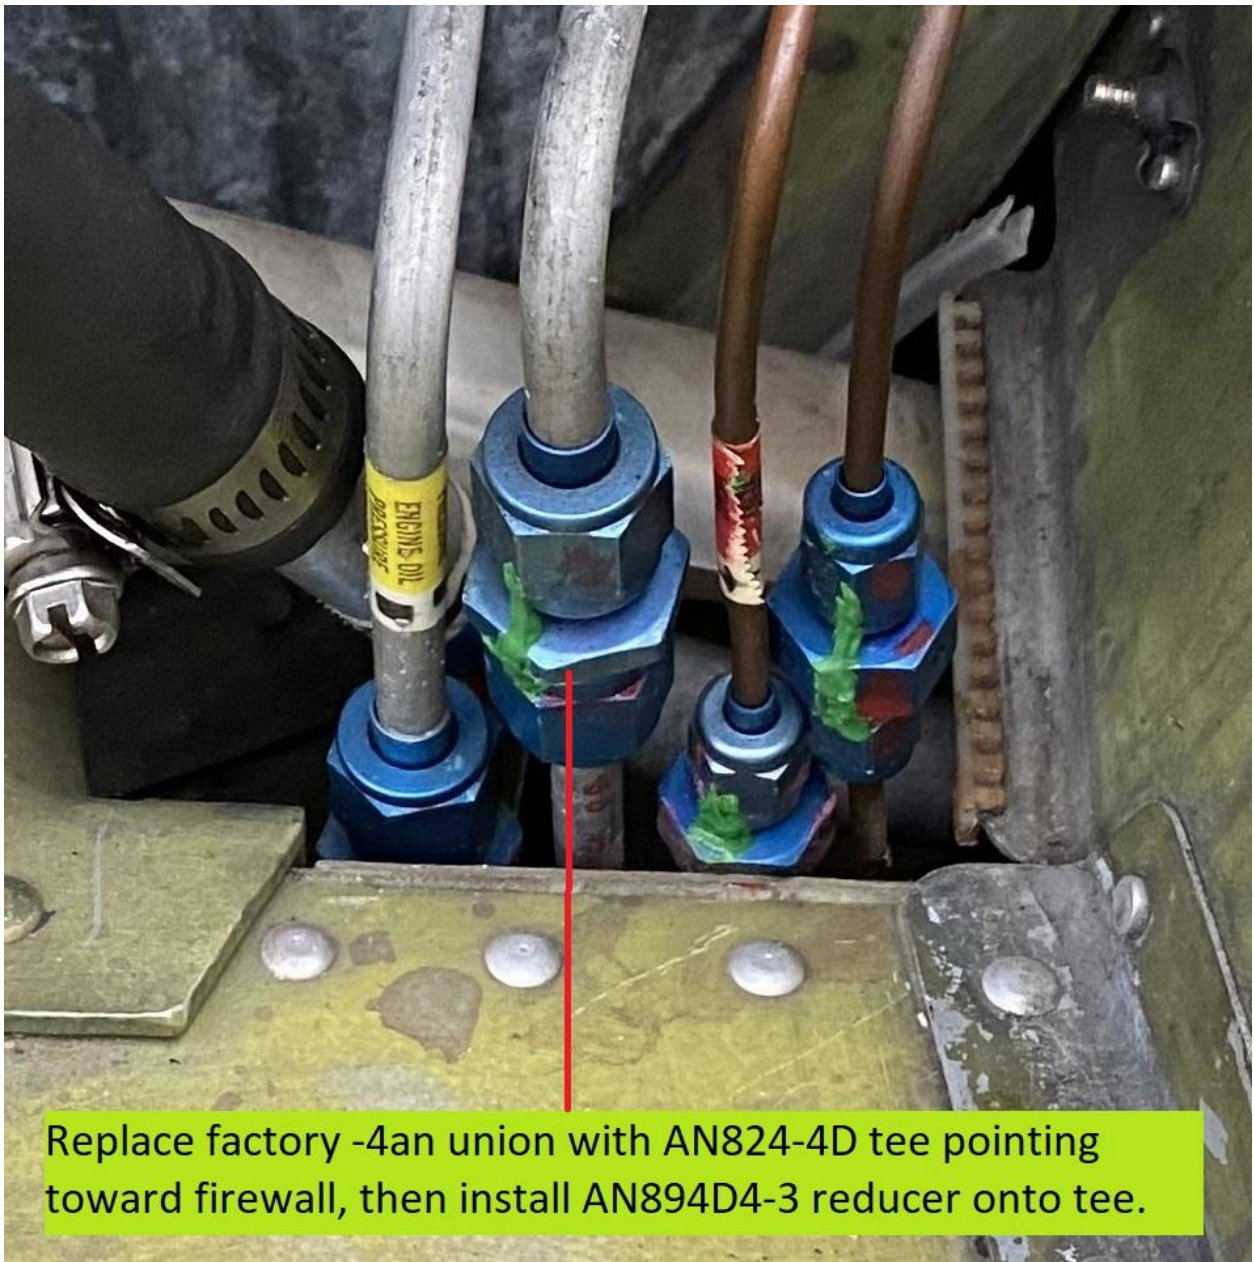
Figure 1-2. Factory Manifold Pressure Union

- 4.) See figure 1-2. Replace factory manifold pressure -4an union with AN824-4D tee pointing toward engine firewall, then install AN894D4-3 reducer onto tee. Temporarily leave AN tee loose to allow for the determination of best routing of vacuum tube.

Replace factory -4an union with AN824-4D tee pointing toward firewall, then install AN894D4-3 reducer onto tee.
