ROAD SAFETY REPORT

MILTON of CAMPSIE

COMMUNITY COUNCIL

Road Safety Proposals

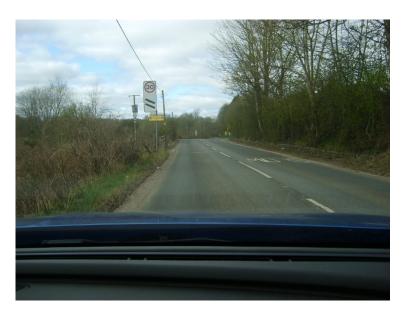
Antermony Road is in a reasonably good state of repair and is governed for the best part by the National Speed limit (60mph) until you are approximately 200 metres from the edge of Milton of Campsie Village where it becomes a 40-mph zone and then at the limit of Milton of Campsie it becomes a 30-mph zone. The approach to the reduced speed zone is a well-known fast stretch of road and as it changes to the 40 mph zone the road drops then has a left then right blind bend as you access the 30 zone. (Image 1 & 2) It is well known for vehicles to pass the entrance to Scott Avenue at this point being in excess of 30mph.

Image 1. Approaching Milton of Campsie from Antermony Road.

- 1. Antermony Road east bound on the approach to the village limits, the 40 MPH sign should be removed and replaced by a 30 MPH at that point. By introducing the restricted speed limit earlier at this point it should ensure that drivers will be at the lower speed as they enter the bends before entering the village. Also, if the 30 limit is extended westwards it will give those emerging from the steadings a better opportunity to emerge safely.

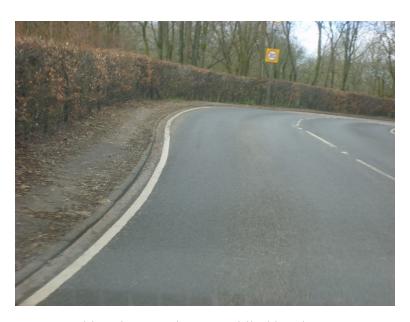
Image 2 – Approaching the 30mph zone at blind bends on Antermony Road.

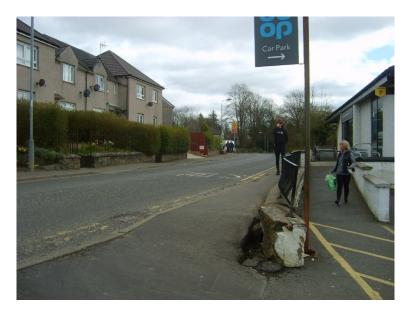
The road narrows at this point as it starts to climb and straighten as it passes the Scott Avenue junction and allows site of the Co-op and the access to the Co-op car park. (Image 3)

Image 3. – View from Co-op car park entrance looking east at approaching traffic.

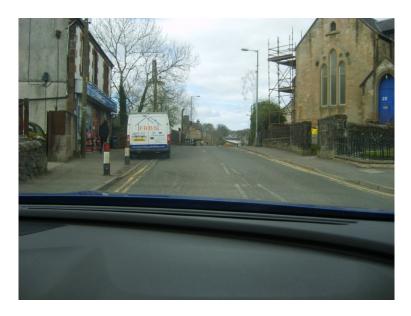
As you pass the Co-op your forward view is limited as you approach Scot Mid, invariably there can be vehicles parked outside Scot mid which you cannot see until you are practically on top of them. (Image 4)

Parking on double yellow lines at this point being a blind summit is particularly dangerous and many near misses of vehicle to vehicle and vehicle to pedestrian has occurred.

The illegal parking at this point is of great concern in the village.

Image 4. Antermony Road approaching blind summit at Scot-Mid.

- 3. More restrictions re parking outside Scot-Mid, perhaps collapsible bollards to allow deliveries and also more attention from council traffic enforcement officers.

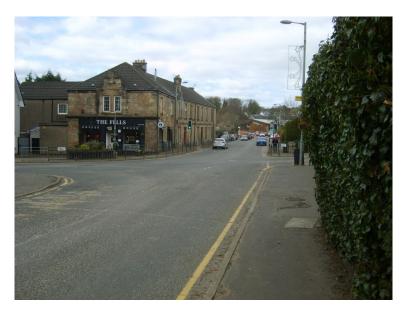
As you continue Westwards towards the cross you have a Pelican Crossing situated some 8 metres west of Milton Cross then a reasonably straight view towards the Church. (Image 5)

Image 5. Milton Cross viewed from Antermony Road.

- 4. Milton Cross, the CC propose the removal of the Pelican Crossing situated close to the cross and replace with ATS at the Cross. This would govern the three roads converging and control the traffic flow. Also Stop lines could be placed appropriately to allow large vehicles the opportunity to turn safely. It could also incorporate a crossing facility that would allow pedestrians to cross safely at all points at the cross.

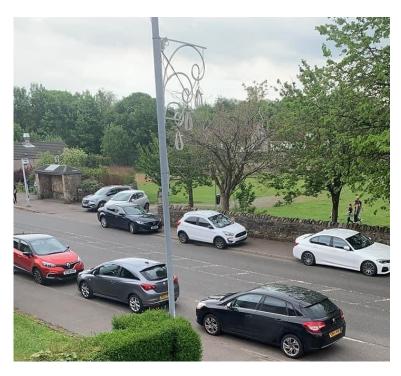
The area of to the left is the Battlefield Football pitch, which under non Covid conditions is in fairly regular use. When games are on you will find many cars parked on the south kerb, they will be from participants in the football match and spectators. The cause of the parking in this manner is the lack of parking in the village as a whole. These illegally parked vehicles restrict the width of the road and available pavement space creating inherent dangers for pedestrians and drivers alike. (Image 6)

Image 6. Cars parked on pavement at Battlefield Park.

A potential solution to this is to open Craighead Primary School parking facilities to the teams or groups booking the pitch and facilities. Within Battlefield park there is also a purpose-built children's play area which is quite substantial and well used.

- 5. The placing of a Pedestrian crossing at or near the play park on Campsie Road, this would allow everyone to access the play park safely and also assist those crossing to gain entry to the church. The second asset here is that installation of a crossing at this locus would prevent indiscriminate parking during football matches, as noted previously the local school parking area should be available to those renting the pitch on match days.

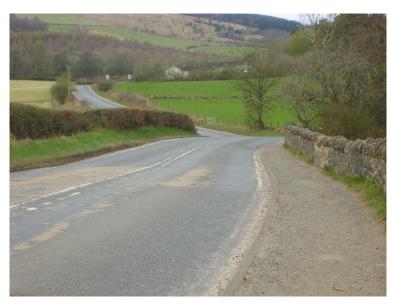
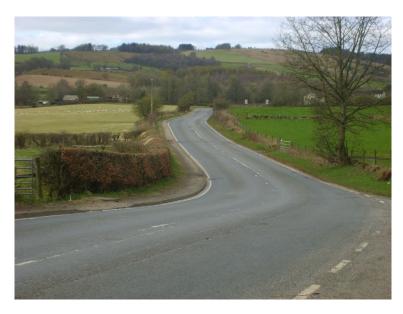
As the road climbs uphill past Mount Pleasant there is a long stretch of road within the 30mph zone passing the Valleyfield Estate which is again known as an extremely dangerous road due to speeding vehicles from both directions. Beyond here the road enters a series of right, left and left blind turns before levelling off for a considerable distance in a section of National speed limit heading towards Lennoxtown. (Image 7 & 8) This whole section of road is a regular accident zone.

Image 7. Campsie Road leaving the village.

Image 8. Campsie Road leaving village on 60mph zone.

- 6. On Campsie Road at the top of the hill near to Mount Pleasant West bound could have signage informing drivers off concealed junctions, exit from new builds on the left.

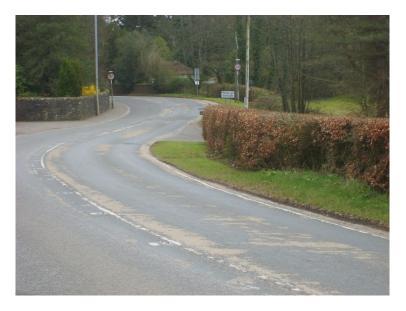
From the west exiting Lennoxtown on Campsie Road you are enter a National speed limit zone which continues for approximately several hundred metres then the road bends slightly left then a sharp right turn. This section is governed by a solid double white line system.

Image 9. Entering the village on fast accident-prone section of 60mph zone.

- 7. Extending the 30 MPH limit from Lennoxtown directly into Milton of Campsie.
- 8. Birdston Road south of Milton Cross warning signs on the approach to the Railway Bridge of narrowing, pavements are very narrow causing pedestrians to access the roadway on occasions.

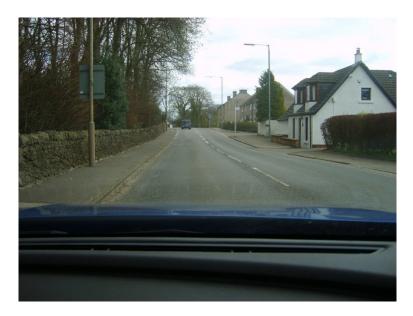
You then enter Milton of Campsie via a slight left bend and the 30-mph zone, the road is straight for a considerable distance before bending to the right and going downhill. This is the section of road passing Valleyfield which is a well-known speeding area. (Image 10)

Image 10. Campsie Road entering the Village passing Valleyfield – speeding and accident zone.

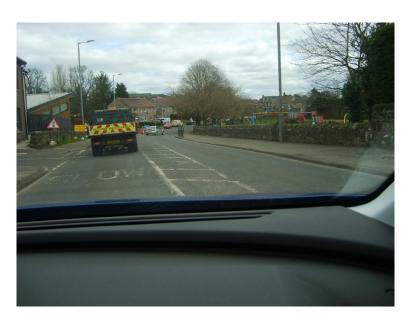
The road then bends to the left and your view is then opened to the Church on your left and the Play area and Football Park on your right. The Pelican crossing is coming into view as are the parked cars both left and right. (Image 11.)

Image 11 Campsie Road approaching church and Battlefield Park

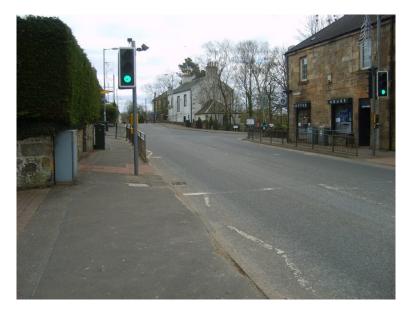
Image 12. Pelican Crossing at Milton Cross.

Approaching Milton Cross the Pelican crossing comes into use before the junction with Birdston Road. The position of this is baffling to most villagers as it only allows potentially safe crossing over one of the roads at the junction and many vehicles turning onto Campsie Road from Birdston road have sped through the lights without noticing that they were at red. This Pelican crossing would have served a far greater purpose and provided far greater safety for the village if it were formed as a three-way set of traffic lights controlling Milton Cross.

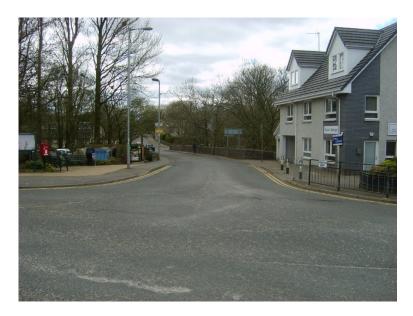
Turning right into Birdston Road presents many challenges, none more so than the state of the road surface. In its presents state the surface of the Moon is probably smoother and there have been many complaints of damages done to car wheels.

There is an area of the width of the road and approximately 29 metres in length which are in a deplorable state of disrepair.

This is at an area where pedestrians are likely to cross to access the car park and we are incredibly surprised that no one has fallen yet in this section of road because the surface is so uneven and as noted previously there is no safe way to cross other than to dodge the traffic. The whole area is an accident waiting to happen.

Image 13 Beginning of Birdston Road and deplorable surface conditions.

Whilst we understand that Birdston road is earmarked for re-surfacing which has been postponed due to Covid we would note that on all three roads the white line and speed indicators on the road surfaces are non-existent. This is also a concern on the majority of side roads in the village. A concerted effort of line painting should be undertaken within the village.

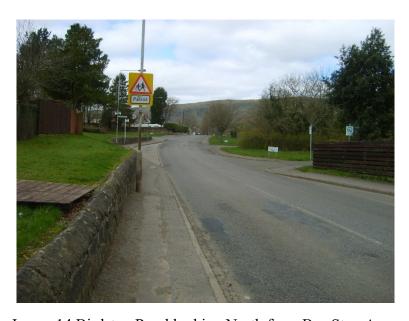
The road then continues straight before bending slightly left and dropping downhill before climbing towards a blind summit, dropping and climbing again. (Image 14)

This whole stretch from Milton Cross to the edge of the village is notorious for speeding and with the best efforts of the Police and MOCCC urging villagers and visitors to slow down it remains an extremely fast stretch of road.

Image 14 Birdston Road looking North from Bus Stop Area.

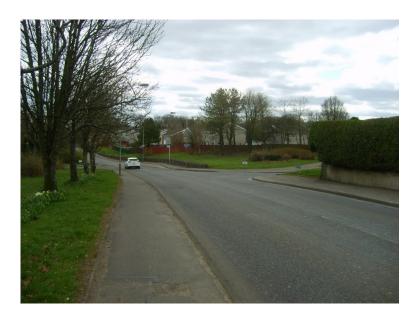
Image 15 Birdston Road looking South towards Redmoss Road Junction & Bus Stops

- 9. Installation of a Pedestrian Crossing near to Kincaid Field, this would aid many of our elderly residents the opportunity to cross to gain access to public transport. It would also have the objective of slowing traffic at that particular stretch of road.

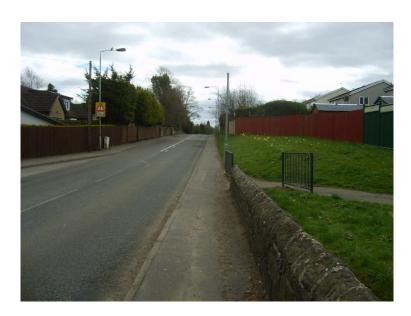
Image 16 Blind summit on Birdston Road.

As the road continues past both bus stops adjacent to Redmoss Road and Kincaid Field the road rises to a blind summit (Image16) descends past the entrance to the Kincaid House Hotel and rise again to another blind summit, at the top of this summit the entrance to the new Cala estate is positioned.

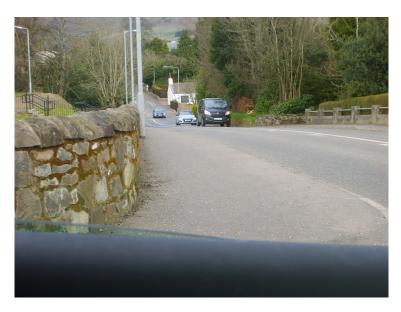
The junction looking north functions reasonably well as the sight lines appear to meet the road development standards regarding junction sight lines and distances. (Image 17)

Image 17. Looking North from Cala Estate junction.

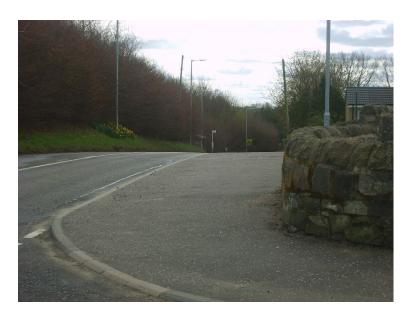
Looking south from the Cala Estate Junction the sight lines are atrocious and it is a hazardous exit from the junction due to the speed of cars approaching from the south and the obvious fact that the junction does not meet the roads development standards for sight lines for drivers of standard vehicles. (Image 18.)

Image 18. Looking south from Cala Estate junction.

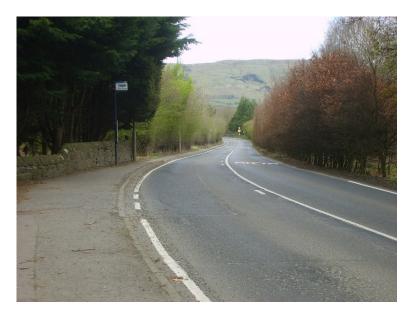
As the road passes this junction and descends it approaches a right-hand bend, is straight for approximately 150 metres before a sharp left bend, governed by a solid double white line and enters Birdston. There have been many near misses on these bends with impatient drivers overtaking poorly.

Image 19. Looking north from Birdston village.

- 10. The section of road from Birdston Kennels to Birdston could be marked with a solid double white line system this would result in fewer vehicles overtaking and therefore speeding on the approach to the blind left bend at Birdston. Also, the erection of warning signage on the approach to the bend of concealed exits just around the bend.

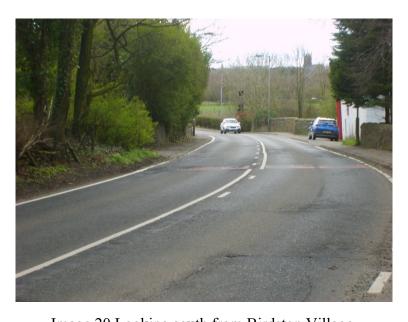
The road straightens again then as you enter a 40 mph zone bends to both right and left before re-entering a 30mph zone and going into Kirkintilloch. (Image 20)

Image 20 Looking south from Birdston Village.
