# Boiler Service Procedure

Xclusive 24 (G.C. 47-291-13)

## **The complete boiler guide**

### **High Efficiency Wall-Mounted Gas Boilers**

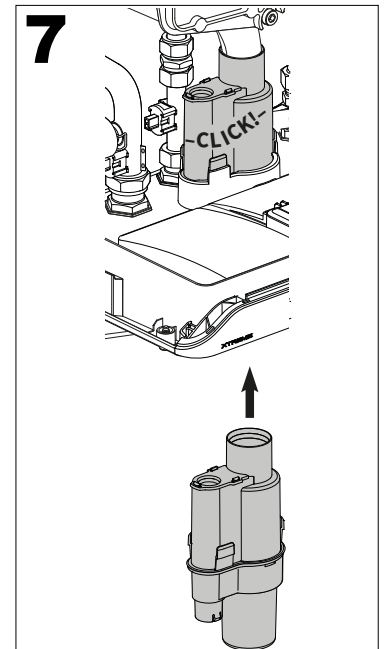
### Annual service (A) continued

- ▶ Lift and rotate the expansion vessel to the left side.
- ▶ Open the gas isolation valve and check both of the gas unions for tightness.
- ▶ Check and repair any water leaks within the boiler.
- ▶ Turn the expansion vessel back to its original position. Make sure the vessel is secured by the lip on the cable cover.
- ▶ Check a 3amp fuse is fitted before re-establishing the power.
- ▶ Switch on the boiler.
- ▶ Check the front plate, the fan seal, fan connection to the front plate, also check the flue components for leakage, repair or replace as required.
- ▶ Check the gas/air control and also test the gas outlet union on the gas valve for tightness.
- ▶ Check the domestic hot water facility for correct operation.
- ▶ Turn to page 12" measuring the flue gas at maximum output" then continue through the procedure.

- ▶ **The expansion vessel must be inspected and tested at each annual service and if required repressurised between 0.75 & 1.0 bar (cold and with no system pressure). Ensure the flexible hose is not kinked, leaking or damaged (Replace if required).**

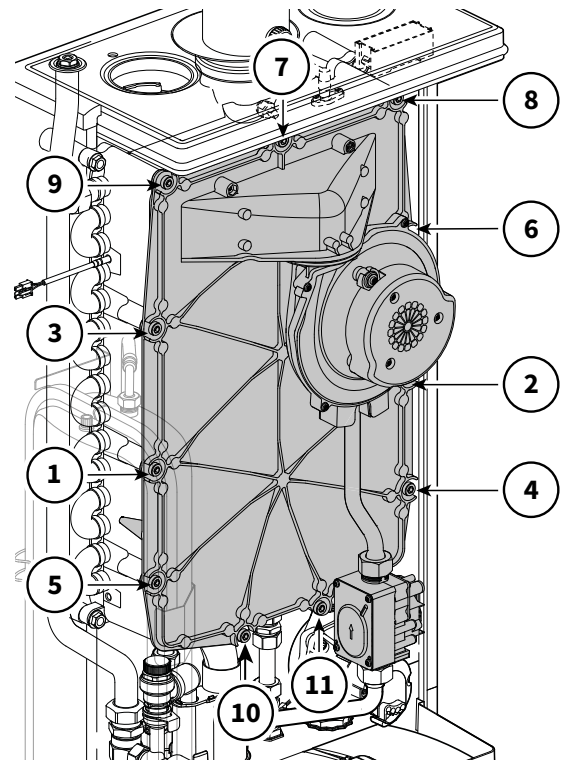
## Annual service (B) (re-assemble)

- ▶ **Replace the Viton front plate O-ring at least every 2 years or if damaged/ discoloured and or if the front plate has been removed. All red Silicon front plate seals must be replaced, regardless of age with the below**  
**Art.no: 086504 (Black Viton) — Xtreme 24/30**  
**086474 (Black Viton) — Xtreme 36**
- ▶ **Check and replace any other worn gaskets (see page 11, 18 & 22) check they are correctly located.**

- ▶ Check whether there is a thin layer of ceramic grease both sides of the front plate where the shoulder bolts protrude especially between the flange of the shoulder bolts and the front plate, itself

- ▶ If there is insufficient grease present, extra must be applied using the foam application tool (A) within the kit (ceramic grease kit available to order, part number 090587).

- ▶ Ensure the Viton O-ring seal is pushed fully into the O-ring chamber around the whole front plate. Place the front panel back on the heat exchanger and attach it with the 6mm Allen key shoulder bolts. Tighten the shoulder bolts (1 to 11)\* by hand, working diagonally. The order of tightening is shown in the diagram.

- ▶ Fully tighten the Allen shoulder bolts with a torque wrench set at 10-12 Nm when available to ensure uniformity.
- ▶ Check and tighten the burner bolts diagonally by hand.

Clicking noise (expansion) during operation is normally due to overtightening of the front panel bolts or lack of ceramic grease.
