Breakwater revetment made from Elastocoast® in Harlingen (the Netherlands)

Case Study

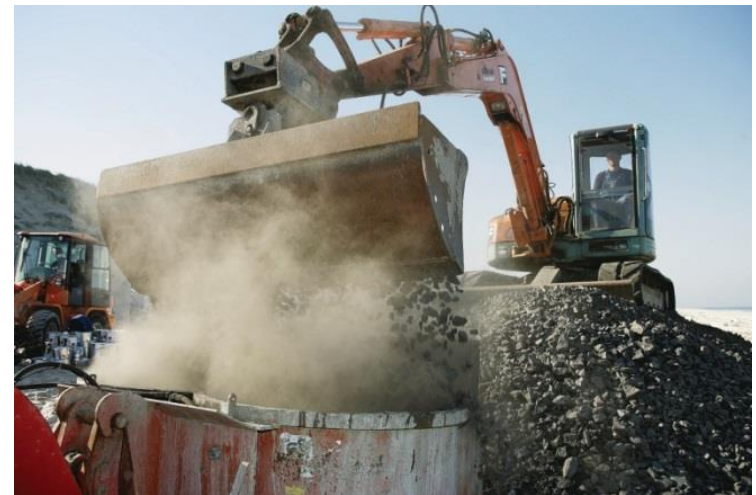
The breakwater revetments in the port of Harlingen consisted of concrete elements which are destroyed by now. In order to fill up the space between these elements Elastocoast® was used in combination with small granulate stones. As a result, the surface could be stabilized.

Construction: Granulate gravel (11/16 mm) and Elastocoast®
