Breakwater made from Elastocoast® on Holm Hamburg (Germany)

Case Study

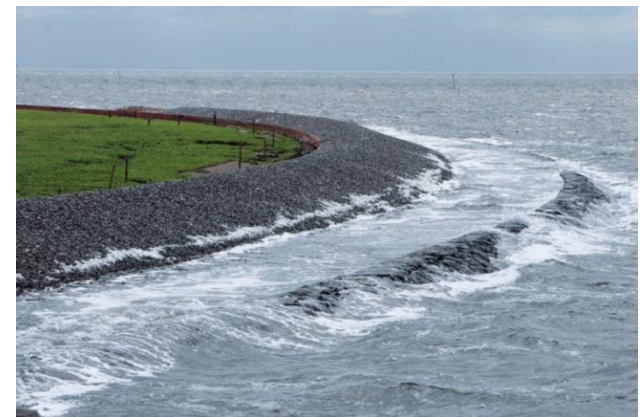
Construction: Iron silicate stones and Elastocoast® on gravel core and geotextile
