# Coastal protection made of Elastocoast® in Sebangau Bajong, Sarawak (Malaysia)

## Case Study

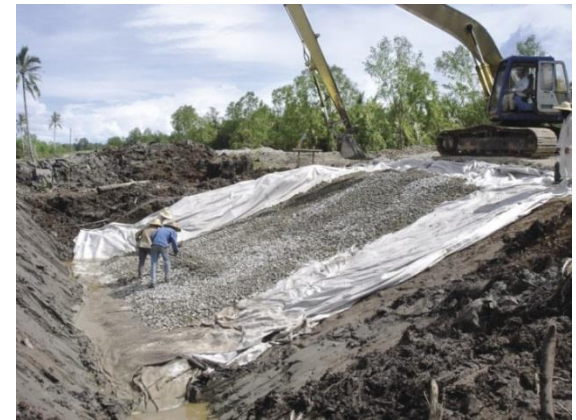
Despite a conventional protection the coast of Sebangau Bajong was eroded more than 500 meters during the past ten years. Now Elastocoast® ensures the protection against erosion and proves to be a suitable solution both from an economic and an environmental perspective. It enables the growth of small plants between the porous granite and furthermore provides a better view along the coastline compared to the use of big boulder.

Task: Coastal protection

Bonding agent: Elastocoast® 6551/103; approx. 8.4 t

Area: 5,000 m<sup>2</sup>
