# Protection against wave impact with Elastocoast® in Walton (Great Britain)

## Case Study

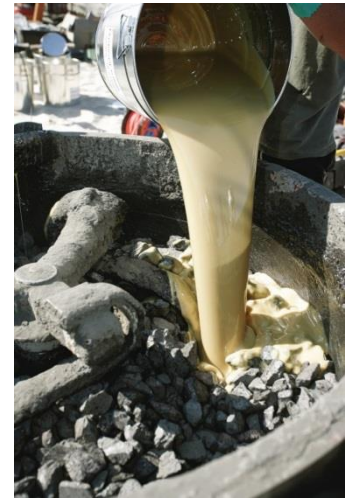
On the coast in “Walton on the Naze” in Colchester, there are plenty of beach houses that suffer from sea damage during storms and winter tides. For additional protection Elastocoast® was mixed with small stones and filled into the free area between the beach and the concrete sea front. For aesthetic reasons Elastocoast® was used in this tourism sector.

Construction: Small stones mixed with Elastocoast®
