StitchDog™

Carbon Fiber Grid Stitch Crack Repair System

Case Study

Hawaii AIPA Parking Deck

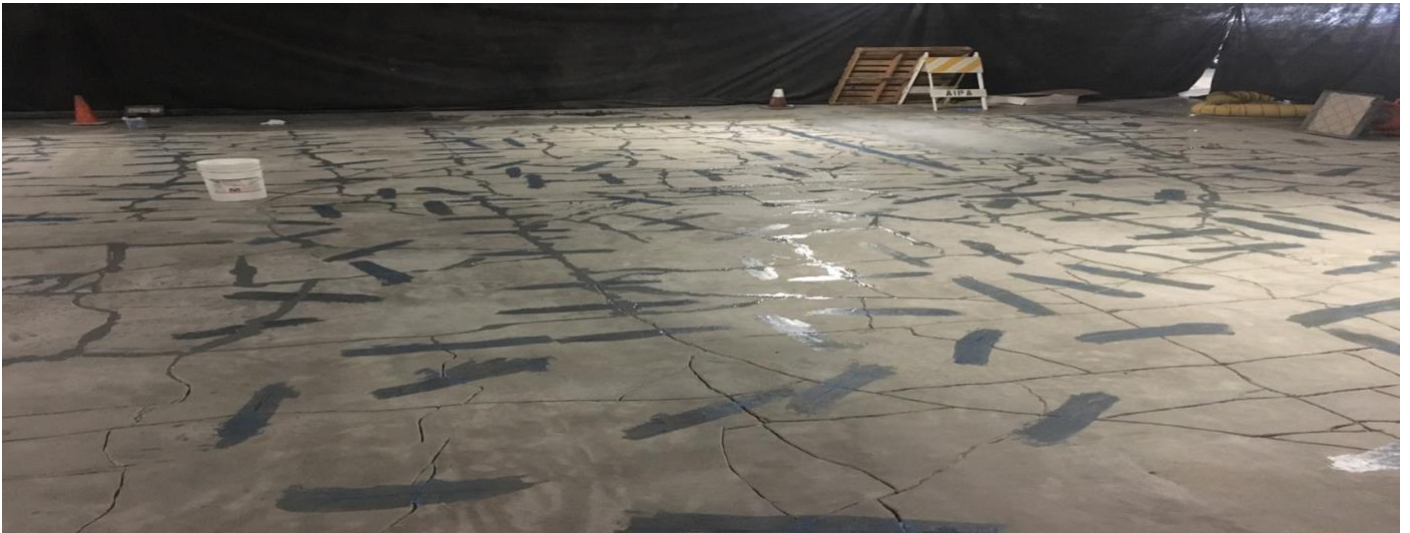
Case Study Image 1

StitchDog™ Carbon Fiber Grid Stitches being installed after cracks were prepped, cleared of loose concrete and area cleaned and vacuumed. Saw cuts are made perpendicular to cracks using a standard circular saw with concrete blade. Because of the failure was so extensive, some of the StitchDog™ CFGS are covering multiple crack lines.

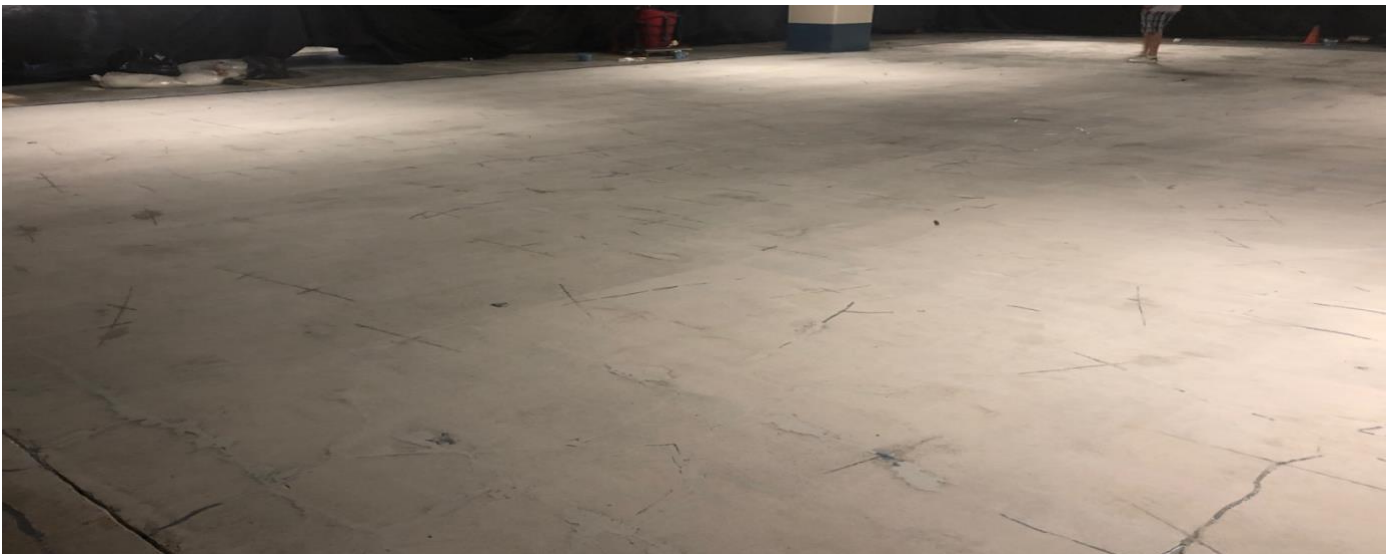
Case Study Image 2

After all of the cracks were repaired with the StitchDog™ CFGS System, the test area was allowed to cure for 24-hours to ensure no degassing of the epoxy would affect the overlay system. This image shows the surfaced prepped with a grinder to a profile necessary for the park deck coating system.

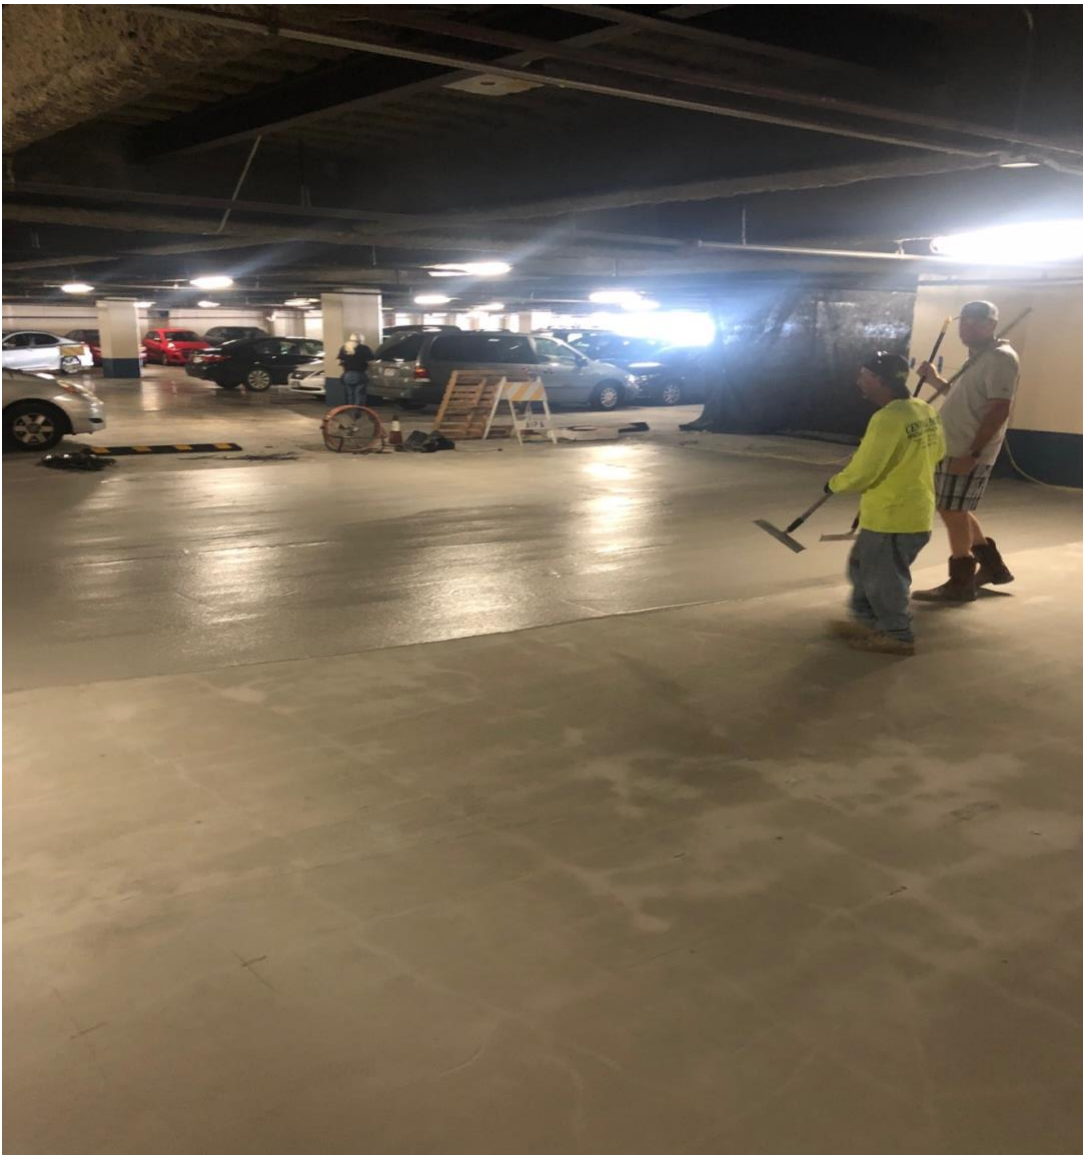
Case Study Image 3

The Miracote MPC Park Deck System being installed. The two-component system consists of a unique rubber-like polymer liquid which is mixed with a proprietary cement and aggregate blend. Typically, the Miracote MPC Park Deck System is applied by hand trowels, magic trowels, brush or spray. Please note that the Miracote MPC Park Deck System allows for the transmission of inherent moisture vapor within the concrete.

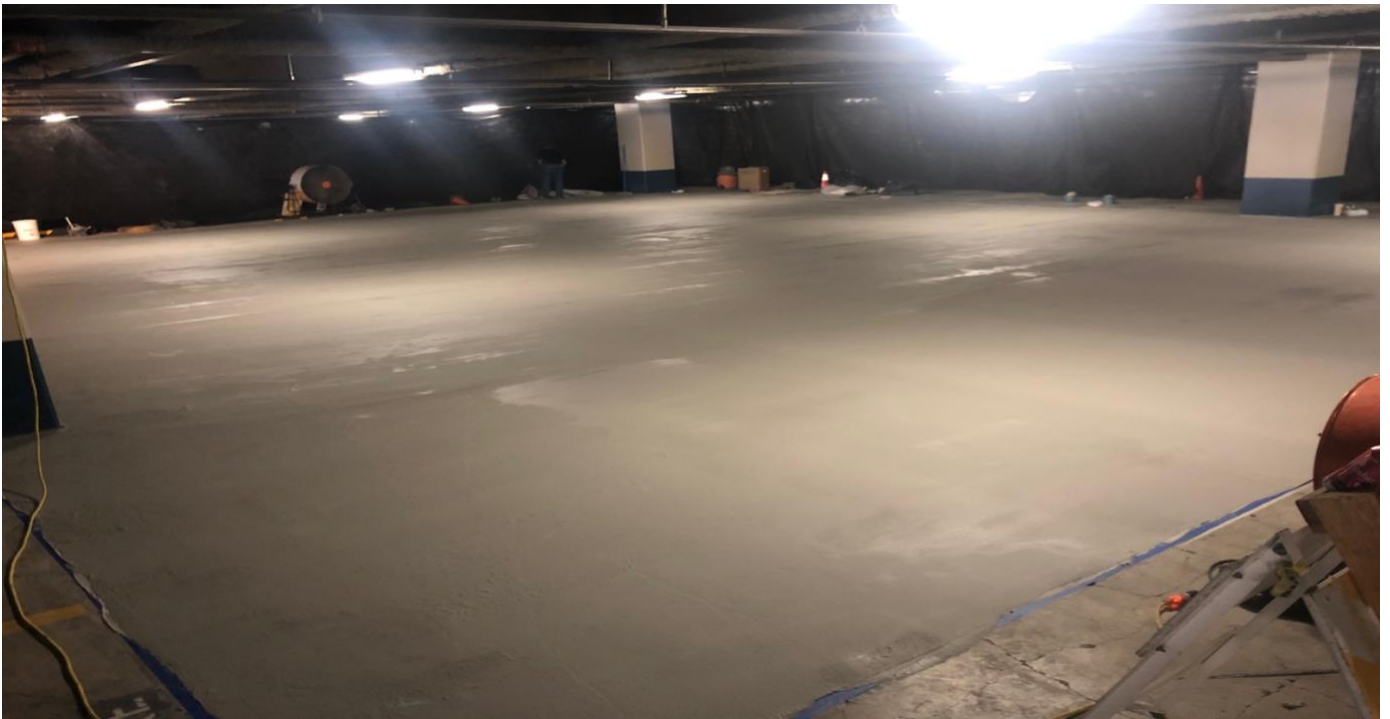
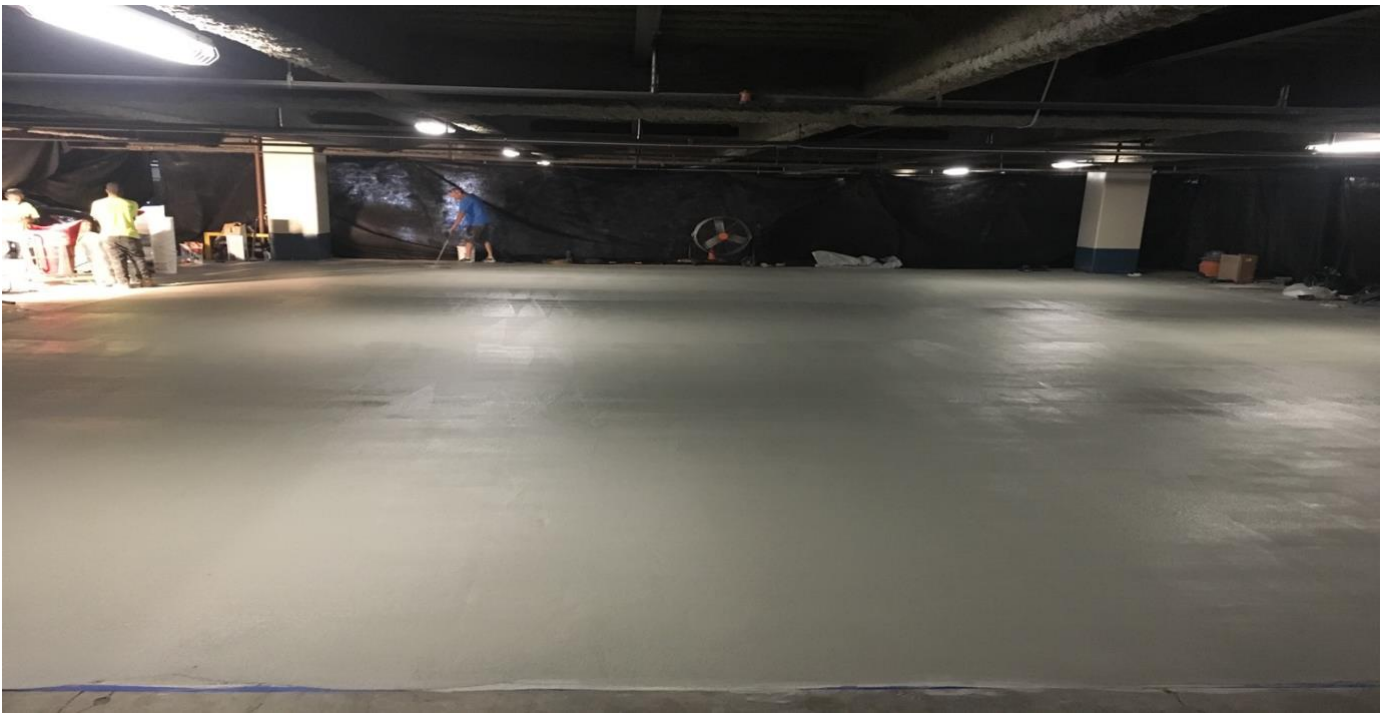
Case Study Image 4

Finishing up the project test area. This test area included parking stalls and part of a drive lane. During the 7-month test period, the project test area received moderate to heavy automobile traffic.
