# Public Water System Annual Report

Southwest Regional Water Treatment Plant & Southwest Regional Water Co-op  
2024

**The Melita Water Treatment Plant**

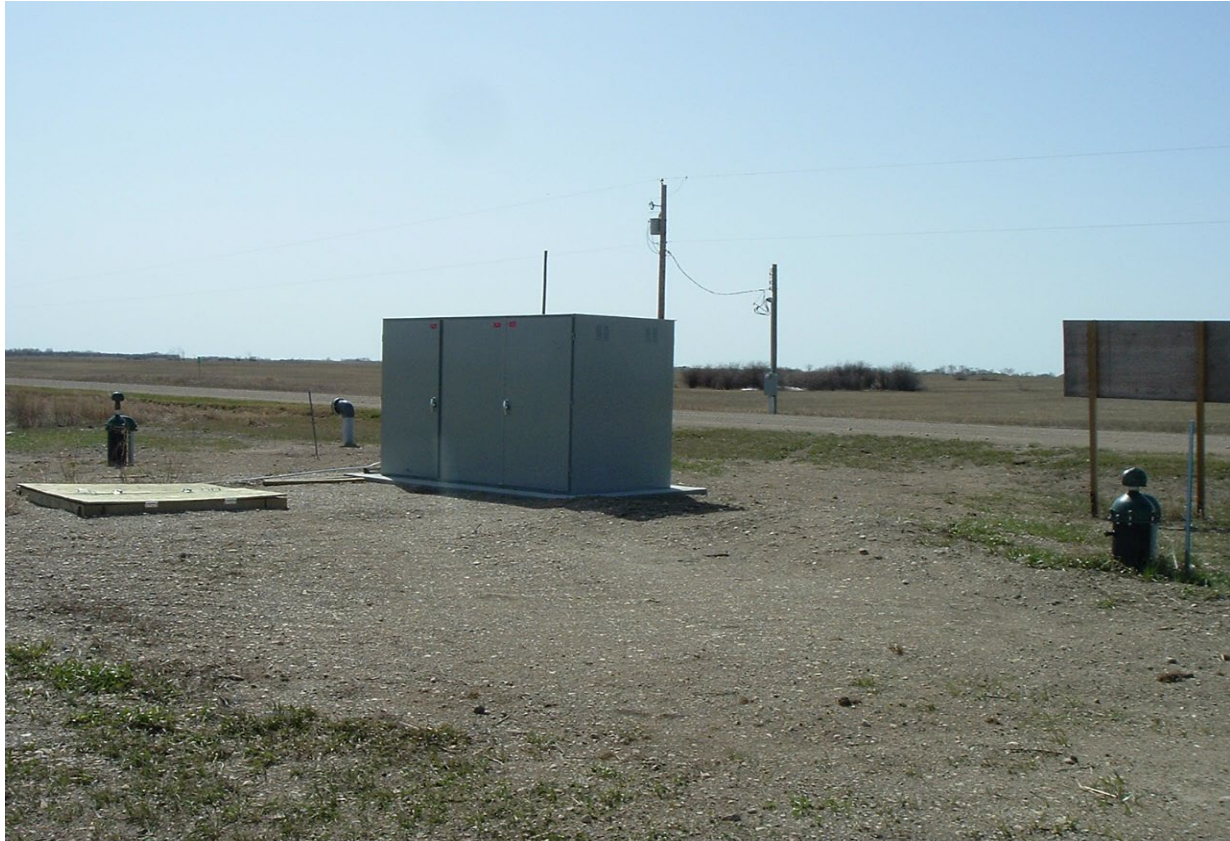
Well Site 1

The WTP receives groundwater from four wells located at 16 km North East of Melita @ NW23-5-27W. The wells draw groundwater from the Oak Lake Aquifer. The wells were drilled to a depth of 33 feet. Raw water pumped from the wells into a 200 mm (8 inch) pipeline where it flows directly into the WTP for processing and treatment.

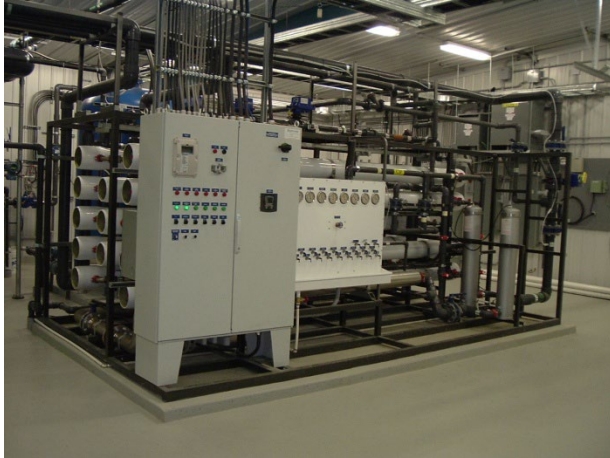
The South RO (original unit)

Raw water is pumped to the WTP where approximately 90% of the flow is directed through reverse osmosis membranes. The remaining 10% by-passes through a sand-filter with 3 new UV (ultraviolet) units prior to blending with membrane permeate. Blended flow is chlorinated with sodium hypochlorite and then stored in a 1,000,000-litre concrete reservoir for distribution. Since membranes remove most dissolved minerals, blending permeate with filter water allows the operation to produce treated water with a more desirable hardness and PH. Approximately 13% of membrane flow (11% of the raw water) is discharged as membrane concentrate to the Souris River. Treated water is distributed to the Co-op and a bulk water (truck) fill is available for rural usage. In the spring of 2014, the second RO unit and filter came online doubling the production capacity of the plant.

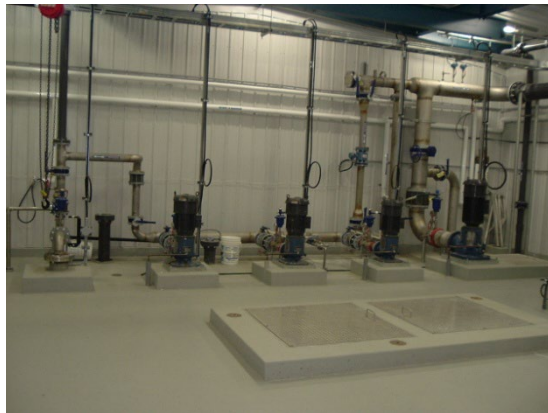
## The Distribution Pumps

Treated water from the reservoir, located underneath the WTP, is pumped throughout the Melita distribution system via two 7.5 horsepower duty pumps, with one 30 horsepower emergency standby pump for firefighting purposes. The SWRWC has one 7.5 horsepower duty pump and a new 2 horsepower jockey pump which was installed in the spring of 2017 to supply the rural side of the system. The SWRWC distribution system consists primarily of High-Density Polyethylene Pipe. In 2017 the rural system was expanded to take in another 71 homes and another 150 km of pipe was installed, the raw, 10" and 8" didn't increase but the rest did. 12 miles of 8" raw water supply line, the distribution consists of the following 11 miles of 10", 5 miles of 8", 19 miles of 6", 30 miles of 4", 68 miles of 3", 49 miles of 2", for a total of 182 miles of pipe in the ground. A map of the distribution system is on the next page. The Waskada Rural Water Co-op already had several miles of pipe in place but is now part of the overall distribution system. The WTP also has a natural gas-powered generator located in the building that powers the distribution pumps during times of a power failure.

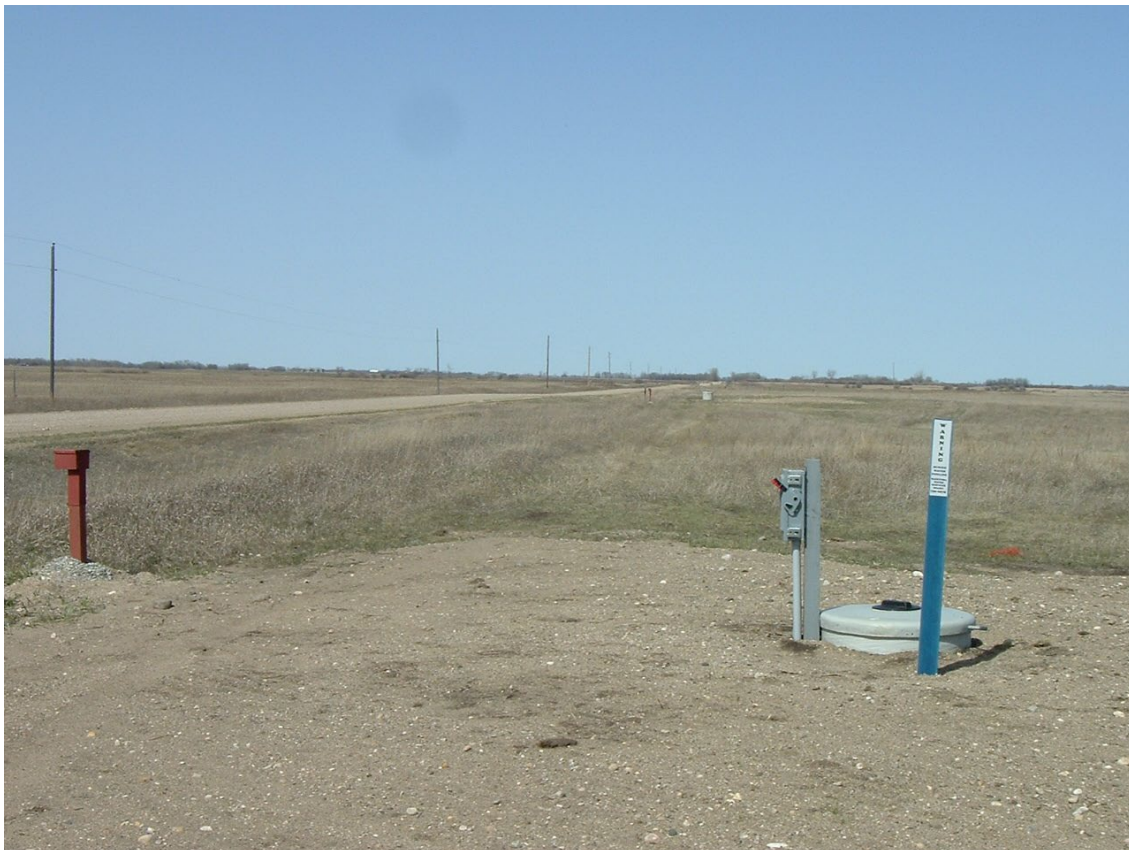
Recharge Wells

The updated graph on page 11 shows ground water levels at various points at and around the new wells.

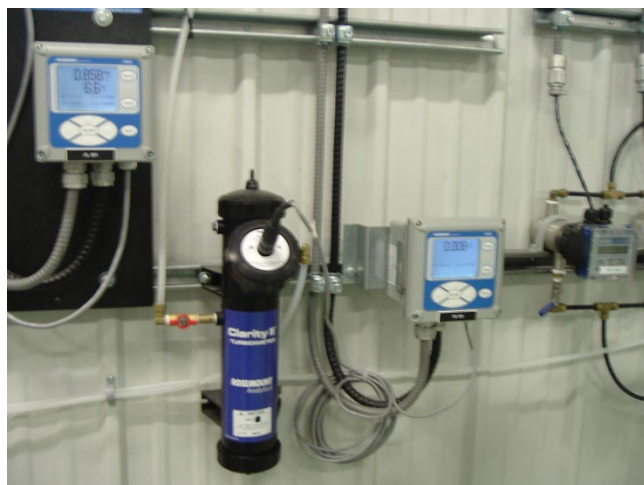
Online Turbidity Monitoring Equipment

As required by the *Drinking Water Safety Act* the Melita PWS ensures continuous disinfection is maintained at the WTP by keeping in stock all spare parts required for the chlorinators, as well there are two spare chlorinator pumps kept at the plant. Disinfection residuals are monitored continuously by an online monitor that monitors the water continuously as it leaves the WTP. We also monitor the residuals daily at the WTP and in the distribution system; these tests are performed at the WTP after the samples are collected. The results of all tests are recorded on our records at the WTP as well as Monthly Chlorination and UV Report forms which are sent to the regional *Drinking Water Officer* at the end of each month, to check for standard compliance.

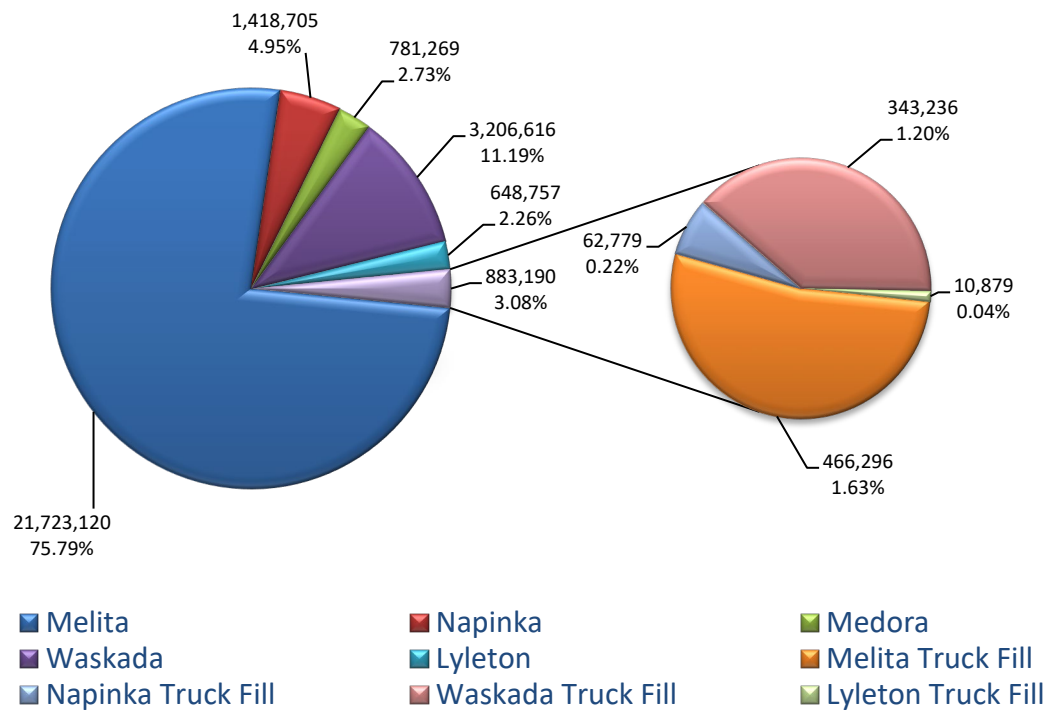
## 2024 Usage Chart in Imperial Gallons

The treatment system capacity was designed to meet a 20-year future demand for Melita as well as additional capacity for the rural water system. The water system production and usage are summarized in the following charts in ***Appendix "A" – Usage Charts.***
