Public Water System Annual Report

Melita Water Treatment Plant & Southwest Regional Water Co-op
2011

The Melita Water Treatment Plant

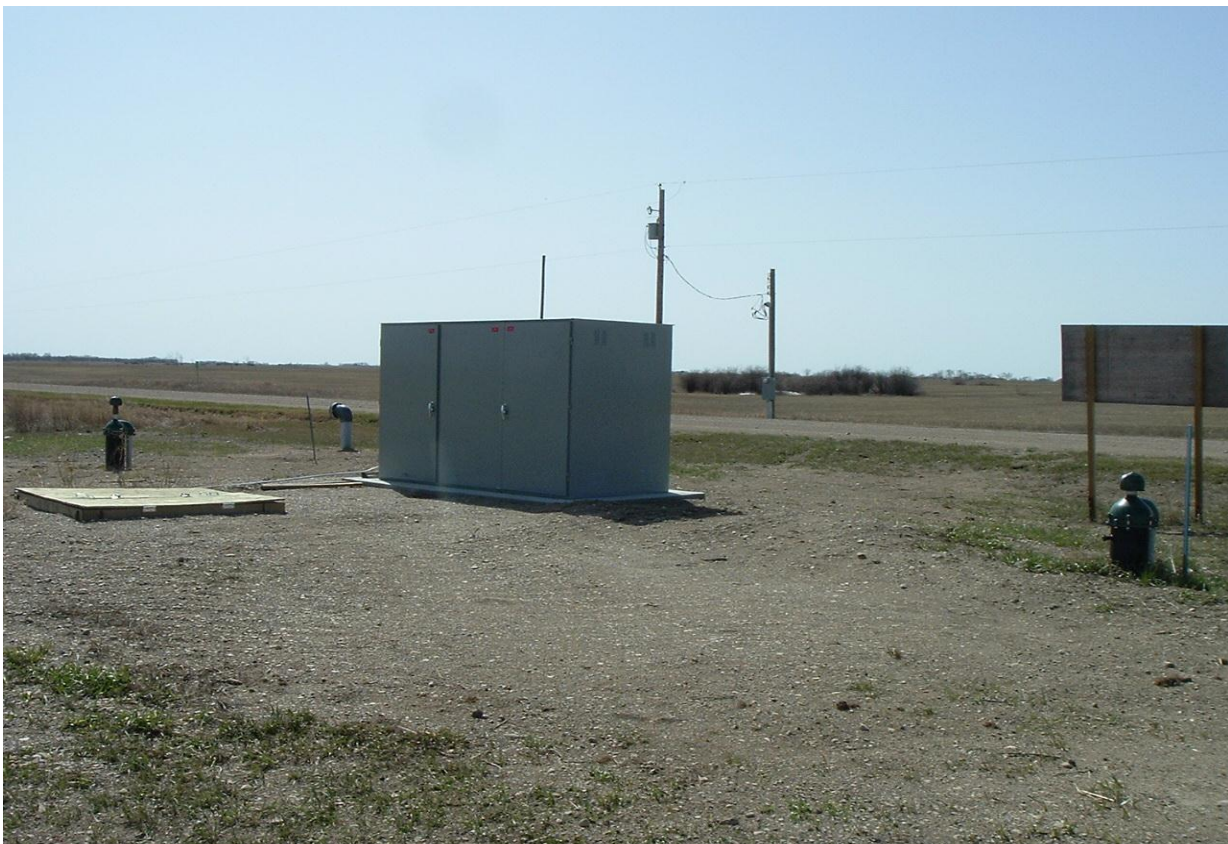
Well Site 1

The WTP receives groundwater from two wells located at 16 km North East of Melita @ NW23-5-27W. The wells draw groundwater from the Oak Lake Aquifer. Both wells were drilled to a depth of 33 feet. Raw water pumped from the wells into a 200 mm (8 inch) pipeline where it flows directly into the WTP for processing and treatment.

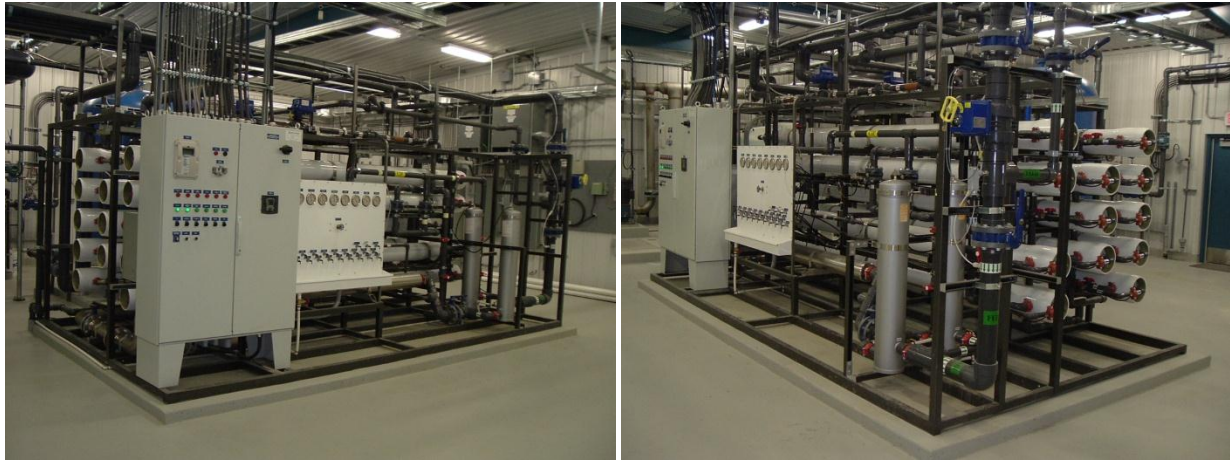
The R.O. Unit

Raw water is pumped to the WTP where approximately 84% of the flow is directed through a combination of nano-filtration and reverse osmosis membranes. The remaining 16% by-passes through a sand-filter prior to blending with membrane permeate. Blended flow is chlorinated with sodium hypochlorite and then stored in a 1,000,000 litre concrete reservoir for distribution. Since membranes remove most dissolved minerals, blending permeate with filter water allows the operation to produce treated water with a more desirable hardness and PH. Approximately 20% of membrane flow (14% of the raw water) is discharged as membrane concentrate to the Souris River. Treated water is distributed to the Co-op and a bulk water (truck) fill is available for rural usage.

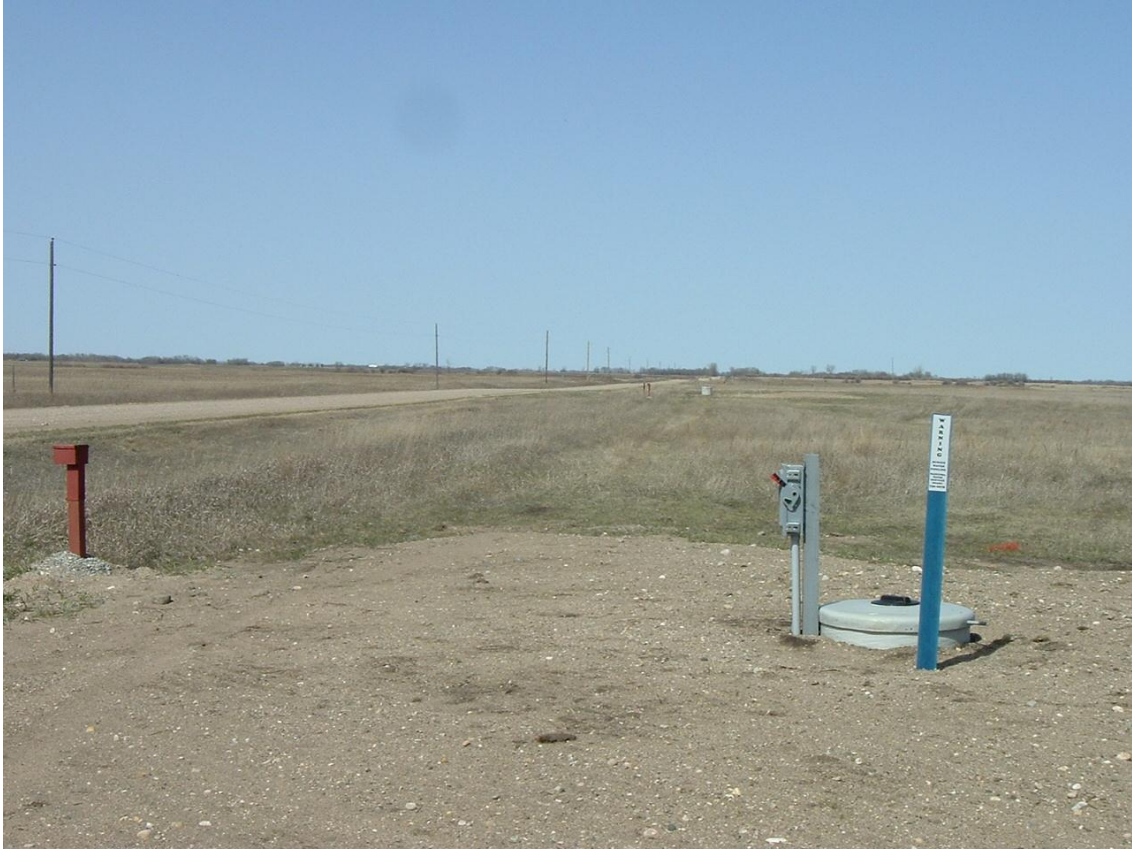
Recharge Wells

Test drilling activities in 2009 revealed at least three separate basins in close proximity to the well field. The basins are referred to as the south, middle and north basins whereby the production wells are located in the south basin. In addition, the Broomhill truck loader station is also located in the south basin. Due to the water table drop, the pump in the truck fill had to be lowered to maintain its operation. Recharge infrastructure include a 760 mm (30 inch) well was installed in both the middle and north basin. A 75 mm pipe line was installed from the middle basin well to the south production well. This would allow groundwater from the middle basin to be pumped to the production well site and artificially recharge the south basin. However, due to Manitoba Hydro power restrictions, this well can only be pumped while the production well is not in operation. The WTP generally requires water for about 10 hours a day such that the middle basin is pumping for about 12 hours a day. An automatic switch-over to the recharge well can be turned on when recharging is needed, when the production well is off the recharge well runs and vice-a-versa. Pumping groundwater from the middle basin to the south basin commenced on August 26th, 2009 on an as needed basis and wasn't used in 2010. Since the middle basin could only be pumped intermittently, the north basin well was temporarily equipped with a pump, generator and overland pipeline to speed up the water table recovery. Pumping from this basin occurred from September 3rd to September 21st until water levels significantly recovered and the north basin water table prevented further pumping. The water table in the north basin has since recovered.

Currently, the middle basin well is intermittently pumped to the production well site in an attempt to maintain water levels until the new well field located on the SE24-5-27W can be put into operation. KGS Group determined that pumping from all three basins will not be sustainable to meet Melita demands and recommended developing the new well site.

In 2011 the recharge well was not used due to the high water table experienced. The updated graph on page 11 shows ground water levels at various points at and around the original wells.

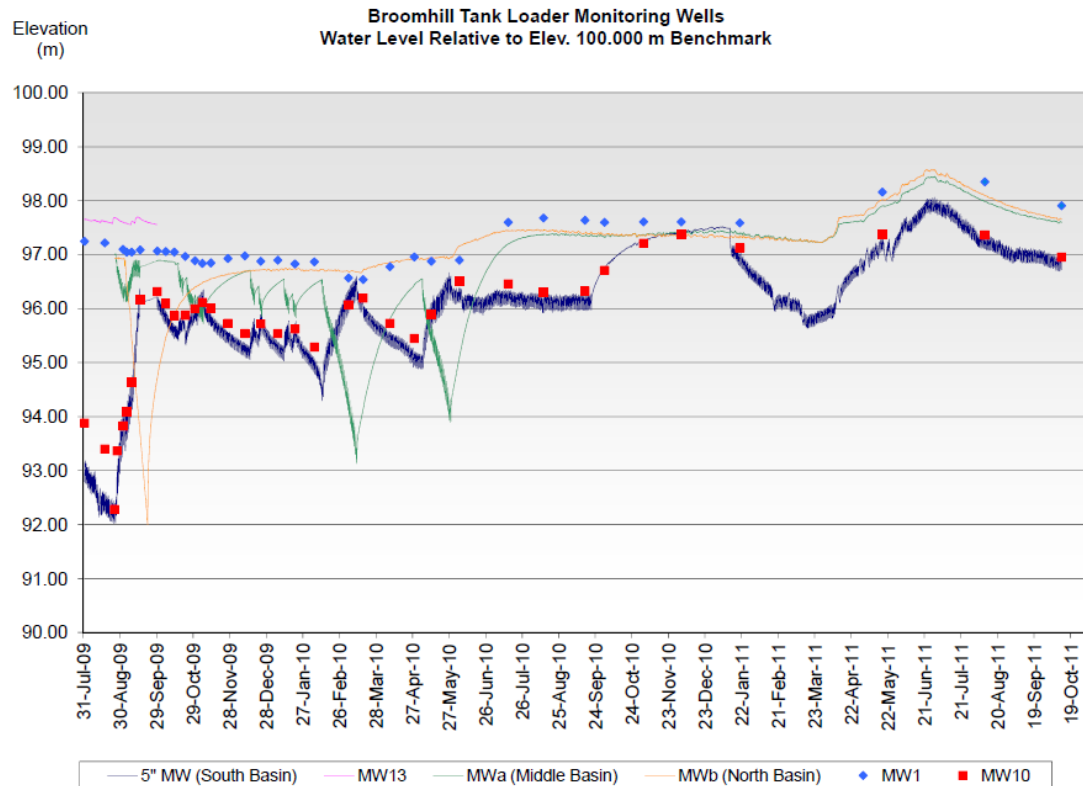
Groundwater monitoring commenced in July 2009. As many as four pressure transducers were initially set-up and currently three pressure transducers are continuous and manual readings. This graph uses a benchmark of 100.00 m in order to compare levels in each the three basins.

The locations of all monitoring wells are shown in the appendices. 5" MW represents the water table depth near the production well, while MWa and MWb represent the water table depth in the middle and north basins.

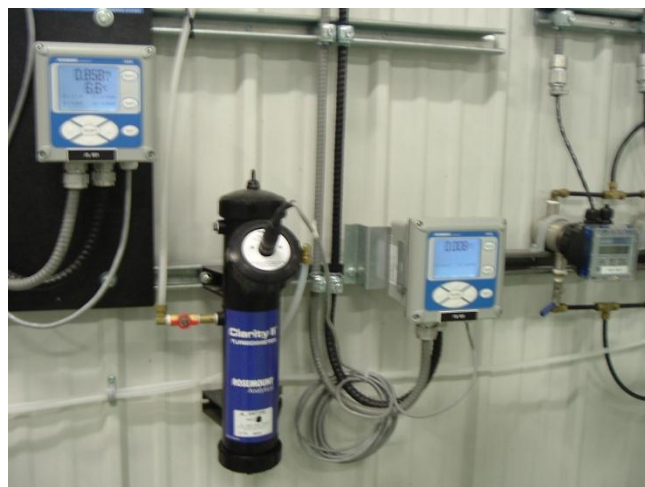
Online Monitoring Equipment

As required by the *Drinking Water Safety Act* the Melita PWS ensures continuous disinfection is maintained at the WTP by keeping in stock all spare parts required for the chlorinators, as well there are two spare chlorinator pumps kept at the plant. Disinfection residuals are monitored continuously by an online monitor that monitors the water continuously as it leaves the WTP. We also monitor the residuals daily at the WTP and in the distribution system; these tests are performed at the WTP after the samples are collected. The results of all tests are recorded on our

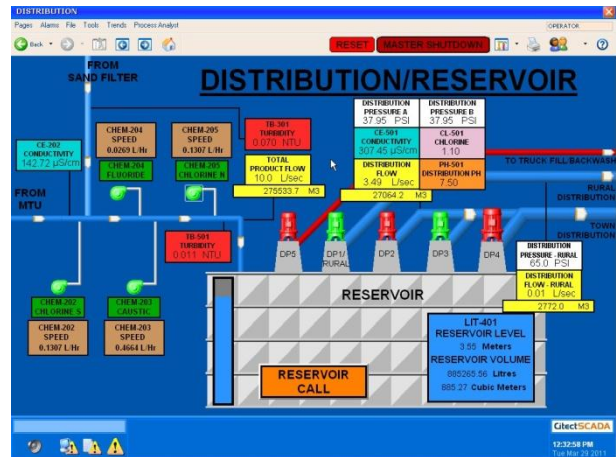
The WTP is monitored continuously by the computer system; it is continuously taking readings from 60 different locations by sensors, probes and meters. This information is displayed in real-time on a different number of screens (*see Figure A, B, C which show three different computer screens*) and is also recorded and compiled in the form of a trend. These trends can be accessed at any time and show a history of plant operation in various areas (*see Figure D for an example of a trend screen*).
