Public Water System Annual Report

Southwest Regional Water Treatment Plant & Southwest Regional Water Co-op
2020

Date Prepared: 3/28/2021

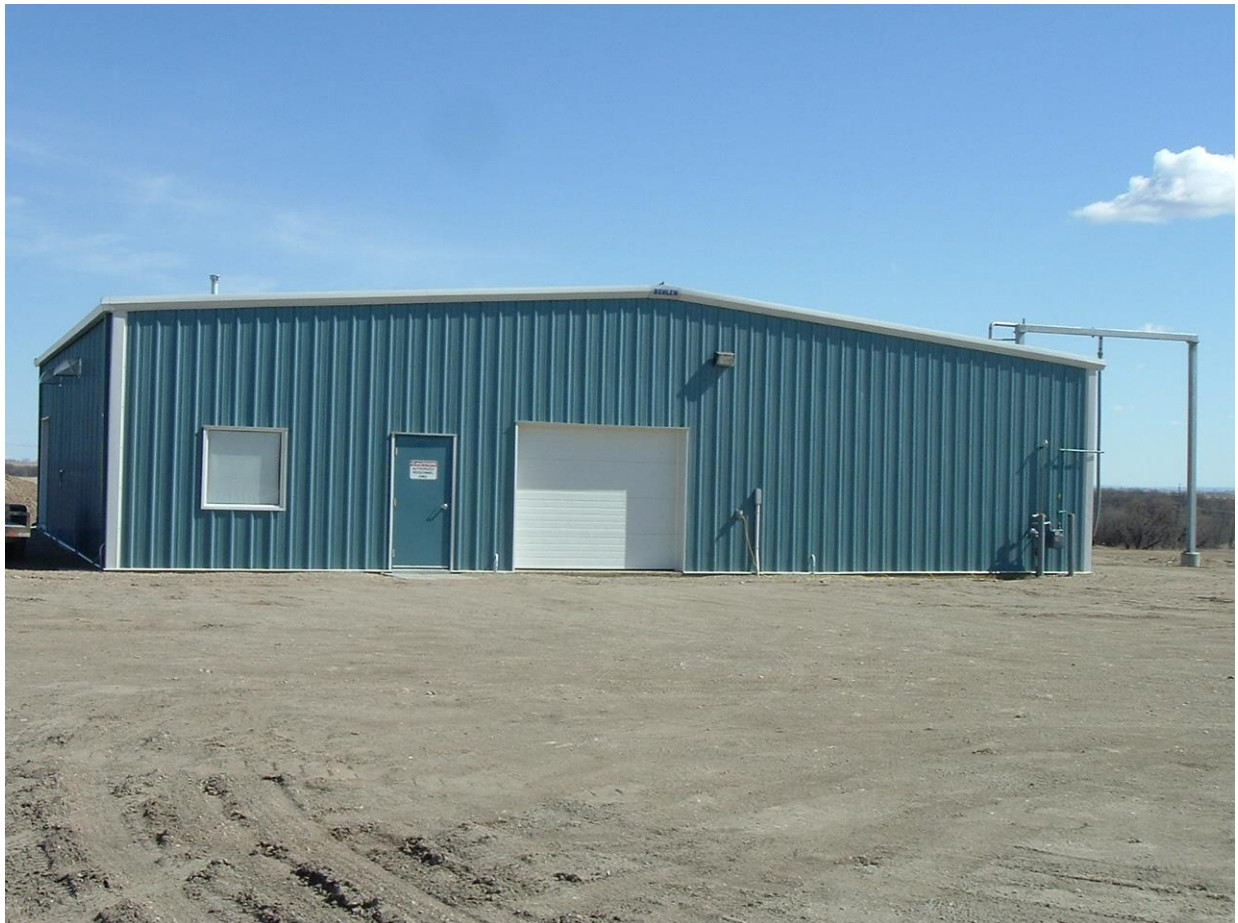
The Melita Water Treatment Plant

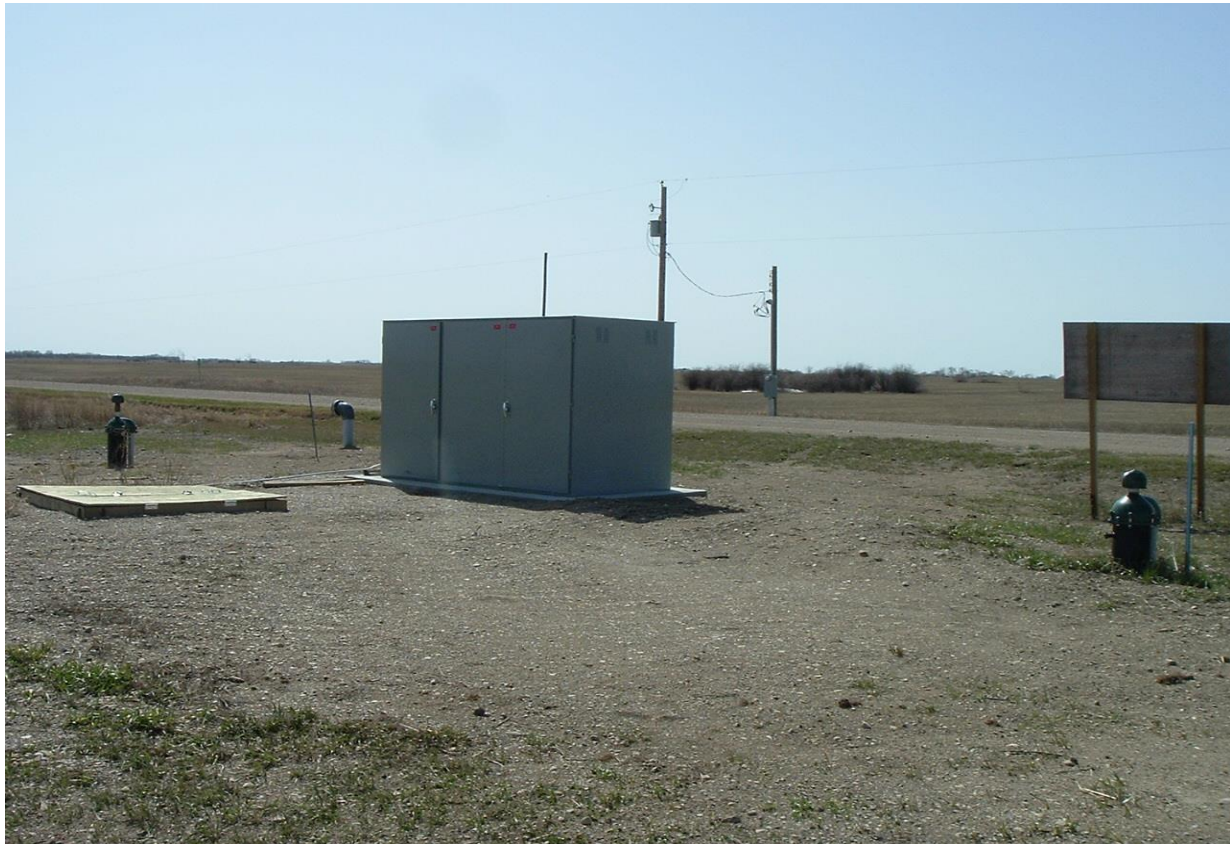
Well Site 1

The WTP receives groundwater from four wells located at 16 km North East of Melita @ NW23-5-27W. The wells draw groundwater from the Oak Lake Aquifer. The wells were drilled to a depth of 33 feet. Raw water pumped from the wells into a 200 mm (8 inch) pipeline where it flows directly into the WTP for processing and treatment.

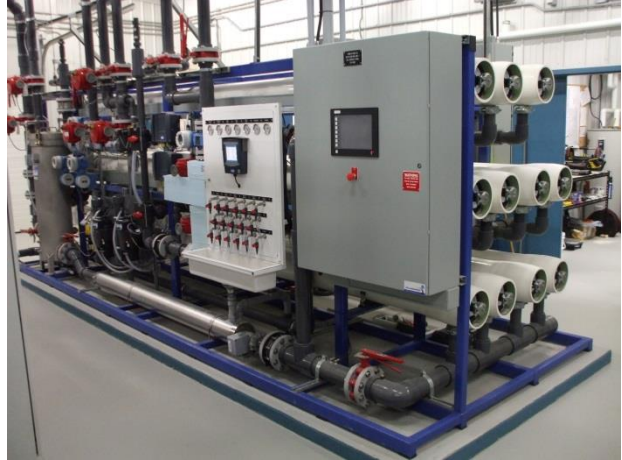
The North RO (new)

Raw water is pumped to the WTP where approximately 90% of the flow is directed through reverse osmosis membranes. The remaining 10% by-passes through a sand-filter with 3 new UV (ultraviolet) units prior to blending with membrane permeate. Blended flow is chlorinated with sodium hypochlorite and then stored in a 1,000,000-litre concrete reservoir for distribution. Since membranes remove most dissolved minerals, blending permeate with filter water allows the operation to produce treated water with a more desirable hardness and PH. Approximately 13% of membrane flow (11% of the raw water) is discharged as membrane concentrate to the Souris River. Treated water is distributed to the Co-op and a bulk water (truck) fill is available for rural usage. In the spring of 2014 the second RO unit and filter came online doubling the production capacity of the plant.

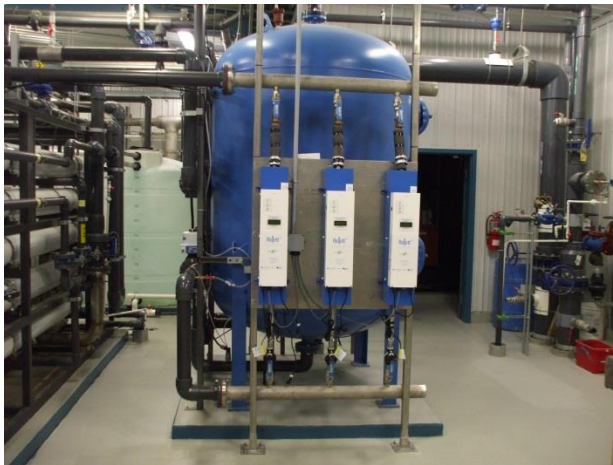
The Original Sand Filter with UV upgrade

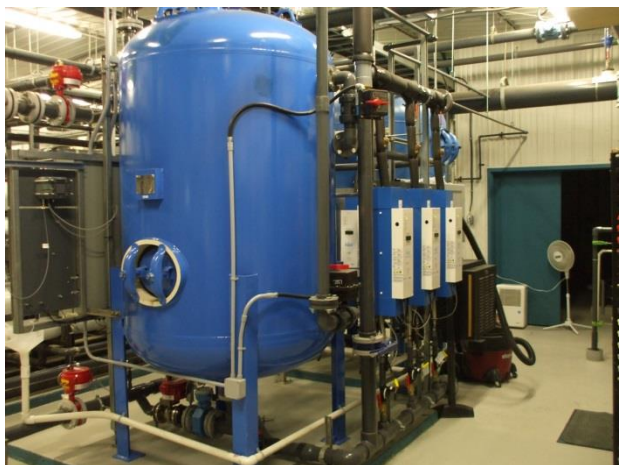
The New Sand Filter with UV

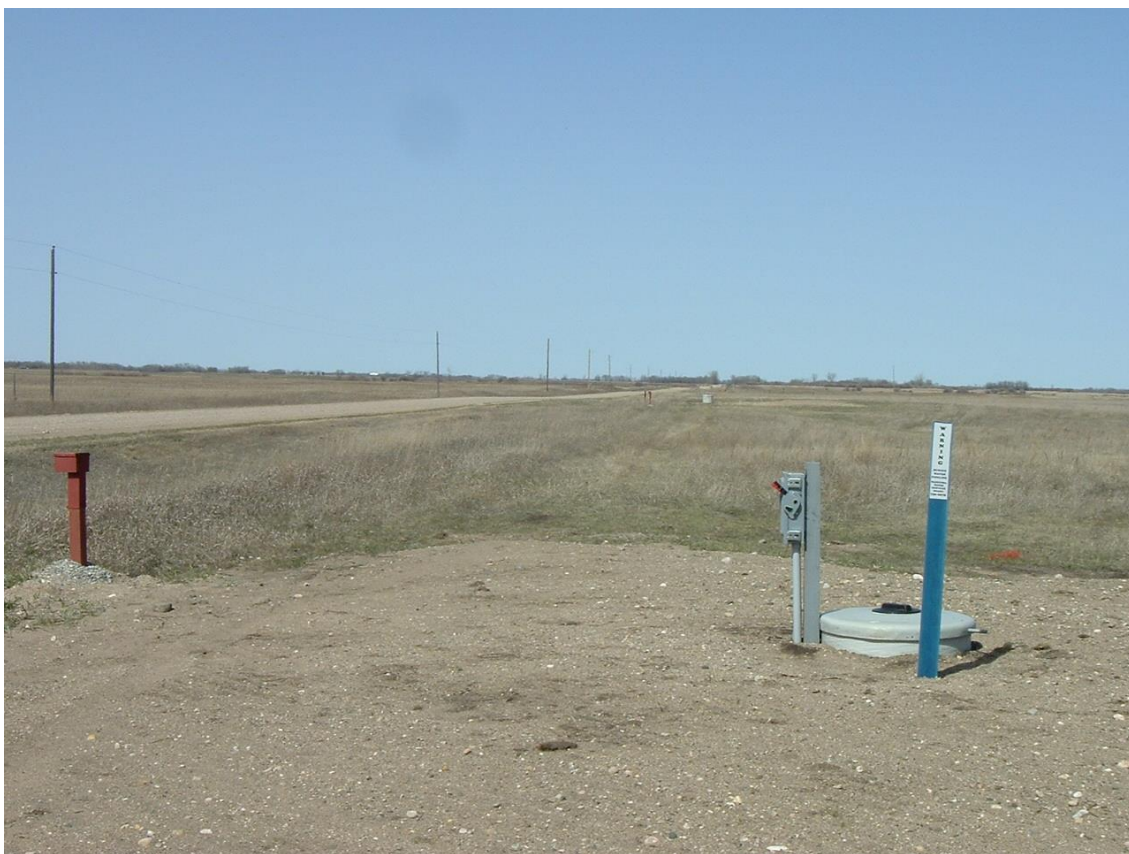
The updated graph on page 11 shows ground water levels at various points at and around the new wells.

Recharge Wells
