Public Water System Annual Report

Southwest Regional Water Treatment Plant & Southwest Regional Water Co-op
2021

Date Prepared: 3/31/2022

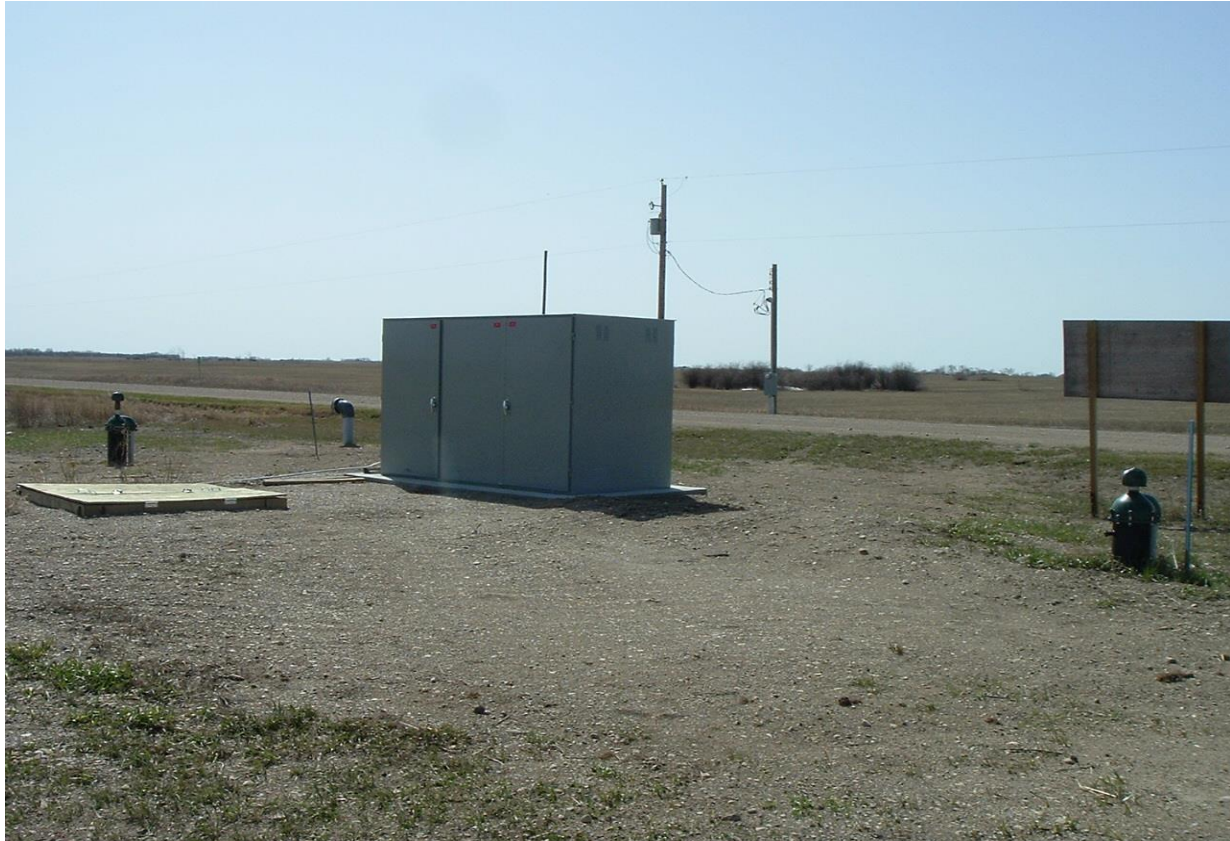
Well Site 1

The WTP receives groundwater from four wells located at 16 km North East of Melita @ NW23-5-27W. The wells draw groundwater from the Oak Lake Aquifer. The wells were drilled to a depth of 33 feet. Raw water pumped from the wells into a 200 mm (8 inch) pipeline where it flows directly into the WTP for processing and treatment.

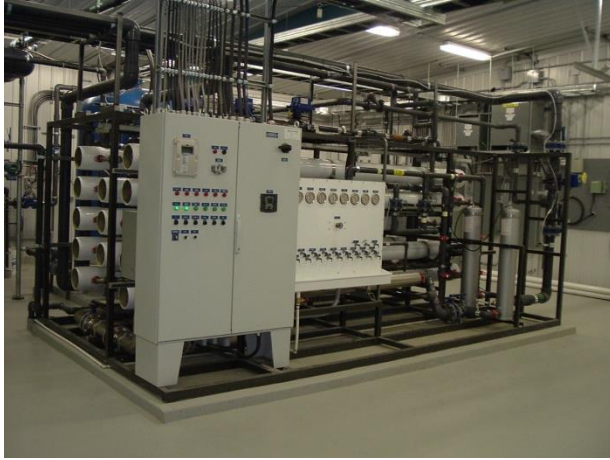
The South RO (original unit)

Raw water is pumped to the WTP where approximately 90% of the flow is directed through reverse osmosis membranes. The remaining 10% by-passes through a sand-filter with 3 new UV (ultraviolet) units prior to blending with membrane permeate. Blended flow is chlorinated with sodium hypochlorite and then stored in a 1,000,000-litre concrete reservoir for distribution. Since membranes remove most dissolved minerals, blending permeate with filter water allows the operation to produce treated water with a more desirable hardness and PH. Approximately 13% of membrane flow (11% of the raw water) is discharged as membrane concentrate to the Souris River. Treated water is distributed to the Co-op and a bulk water (truck) fill is available for rural usage. In the spring of 2014 the second RO unit and filter came online doubling the production capacity of the plant.

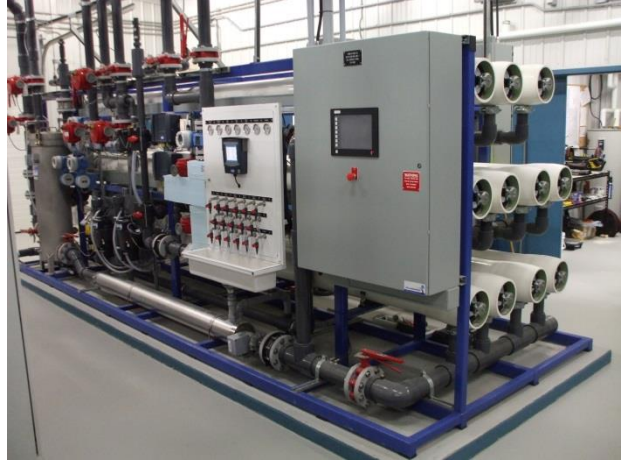
The North RO (new)

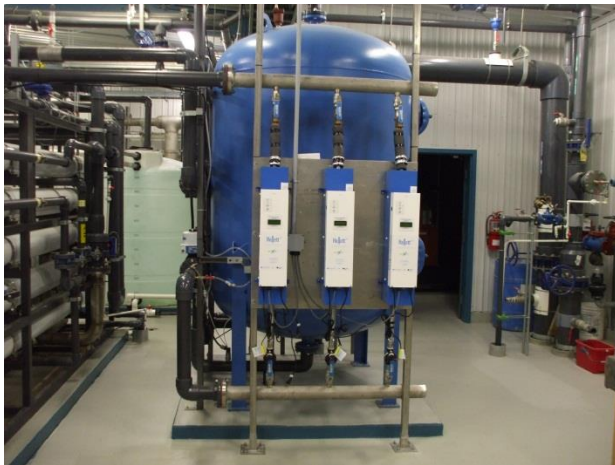
The Original Sand Filter with UV upgrade

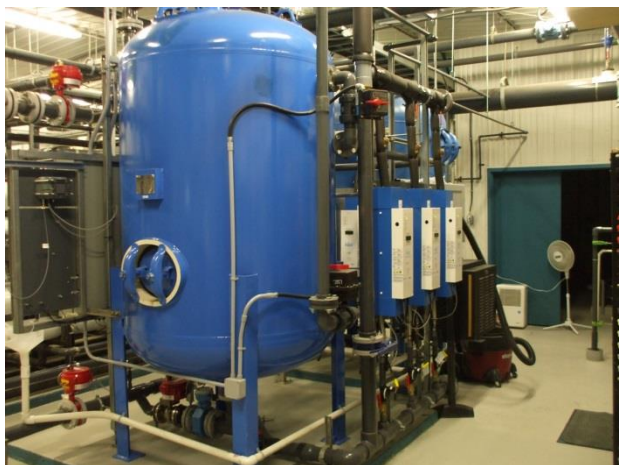
The New Sand Filter with UV

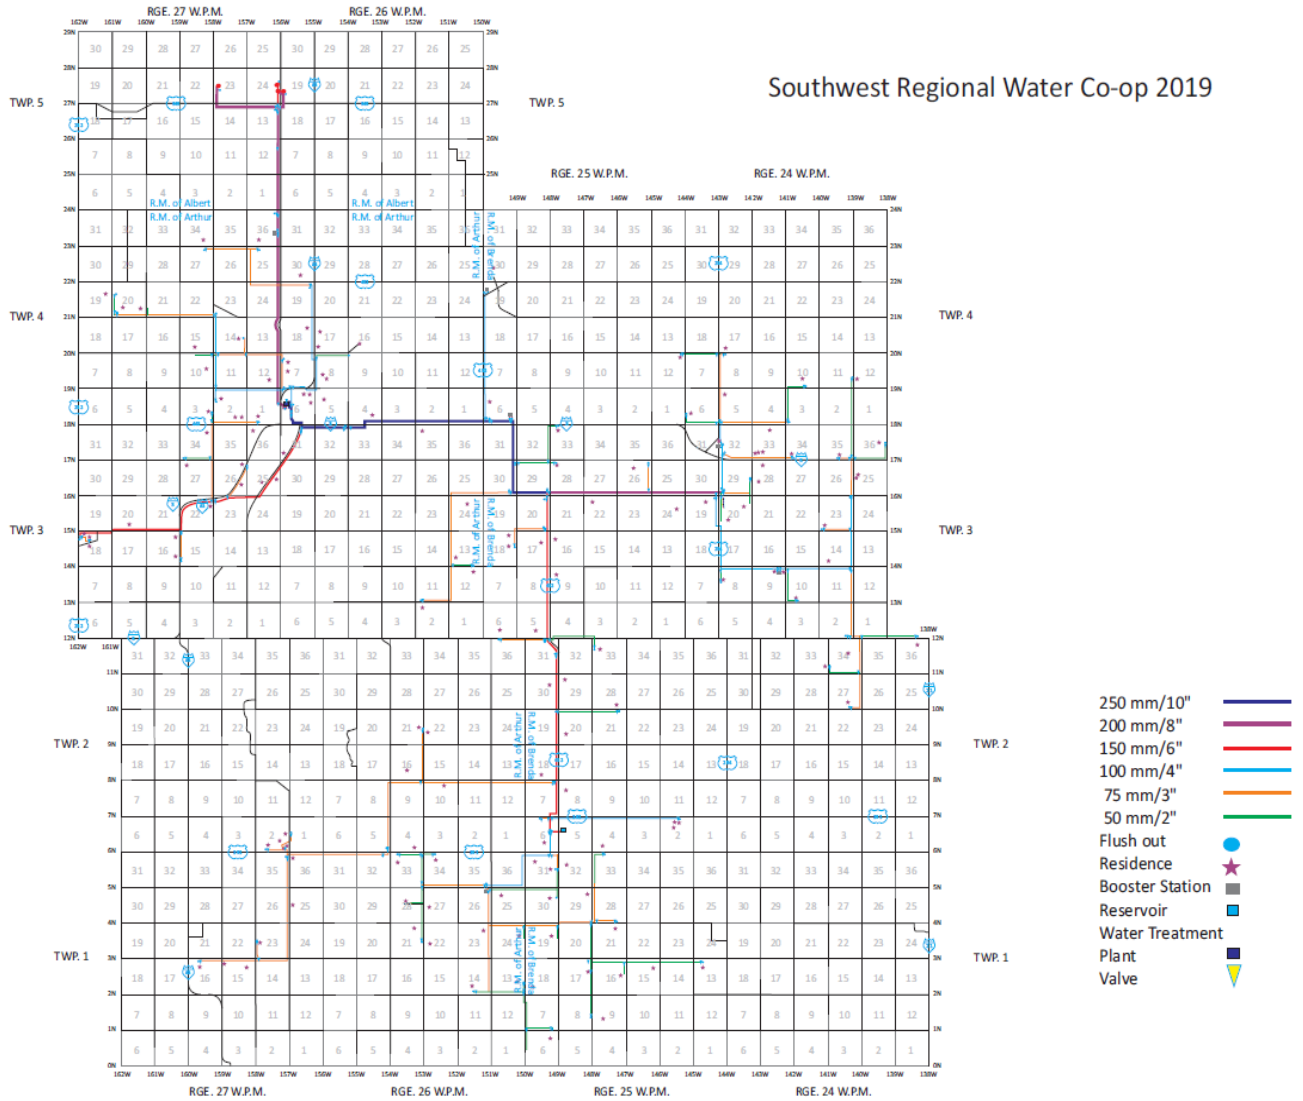
The Distribution Pumps

Treated water from the reservoir, located underneath the WTP, is pumped throughout the Melita distribution system via two 7.5 horsepower duty pumps, with one 30 horsepower emergency standby pump for firefighting purposes. The SWRWC has one 7.5 horsepower duty pump and a new 2 horsepower jockey pump which was installed in the spring of 2017. The SWRWC distribution system consists primarily of High Density Polyethylene Pipe. In 2017 the rural system was expanded to take in another 71 homes and another 150 km of pipe was installed, the raw, 10" and 8" didn't increase but the rest did. 12 miles of 8" raw water supply line, the distribution consists of the following 11 miles of 10", 5 miles of 8", 19 miles of 6", 30 miles of 4", 68 miles of 3", 49 miles of 2", for a total of 182 miles of pipe in the ground. A map of the distribution system pre-expansion is on the next page, a current map is not yet available. The Waskada Rural Water Co-op already had several miles of pipe in place but is now part of the overall distribution system. The WTP also has a natural gas powered generator located in the building that powers the distribution pumps during times of a power failure.

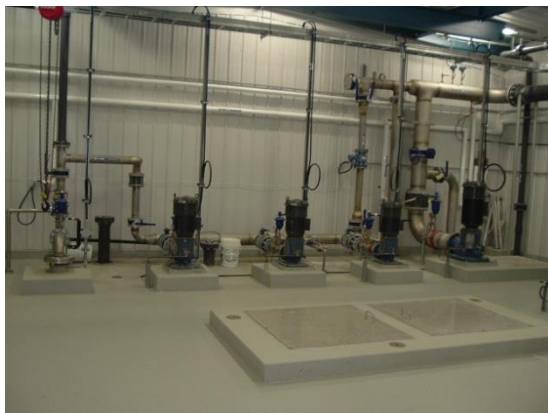
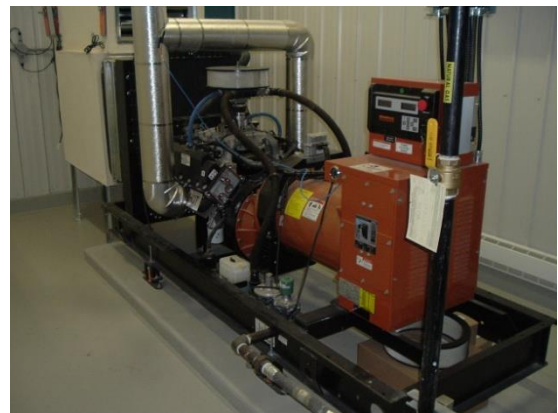
The Generator

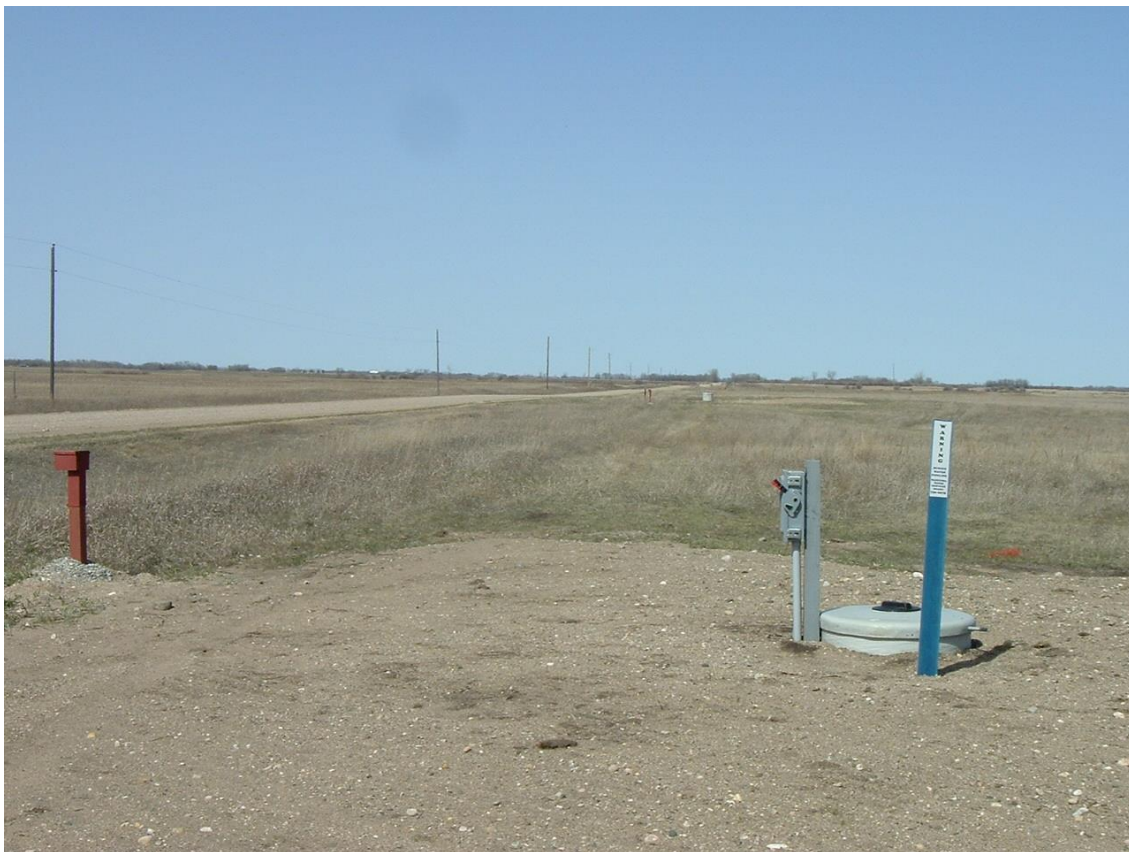
Recharge Wells

Since fall of 2017 we have not had to recharge the east site because we stopped pulling water from these wells and now only pull from the new ones at the East site.

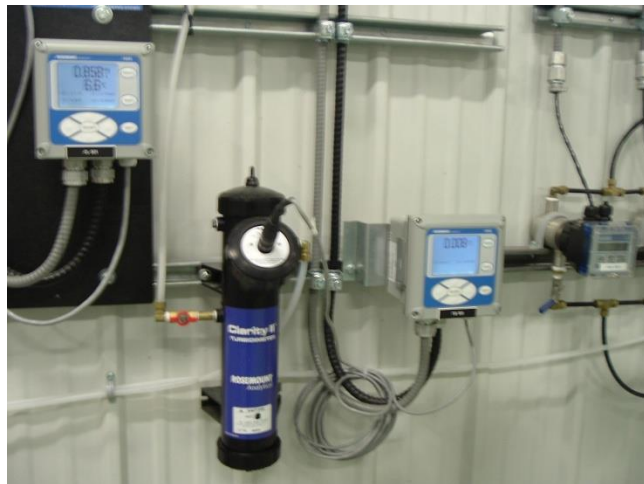
Online Turbidity Monitoring Equipment

As required by the *Drinking Water Safety Act* the Melita PWS ensures continuous disinfection is maintained at the WTP by keeping in stock all spare parts required for the chlorinators, as well there are two spare chlorinator pumps kept at the plant. Disinfection residuals are monitored continuously by an online monitor that monitors the water continuously as it leaves the WTP. We also monitor the residuals daily at the WTP and in the distribution system; these tests are performed at the WTP after the samples are collected. The results of all tests are recorded on our records at the WTP as well as Monthly Chlorination and UV Report forms which are sent to the regional *Drinking Water Officer* at the end of each month, to check for standard compliance.

the raw, treated, sand-filters and distribution by a portable testing meter. The water from the sand-filters and from the MTUs is monitored continuously while the plant is in operation, by two separate online turbidity monitors. The results of all turbidity tests are recorded on our records at the WTP as well as Monthly Turbidity Report forms which are sent to the regional *Drinking Water Officer* at the end of each month to check for standard compliance. For 2021 all samples met the turbidity standards.
