# Public Water System Annual Report

Southwest Regional Water Treatment Plant & Southwest Regional Water Co-op  
2022

Date Prepared: 3/21/2023

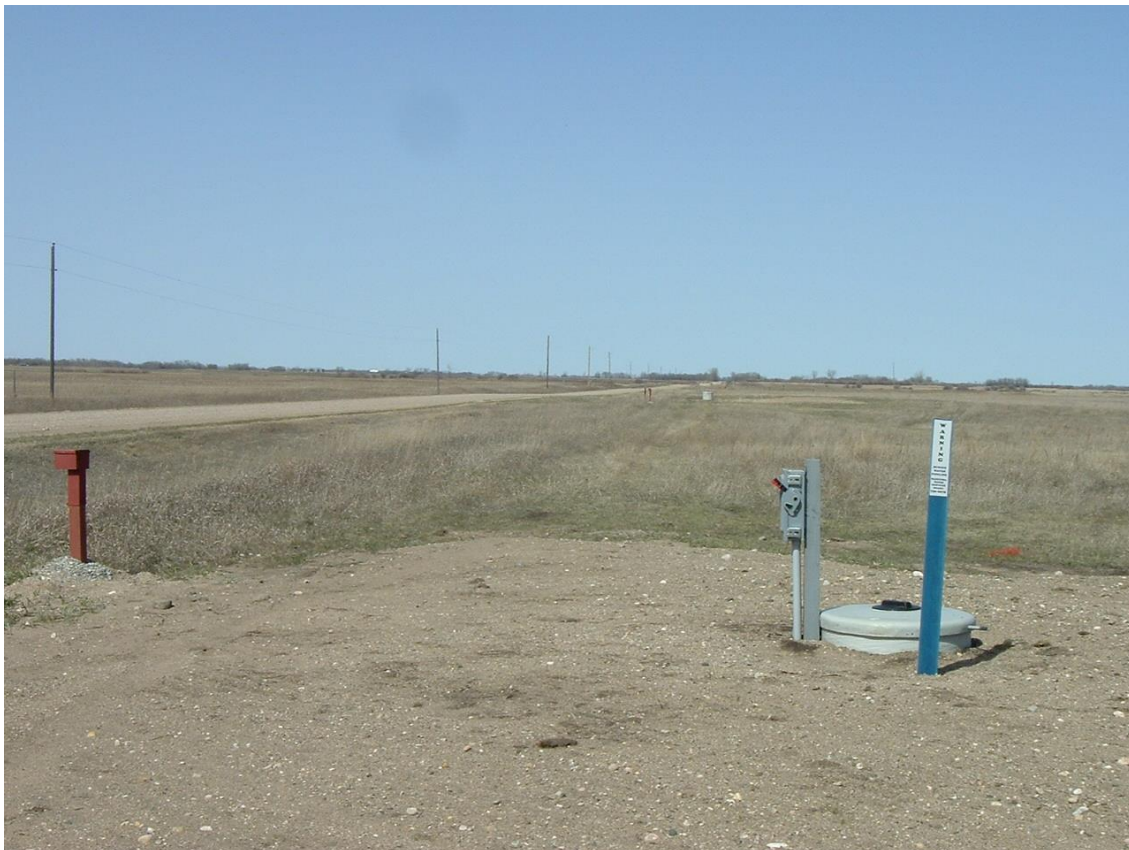
Recharge Wells

Since fall of 2017 we have not had to recharge the east site because we stopped pulling water from these wells and now only pull from the new ones at the East site.

Since the middle basin could only be pumped intermittently, the north basin well was temporarily equipped with a pump, generator, and overland pipeline to speed up the water table recovery. Pumping from this basin occurred from September 3<sup>rd</sup> to September 21<sup>st</sup> until water levels significantly recovered and the north basin water table prevented further pumping. The water table in the north basin has since recovered. In 2012 the north basin was converted to a supplemental well to improve operating pressures and flows to the plant when it is in operation.

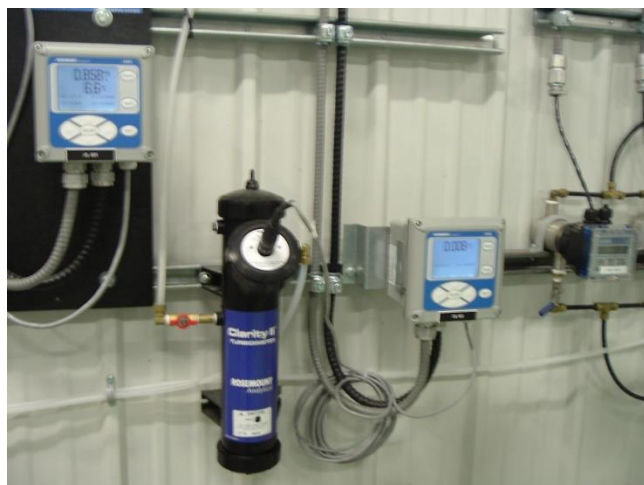
Online Turbidity Monitoring Equipment

As required by the *Drinking Water Safety Act* the Melita PWS ensures continuous disinfection is maintained at the WTP by keeping in stock all spare parts required for the chlorinators, as well there are two spare chlorinator pumps kept at the plant. Disinfection residuals are monitored continuously by an online monitor that monitors the water continuously as it leaves the WTP. We also monitor the residuals daily at the WTP and in the distribution system; these tests are performed at the WTP after the samples are collected. The results of all tests are recorded on our records at the WTP as well as Monthly Chlorination and UV Report forms which are sent to the regional *Drinking Water Officer* at the end of each month, to check for standard compliance.
