# Fagan Lake Values Survey and Lake Summary Report

Year Assessed: 2024

Love Your Lake is a program of Watersheds Canada and the Canadian Wildlife Federation

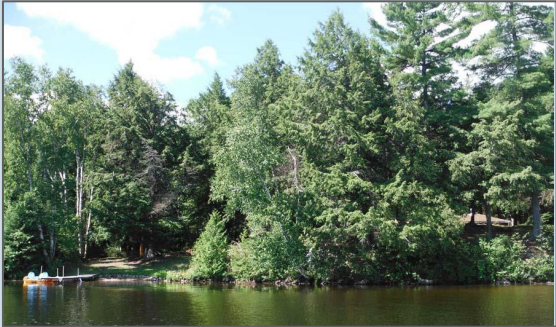
| Classification & Description | Photograph Example* |
|---|---|
| <b>Natural</b> – Areas that show no significant human disruption to the natural vegetation or land cover. | |

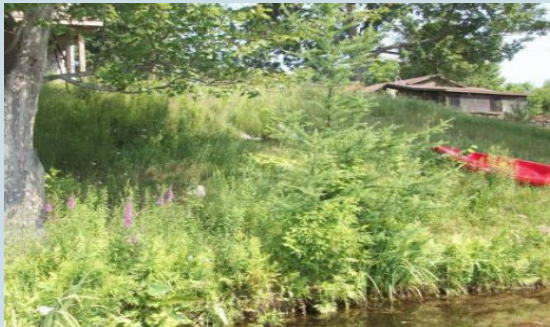
| Classification & Description | Photograph Example* |
|---|---|
| <b>Regenerative</b> – Natural vegetation has been removed in the past but is in the process of growing back towards a natural state. | |

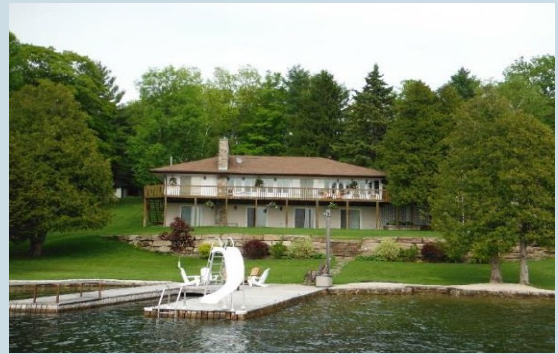
**Manicured** – Areas where the natural vegetation has been removed and replaced with a manicured lawn, artificial turf, ornamental garden, man-made beach and/or agricultural crops.

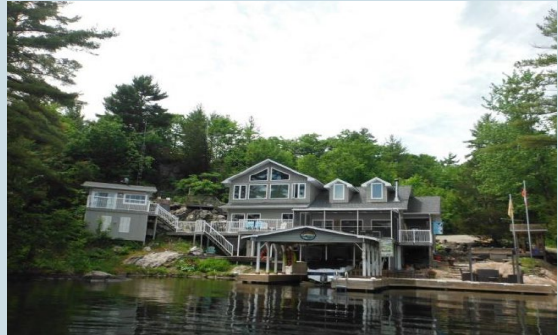
**Developed** – Refers to any buildings, structures or impervious surfaces (e.g. paved stones, driveways or pathways).

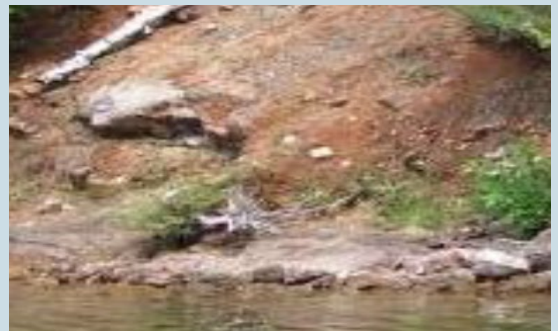
**Degraded** – Natural vegetation has been lost; soil erosion, undercutting of the bank and/or exposed roots of shrubs and trees are significant.

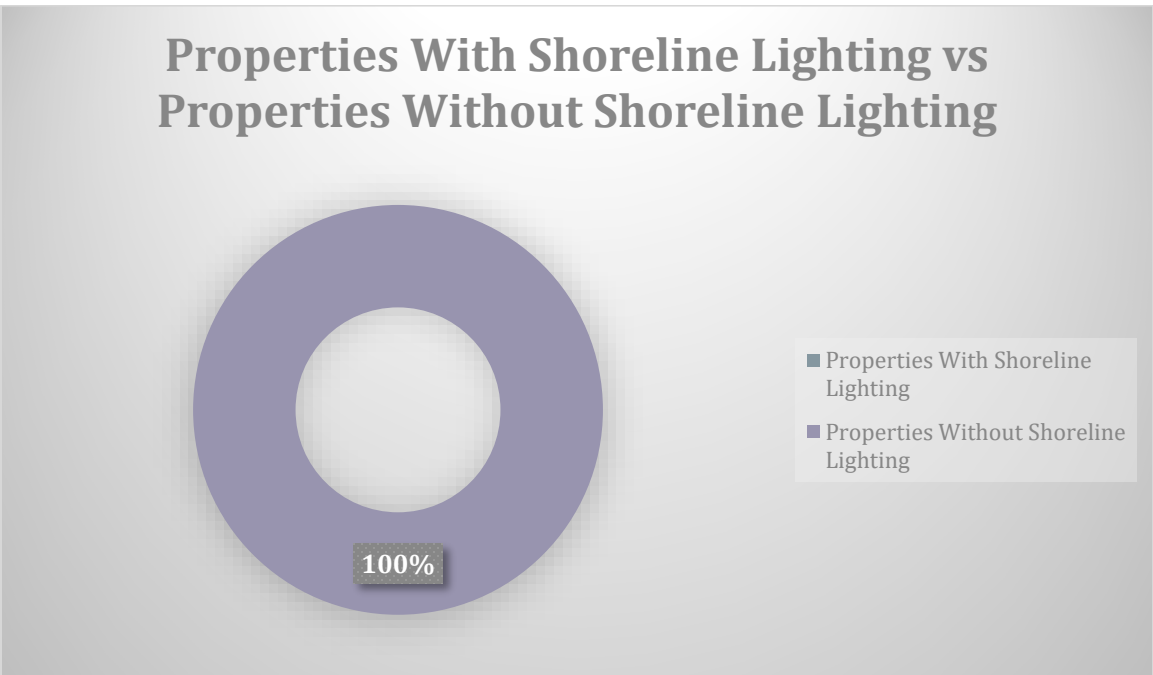
The number of shoreline properties with shoreline lighting was observed. This included lighting along docks, erosion control structures as well as pathways and stairs that lead to the shoreline. On Fagan Lake, 0 properties used shoreline lighting. The figure below shows the number of properties that have shoreline lighting in comparison to those properties that do not have shoreline lighting. While shoreline lighting can help property owners maximize the enjoyment of their properties at night, excessive lighting can disturb wildlife by altering foraging, mating, hibernation and migration patterns.
