## Water Leaks—Door

Condensed from DMC Service Bulletin ST-33-12/81

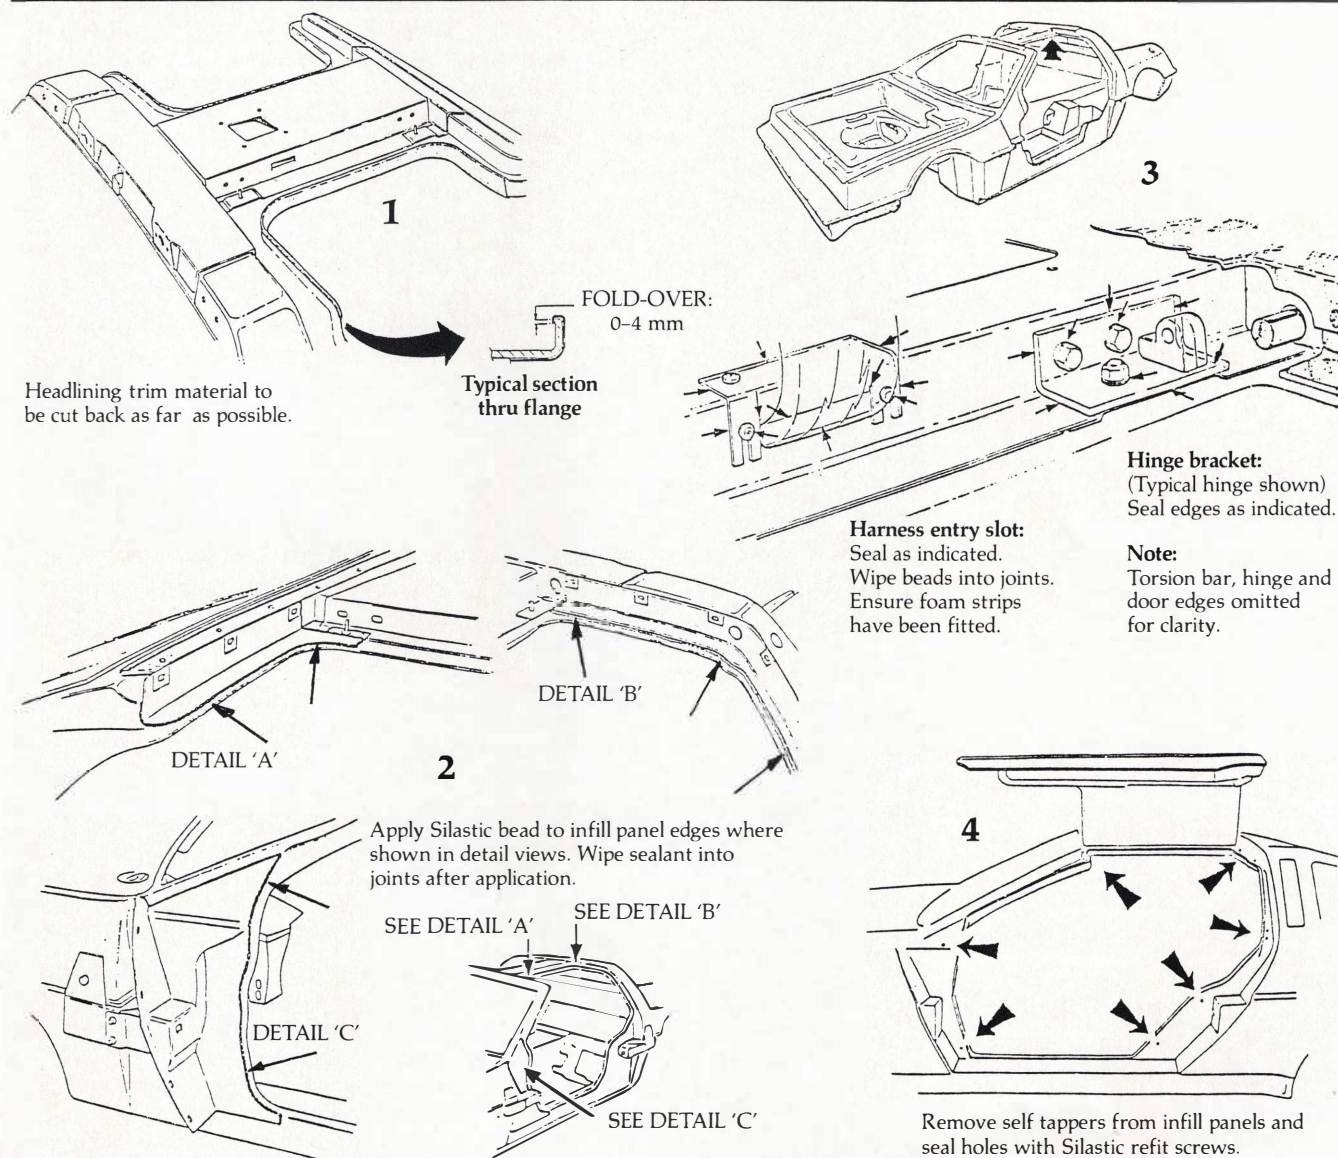
The joints of the body panels and windows, are sealed in areas where water entering at these points would drain to the inside.

When sealing the indicated joints use *Dow Silastic 732 R.T.V.* or equivalent.

Certain vehicle areas have designed drains to direct water to the outside. For example, drains are found on the bottom of the doors or around the door openings of the body to allow water that entered at the window lip seals, which due to their function cannot provide a full seal, to escape to the outside. Water entering through the gap of the doors is drained to the outside. Due to

their function, all drains must be free of obstruction and seals (watertight) from the rest of the body.
