Engineering for Safety

In this Readers' Platform, your author says cab manufacturers' involvement in design and testing of safety gears is vital.

by Muharrem B. Çakirer

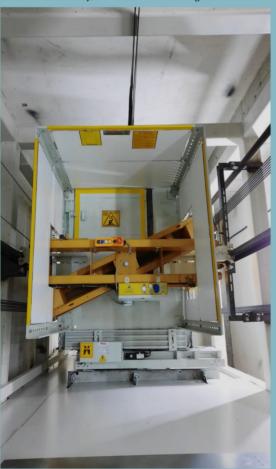
▲ Safety gear installed on upper girder

The progressive safety gear is a mechanical system. It can be installed to the lower or upper supporting girders of the cabin sling. If there is a living space like a residence or office under
