TS-940 LCD Display LED Installation and Clock Battery Replacement

TS-940 LCD Display – LED installation kit & Clock Battery Replacement

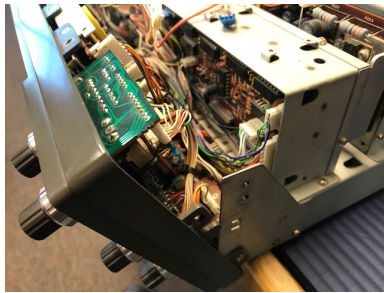
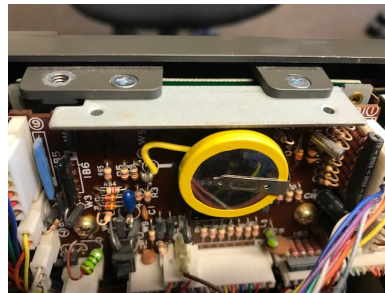
Remove these 2 screws

3. Once the front panel is tilted down, remove the 2 screws that hold in the clock/timer & LCD display modules. (see image of the 2 screws just above the battery. You can then tilt out the Timer module and LCD display.
4. There are 4 screws holding the LCD display to the timer module. We suggest using a magnetic screw holding Philips screwdriver to remove the screws. Being careful not to drop any screws inside the radio! They are very hard to find! Remove the four screws, then unplug the 2 pin black and orange wire from the right (Front) side of the display.

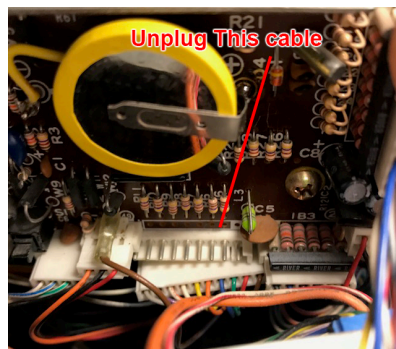
Unplug This cable

5. Finally, unplug the 10 pin cable as shown below on the battery side of the clock board. Now, the LCD display should be completely free and ready for the LED upgrade. Be sure to handle the LCD display carefully and it is a good idea not to touch the glass on the front.

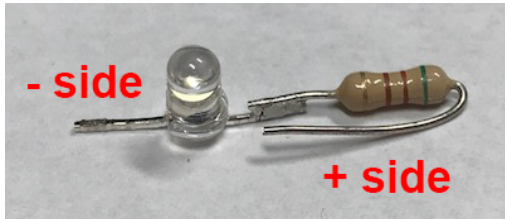
6. Once you have the display detached from the clock board, lay it down with the display down and the circuit board facing up. Use a small pencil type iron to remove the 2 existing incandescent light bulbs from the circuit board side of the display. There are 2 small pads on each end of the display. Simply heat each pad very quickly and lift up the wires from the light bulbs. You can also choose to just cut the wires on the bulb and lift them out. Pull straight up on the light bulbs and they will come right out.
7. To install the new LEDs, bend the – side (Short wire) at a 90 degree angle and cut it to about 1/4" as shown. Then, solder one side of the 510 ohm resistor to the + side of the LED as shown.

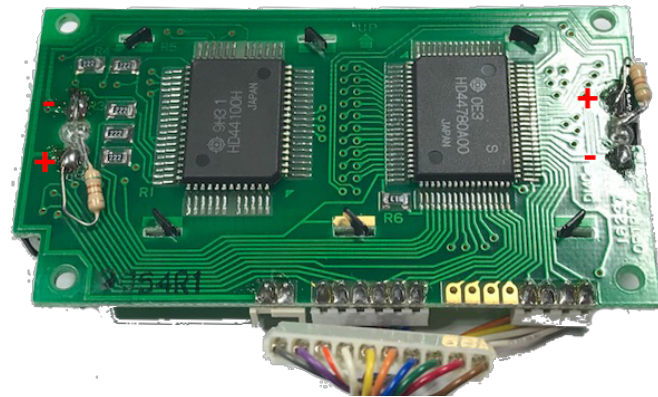
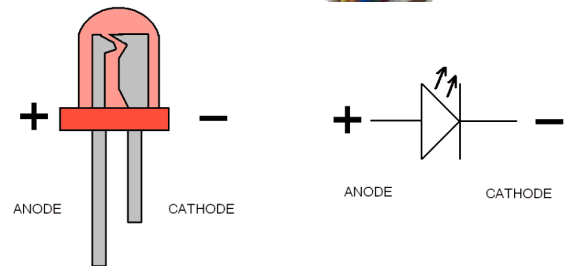
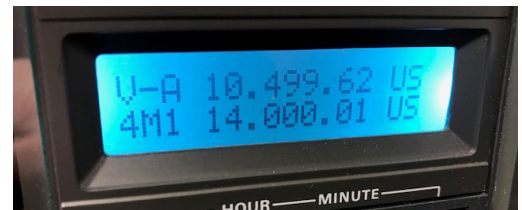
8. Next, just insert the LED into the space where the old lights came out and solder as shown. NOTE: Pay attention to which side is + and -. They are mounted in different directions on the board as you can see so make sure that you have the polarities correct. Once you have the LEDs correctly mounted on the LCD display, re-mount the LCD to the clock board using the 4 screws that were removed in step 4.

9. Be sure to plug in the 2 conductor cable that was removed in step 4 and the 10 pin connector from Step 5.
10. Remount the LCD Display and Clock module using the 2 screws that were removed in Step 3. It is a good idea to test the display to make sure the LEDs were installed correctly. The LCD display should have a great looking Blue color with nice high brightness!

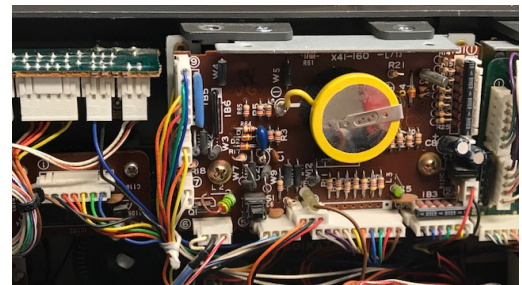
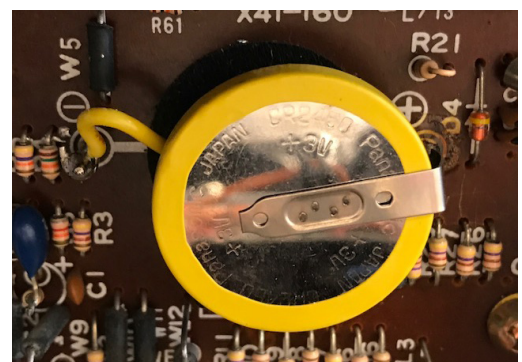
1. Look at the existing battery and its orientation. The positive side (+) is on the top normally. On most batteries, it is clearly marked.
2. It is a good idea to check the voltage across the battery with the power unplugged from the radio. If it is +3V or above, the battery is still good.

3. To replace the battery, simply unsolder both sides of the battery and remove it. Re-solder the new battery making sure that the + and – terminals are oriented correctly.

4. NOTE: Some TS-940s have 2 batteries soldered into the clock module. You can replace these with one. The 2 batteries were apparently an optional way of extending the battery life but to our knowledge, there was no other reason since they were in parallel.

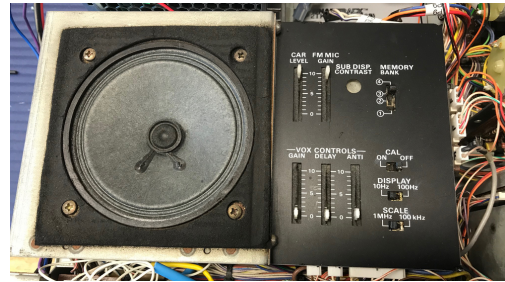
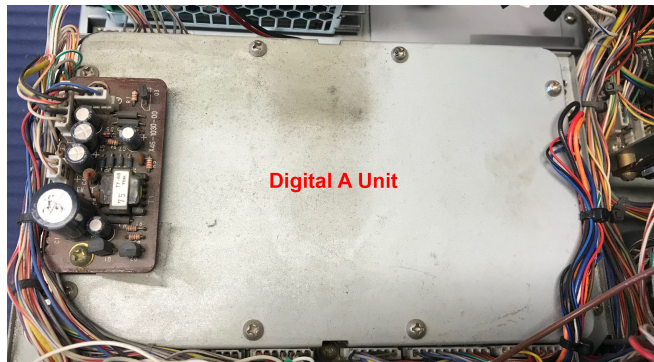
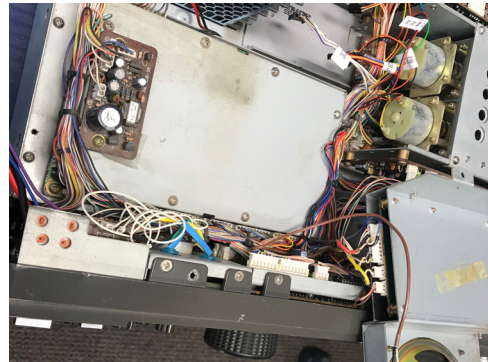
1. There is a 2nd battery that should also be replaced. It is located under the speaker and then inside an RF Can (Digital A Unit). On the left and right sides of the speaker assembly, you will find two screws that need to be removed on each side. After you remove these, the entire speaker assembly can be pulled up and moved out of the way to the right.
2. Next, remove all 8 screws from the cover over the Digital A Unit. Once the cover screws are removed you can carefully swing the cover to the left and out of the way. This exposes the battery so it can be replaced.

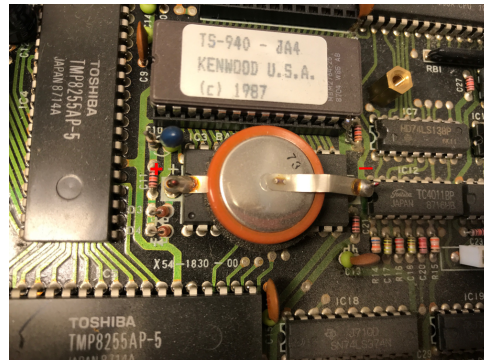
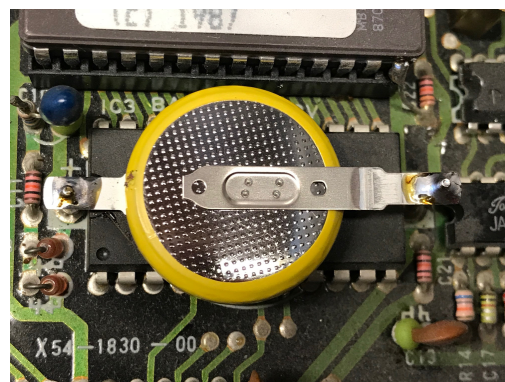
3. Remove the old battery with a low wattage soldering iron by simply heating up the tab until the solder melts then lift the tab straight up and off of the board.
4. Install the new battery and make sure that the + side of the battery goes to the left and the - side goes to the right. The new battery (Yellow) is installed just like you found the original.
5. Carefully re-install the cover to the Digital A Unit with the 8 screws and then re-secure the speaker with the 4 screws that were removed in Step 1

NOTE: These batteries should last at least 5 years but should be checked occasionally to make sure they are at a voltage of +3V or more. If the TS-940S has to be continually reset using the A=B key on power-up, it is an indication that the Digital A Unit battery is defective.

If the TS-940S time changes from your initial settings, it is an indication that the Clock/Timer battery is defective and it should be replaced.
