Corrosion problem: Air conditioning systems ductwork is rusting.

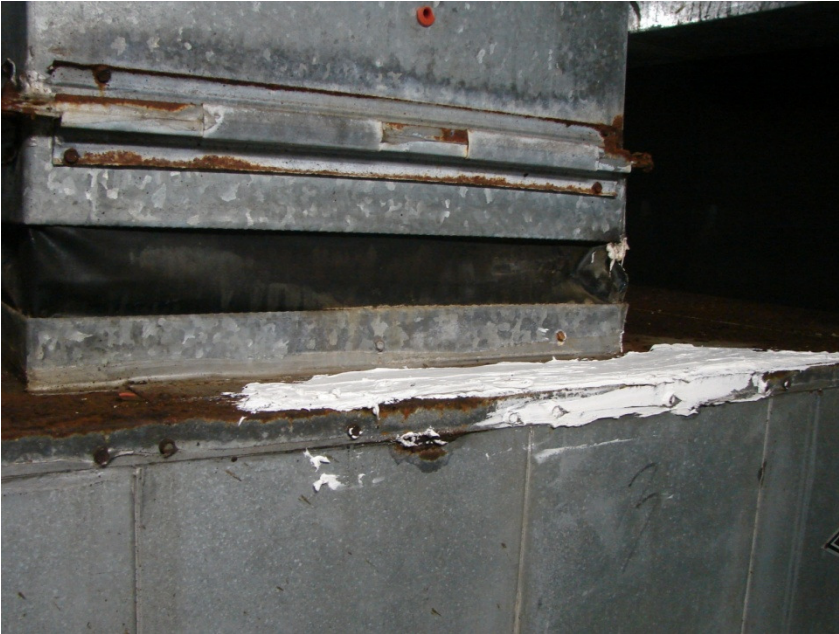
Exterior:

Galvanized sheet metal ductwork is particularly susceptible to corrosion and once corrosion starts, the corrosion can accelerate at a higher rate due to the combination of metals and sacrificial anode characteristic of galvanized finish.

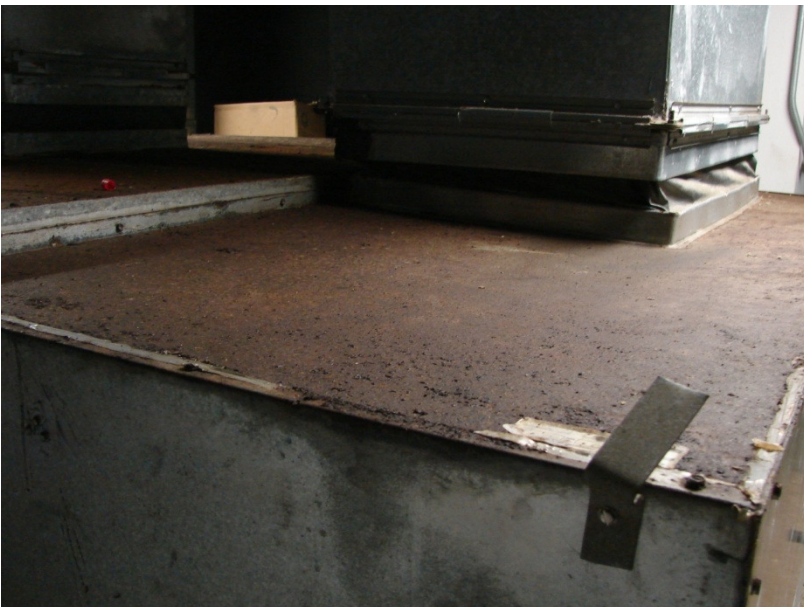
Exterior treatment with thin film rust inhibitors (CarWell CP90) for corrosion control is practical and inexpensive as seen here:

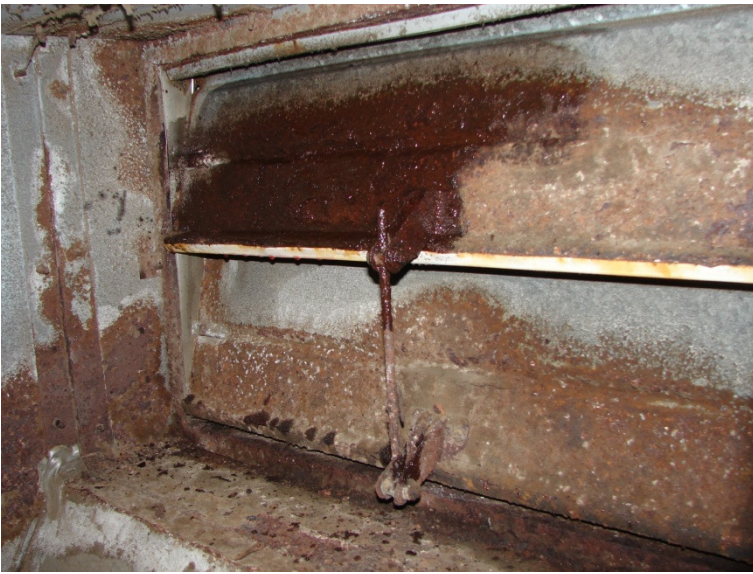
Consideration of what is going on with the interior of the assembly requires recognition as seen here:

The above image shows partial surface treatment & drops of a thin film rust inhibitor that was applied too late in the life cycle of this ductwork and mechanical louver system. While the use of thin film inhibitors will slow the corrosion rate & forestall the eventual decay to stage 4 corrosion, holed sheet metal with a high % of good substrate material loss may become a candidate for complete replacement. Note the fastening assembly as it relates to allowing any swiveling of the linkage. This frozen assembly is direct cause for electrical control system failure as the system pertains to opening and shutting this louvered system.

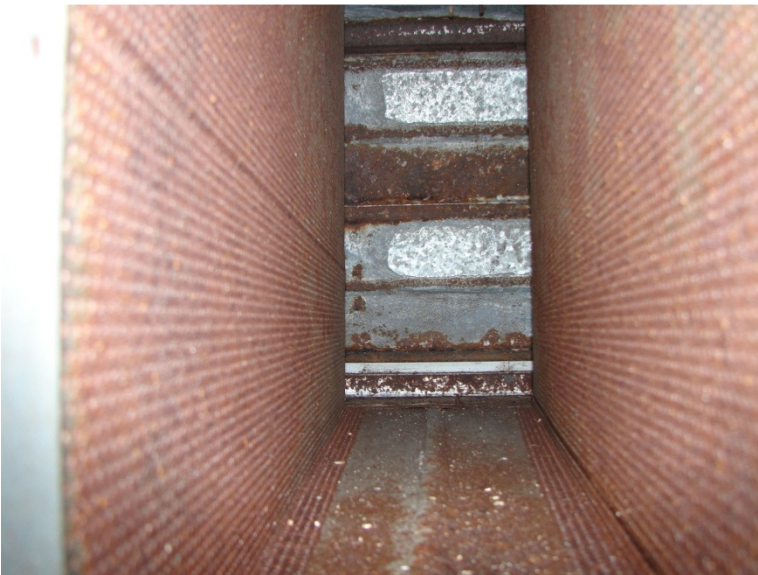
While the baffle plates within this system show good integrity, where the moist air that has sped behind it hits against the flat wall of the enclosure, corrosion problems accelerate. Certain design changes could aid in longer life.

While design changes help, including a sound corrosion prevention program will aid in providing longer life from these components allowing the facility owner to get the return on their investment for an important part of their facility.

Systems that are subject to the close proximity of the Pacific ocean, along windward coast lines, or/and where the ocean tidal and wave activity and spray results in the chloride rich moisture being picked up and carried to air conditioning intake systems should require ways of entering duct work to aid in providing access to the galvanized panels and mechanical components for corrosion protection. Standard coatings applied during manufacture would help, but follow on annual inspections and CPAC treatments would aid in obtaining the longest life possible. Contact Us for details.
