Re: Report on Sault Ste. Marie 2006 Particulate Monitoring Special Study

## Background

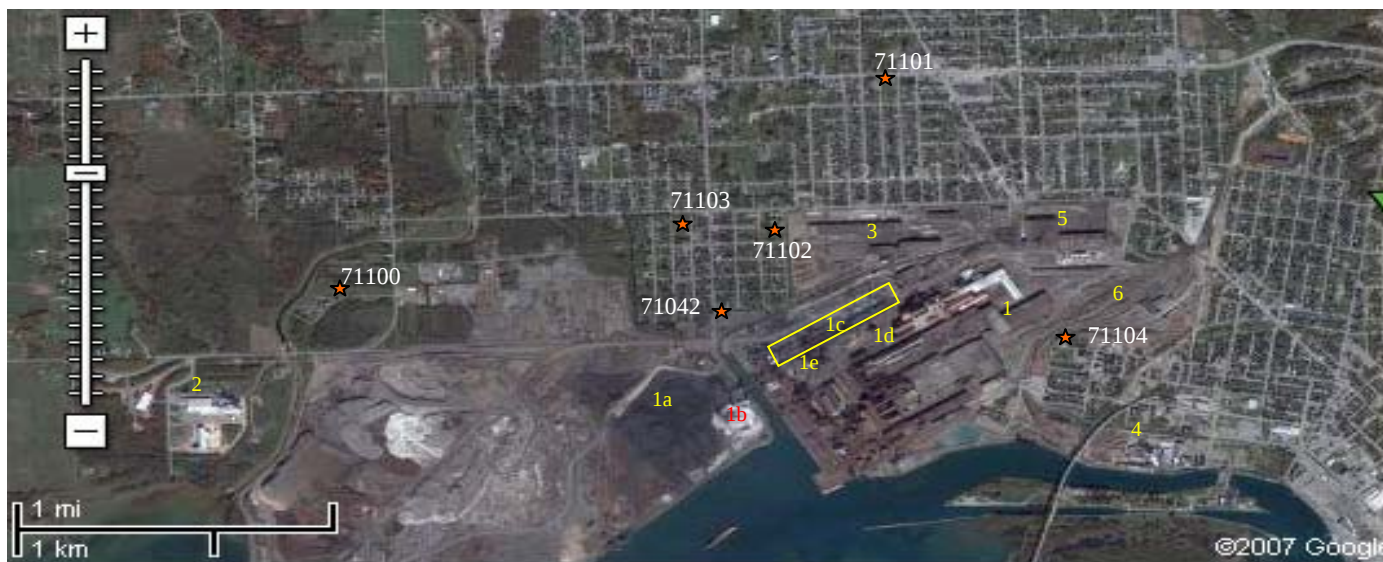
Figure 1: Satellite image overview of study area. Particulate sources: 1- Algoma Steel Inc, 2 – Flakeboard (SSM) Co. Ltd., 3 – Algoma Tubes Inc., 4 – St. Marys Paper, 5 – Praxair, 6 – Algoma Central Railway. Sources within ASI: 1a – coal piles, 1b – lime plant, 1c – coke oven stacks, 1d – dekish area, and 1e – blast furnace vents. Map from Google.

This report presents the results of continuous monitoring and discrete particulate sampling conducted in 2006 at 6 locations within Sault Ste. Marie around the ASI facility (Fig. 1). The objectives of this study were to further quantify and characterize airborne particulate in the neighbourhoods around ASI, focusing on the Bayview neighbourhood and to further quantify airborne PAH levels in the Bayview neighbourhood to complement soil and vegetation PAH sampling that was conducted by the ministry's Environmental Monitoring and Reporting Branch (EMRB) in 2005.

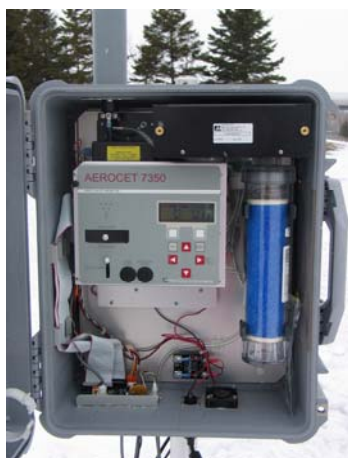
The Aerocet uses light scattered from suspended particulate to provide a continuous real-time measurement of airborne particulate. An internal visible laser diode is collimated and directed through sample air. Sample air is drawn into the Aerocet by an internal pump at  $1.0 \text{ L min}^{-1}$ . The Aerocet can provide 15-min to 24-hr averages: for this study, 15-minute particulate averages were collected and downloaded on a weekly basis.

Figure 2: Aerocet 7350 continuous particulate monitor.

Continuous particulate monitoring was performed using MetOne Aerocet Model 7350 continuous particulate monitors fitted with wind speed and direction instrumentation all locations (Fig. 2). TSP results from this instrument will be discussed within this report. The ministry's suspended particulate schedule 1 0.5-hr standard is  $100 \mu\text{g m}^{-3}$  and the schedule 3 24-hr standard is  $120 \mu\text{g m}^{-3}$ .

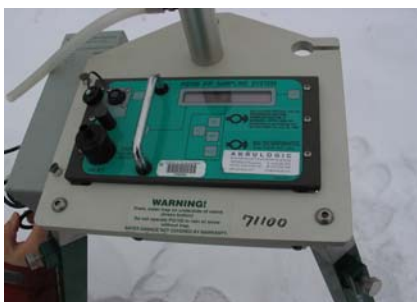
Discrete particulate sampling was performed at all locations using either PQ 100 or PQ 200 samplers (Fig. 3) with 47 mm Teflon filters on a 24-hr 3-day sampling schedule. The PQ 100 samplers are portable samplers which draw ambient air at  $16.7 \text{ L min}^{-1}$ . For this study, the  $\text{PM}_{10}$  (particulate matter  $10 \mu\text{m}$  in diameter and smaller) sampling head was used: the ministry's 24-hr interim  $\text{PM}_{10}$  standard is  $50 \mu\text{g m}^{-3}$ . The  $\text{PM}_{10}$  results can also be compared to the schedule 3 24-hr suspended particulate (particulate less than  $44 \mu\text{m}$ ) standard. Filters were analyzed for a suite of metals by the ministry's Laboratory Services Branch (LaSB). Table 8 summarizes the analysed metals and the ministry standard, where available.

Figure 3: PQ 100 sampler.

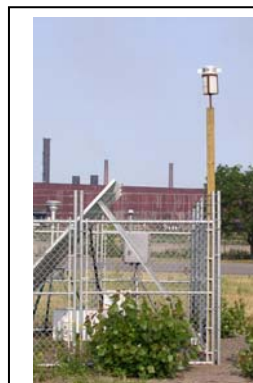
Figure 4: Dustfall

Dustfall jars were installed at all 6 locations (Fig. 4). Dustfall comprises the largest fraction of particulate, generally in the  $25$  to  $100 \mu\text{m}$  range and larger more visible particulate matter which settle out from the atmosphere by gravity into dustfall jars. Jars are left in place for a period of 1 month. In combination with the identification of particles by optical microscopy, this method can serve as a useful indicator of the types and possible sources of particulate matter in areas

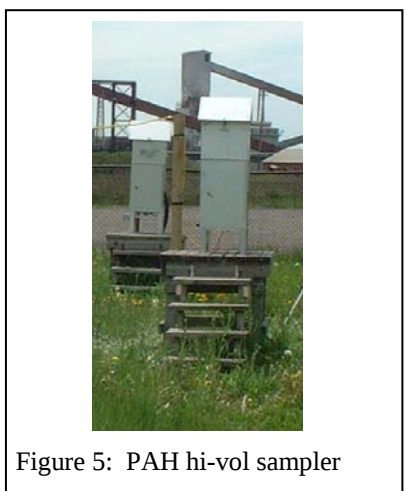
24 hour polycyclic aromatic hydrocarbon (PAH) samples were collected using hi-vol samplers (Fig. 5) on a 12-day schedule at the Bonney St. location. Filters were analyzed for a suite of PAHs. Only Benzo-a-pyrene (BaP) will be discussed within this report since the ministry has an Ambient Air Quality Criteria (AAQC) for only this PAH.

Figure 5: PAH hi-vol sampler

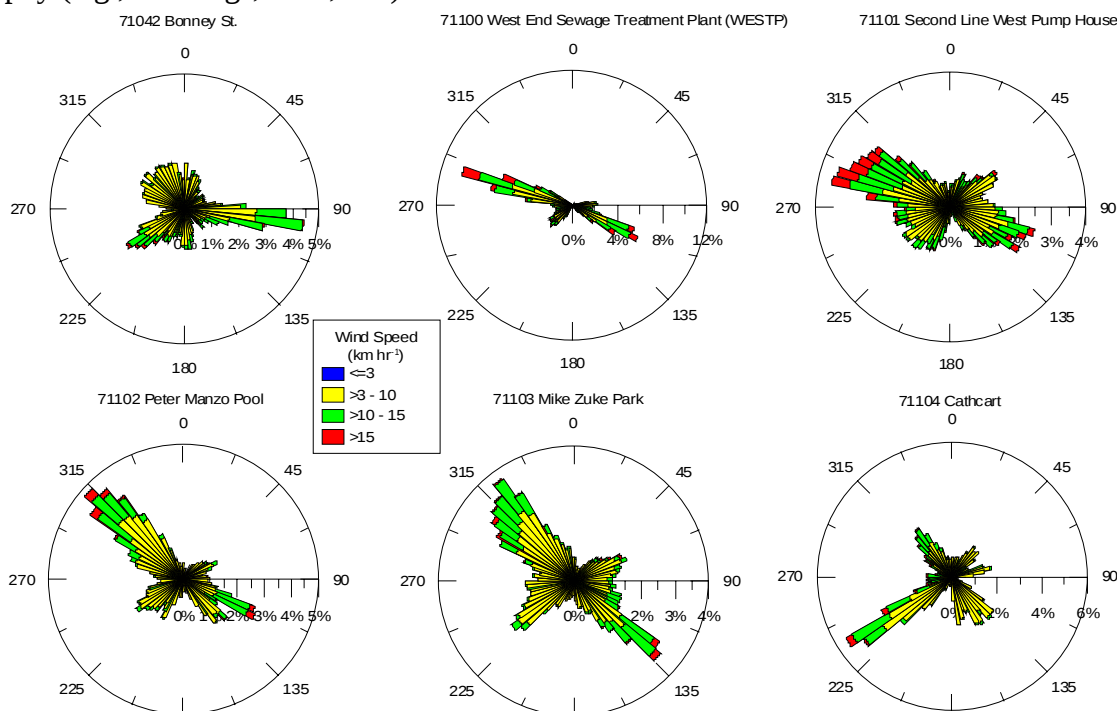
Fig 6 presents wind roses, generated from the 15-min Aerocet data, for each of the 6 monitoring locations. Wind directions associated with wind speeds less than  $3\text{ km hr}^{-1}$  have been excluded since they are unreliable at these speeds. The predominant wind directions at most of the locations tend to be from the south east and north west. Some locations are impacted by local topography (e.g., buildings, trees, etc.)

Figure 6: Wind roses for each of the 6 monitoring locations. Generated from the 15-min Aerocet data.

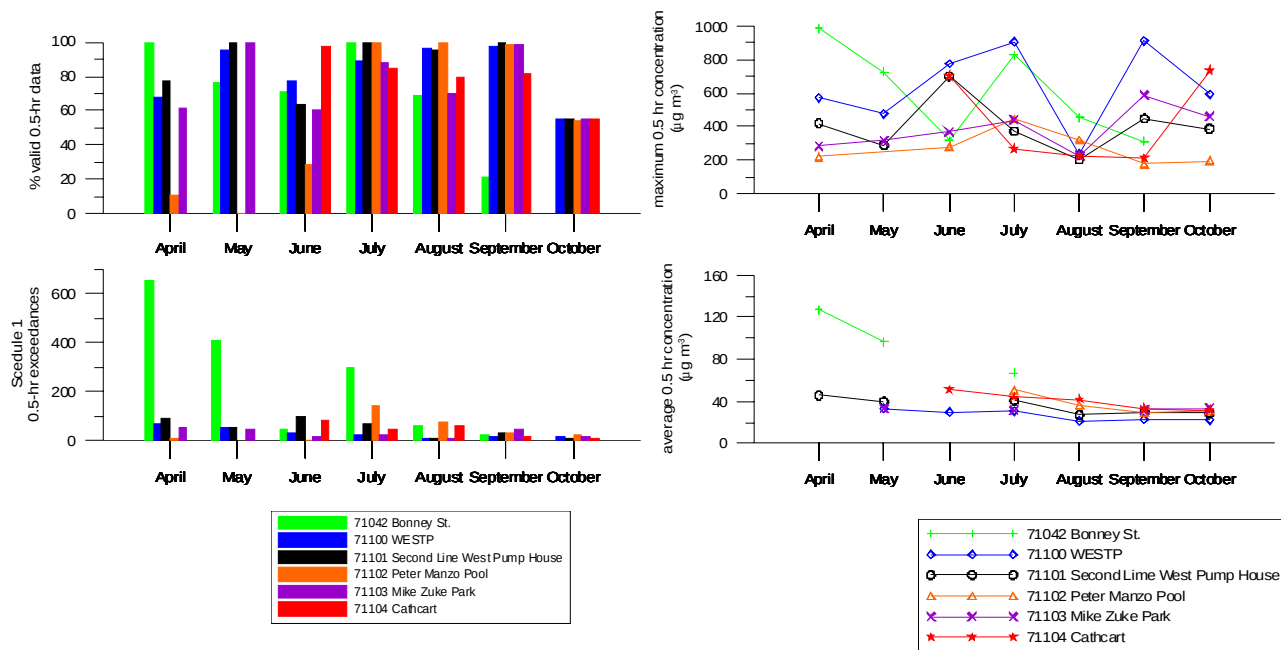
Figure 7: 0.5-hr TSP statistics for the 6 monitoring stations presented by month.

Table 5 summarizes the 0.5-hr and 24-hr statistics for the full data set as described in Table 4. A minimum of 75 % valid data was required before calculating the 0.5-hr and 24-hr averages using the 15 minute raw data. Fig. 7 presents the monthly statistics for the 0.5-hr data and Fig. 8 presents the monthly statistics for the 24-hr data.

Exceedances of the suspended particulate schedule 1 0.5-hr standard of  $100\text{ }\mu\text{g m}^{-3}$  occurred at all monitoring locations: the highest average concentration and largest exceedance rate occurred at 71042 Bonney St. and the lowest average concentration and smallest exceedance rate occurred

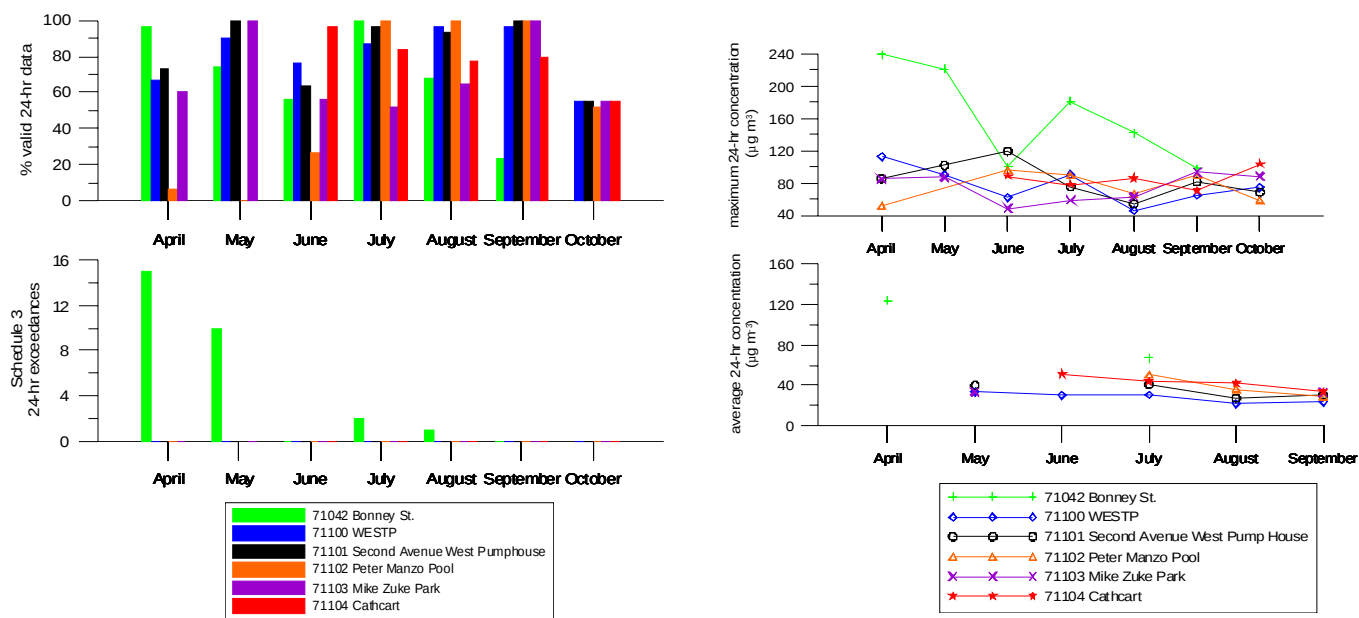
Figure 8: 24-hr TSP average statistics for the six monitoring locations presented by month

at 71100 WESTP and 71104 Cathcart, respectively. With the 24-hr averages, only two locations experienced exceedances of the schedule 3 standard of  $120 \mu\text{g m}^{-3}$ : 71042 Bonney St. with 33 exceedances and 71101 Second Line West Pump House with 4 exceedances. These data show that TSP concentrations and number of 0.5-hr and 24-hr exceedances quickly drop in value as one moves away from the Algoma Steel Inc. property line: particulate concentrations within Bayview that are not adjacent to the ASI property line (i.e., 71102 Peter Manzo Pool, 71103 Mike Zuke Park) are comparable to those found at the other monitoring locations which are further away from ASI.

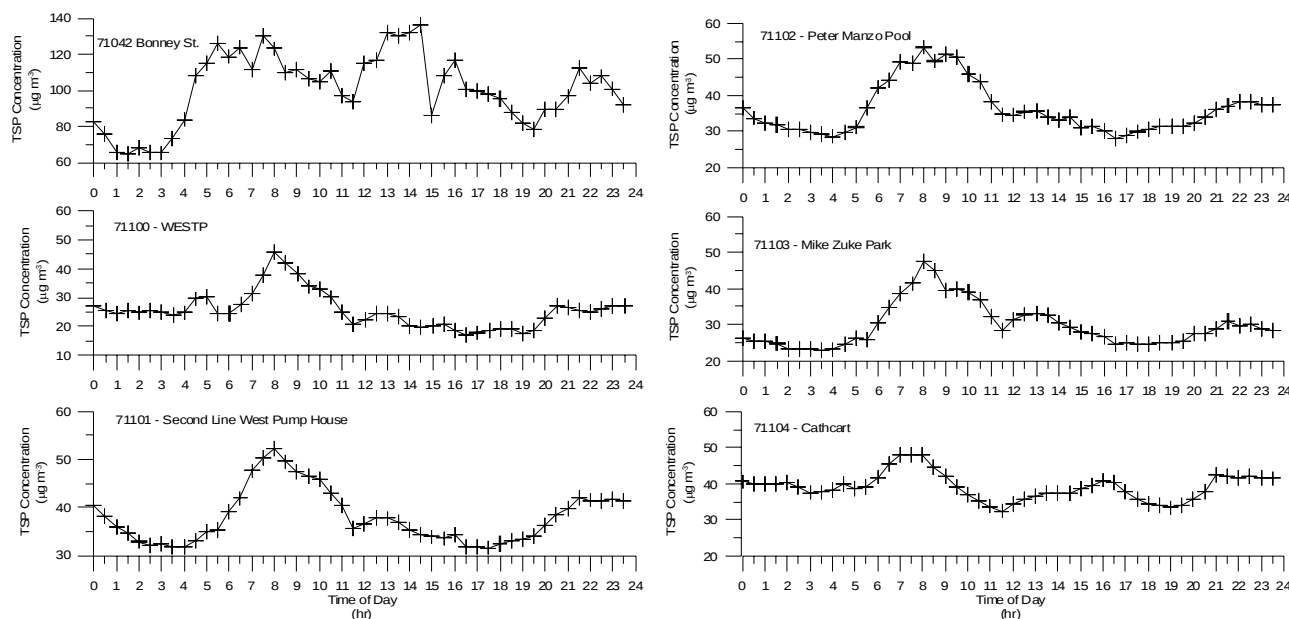
The availability of high resolution data is an advantage of using continuous monitoring. The collected data can be correlated by time to industrial processes or other emission activities and by wind direction to assist in attributing particulate to local sources. Fig. 9 presents time averaged 0.5-hr TSP concentrations for the entire study period. Standard deviations were large; error bars were excluded to enable viewing of diurnal trends. Diurnal variability is obvious in the data from all the sites except possibly 71042 Bonney St. Peak TSP concentrations occurred around 08:00 at 5 of the 6 sites. These maximum are likely due to a combination of morning rush hour vehicle traffic, initiation of daily industrial activity and the increased atmospheric

turbulence that occurs at dawn. Two daily TSP minimums can be identified and typically occurred before dawn between midnight and 04:00 and again around 17:00.

Figure 9: Diurnal variability in 0.5-hr averaged data. Error bars were large and have been excluded for easier viewing.

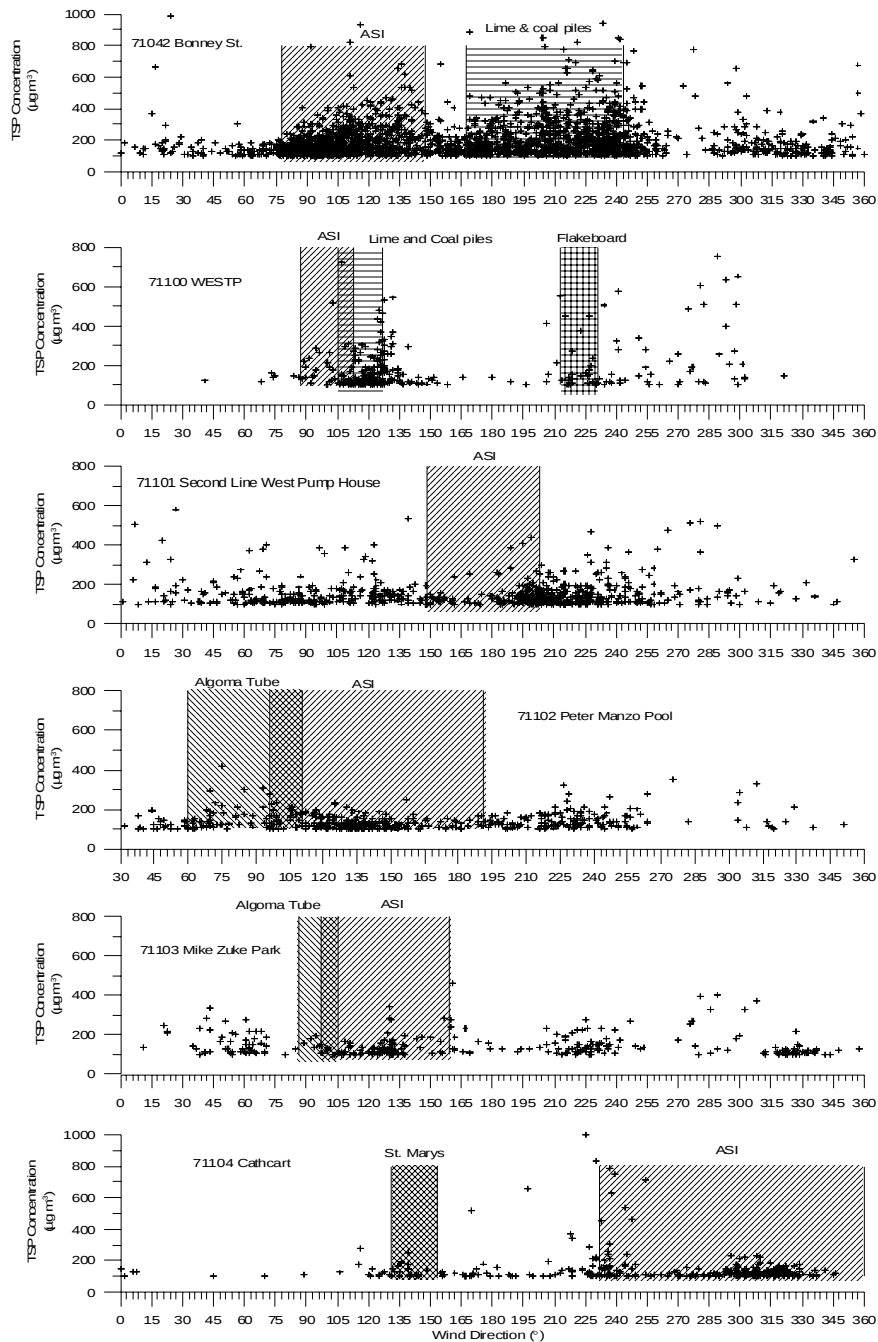
One needs to be cautious when attributing particulate levels to sources since there is a variety of sources in the vicinity of the monitoring locations and extensive areas of unpaved parking lots and industrial storage yards. At some of the stations industrial sources have a clear impact on particulate concentrations. At 71042 Bonney St., ASI, the associated coal and lime storage piles, and other upwind areas (e.g., unpaved parking lots) are the most significant source of particulate (Fig. 10). The wind directions associated with the storage piles provides a larger number of particulate concentrations greater than  $100 \mu\text{g m}^{-3}$  and higher TSP concentrations in general.

At 71100 WESTP, ASI lies upwind of the monitoring location and appears to be contributing to elevated TSP concentrations; however, there are light industrial areas and extensive unpaved areas located between the monitoring location and ASI. Flakeboard, which is southwest of WESTP, also appears to be contributing to elevated particulate at this location. At 71101 Second Line West Pump House there were elevated particulate measured at this location which may have originated from ASI and associated storage piles. At 71102 Peter Manzo Pool, ASI and Algoma Tubes Inc. both have an impact on elevated TSP levels, but not to the extent observed at 71042 Bonney St. At 71103 Mike Zuke Park, TSP concentrations were similar to 71102 Peter Manzo Pool. At 71104 Cathcart, the contribution of ASI on elevated particulate is minimal compared to 71042 Bonney St. which is the same distance from ASI, but on the opposite side of the facility. St. Marys Paper may have also had an impact on particulate levels at 71104 Cathcart.

Figure 10: Wind direction analysis of 15 min average TSP data. Various industrial particulate sources are identified. Only TSP values greater than  $100 \mu\text{g m}^{-3}$  have been included. Wind directions associated with wind speeds less than  $3 \text{ km hr}^{-1}$  have been excluded since wind direction becomes unreliable at low wind speeds

Not all airborne particulate in the vicinity of Algoma Steel Inc. is a result of activities at the facility. Other sources include additional industries in the area (e.g., Algoma Tubes Inc., Praxair, Flakeboard), vehicular traffic, heating exhaust, burning, road dust, and construction activities (e.g., Bonney St. construction ongoing for most of summer). Wind direction analysis of the continuous particulate data can help identify sources around the monitoring locations. Table 6 summarizes the approximate distances and wind directions from the stations to the various sources: sources within 1.5 km were the primary focus. Fig. 10 presents all 15-min concentrations greater than  $100 \mu\text{g m}^{-3}$  correlated with wind direction. Calm winds less than  $3 \text{ km hr}^{-1}$  were filtered out since wind direction measurements are not reliable under calm conditions. Monthly breakdowns of the particulate versus wind direction are located in Appendix 3.

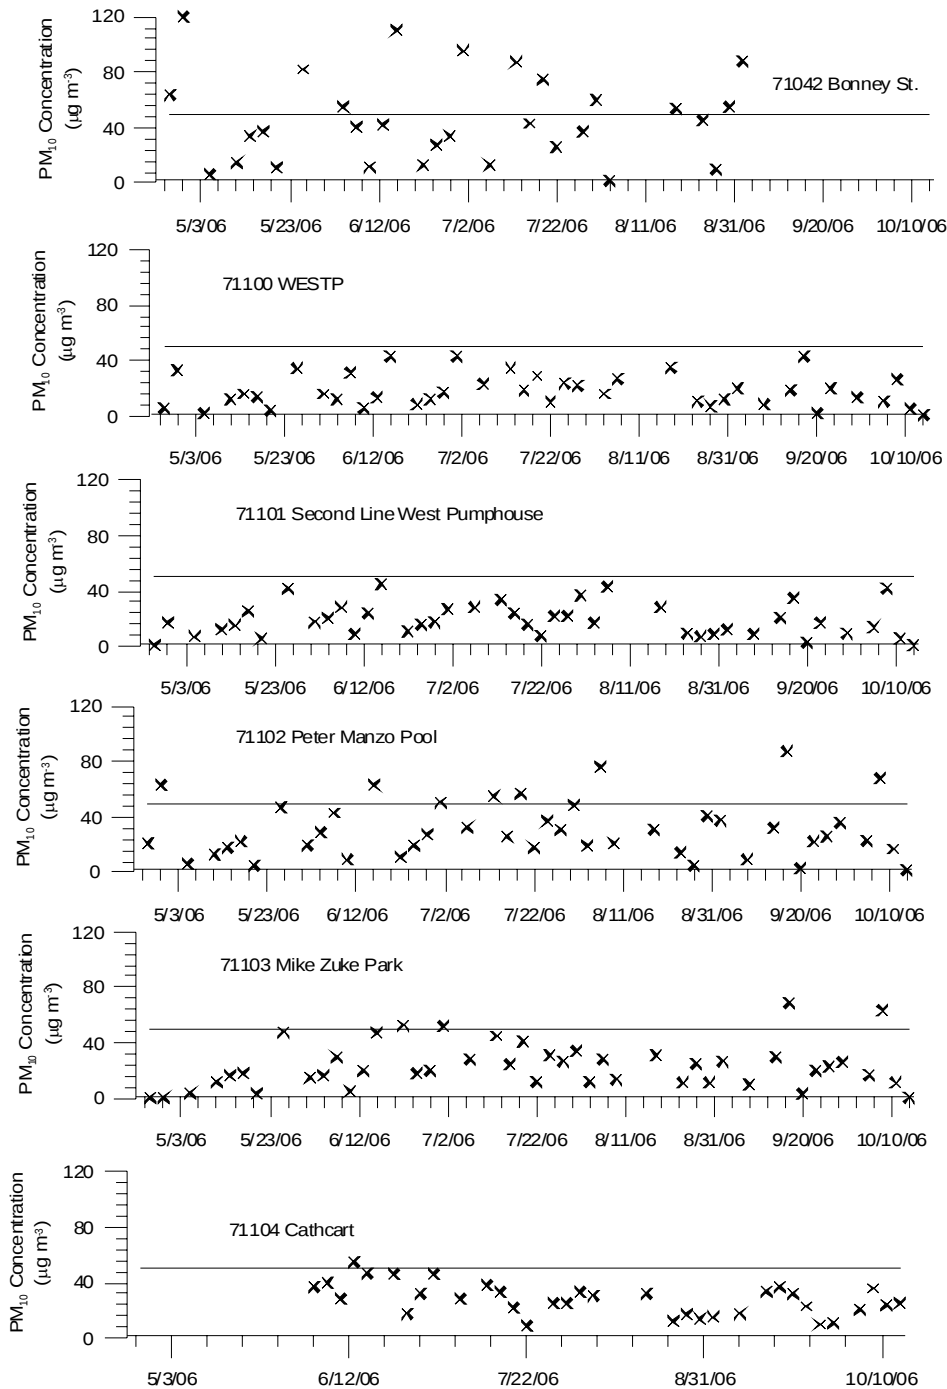
Figure 11 presents all the PM<sub>10</sub> particulate data for the study period in time series format. 71042 Bonney St. recorded the highest concentrations and the most exceedances of the 24-hr PM<sub>10</sub> interim AAQC (Table 7). Exceedances were also recorded at the other two stations within the Bayview neighbourhood. Exceedances were not measured at 71100 WESTP or 71101 Second Line West Pump House. There were no exceedances of the ministry's schedule 3 24-hr suspended particulate standard.

Figure 11: Time series presentation of PM<sub>10</sub> 24-hr sampling results

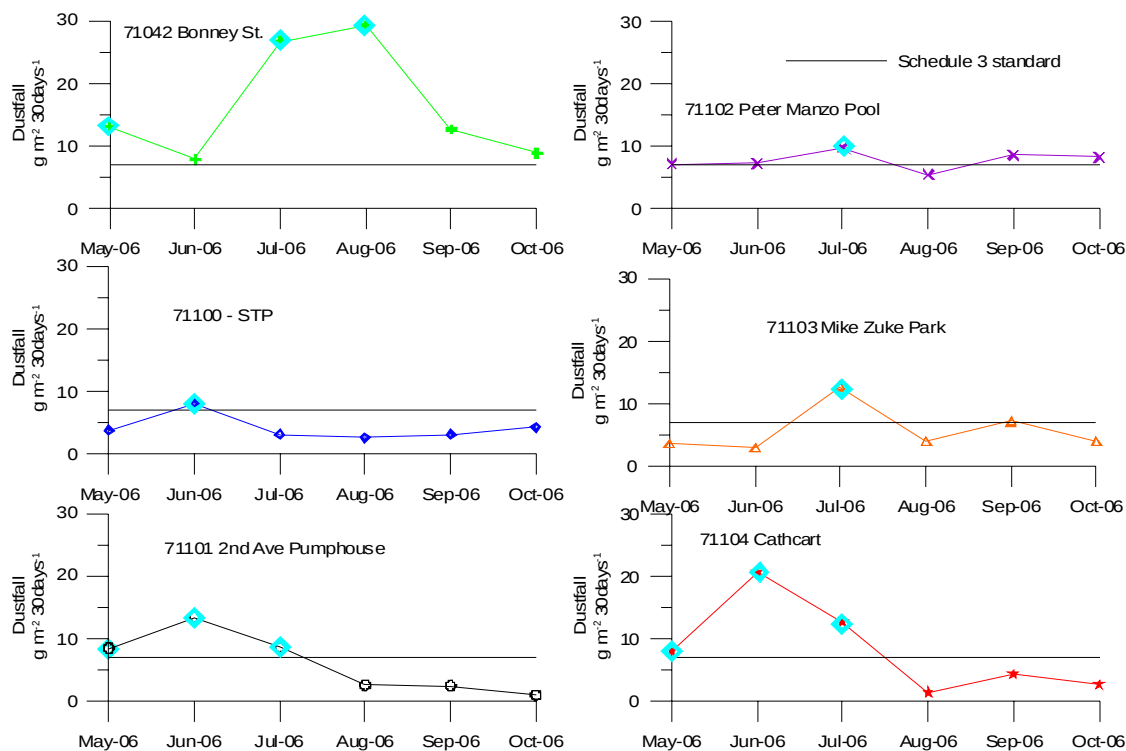
Figure 12: Summary of dustfall results May through October 2006 at the 6 sampling sites. The turquoise diamonds highlight samples in which algae was identified

Stations within the Bayview area were the only locations in which exceedances of the schedule 3 standard occurred. Optical characterisation was performed on all samples and provided insight into the sources of the particulate captured in the jars. Figure 13 presents the results of the optical characterisation: only non-trace level particle types are included. Within many of the samples, biological material and silicates contributed significantly to the dustfall. Biological material is primarily insect parts while silicates are primarily road dust from local streets or nearby unpaved areas. Table 12 lists the non-algae containing samples, the major particle types and the likely source.

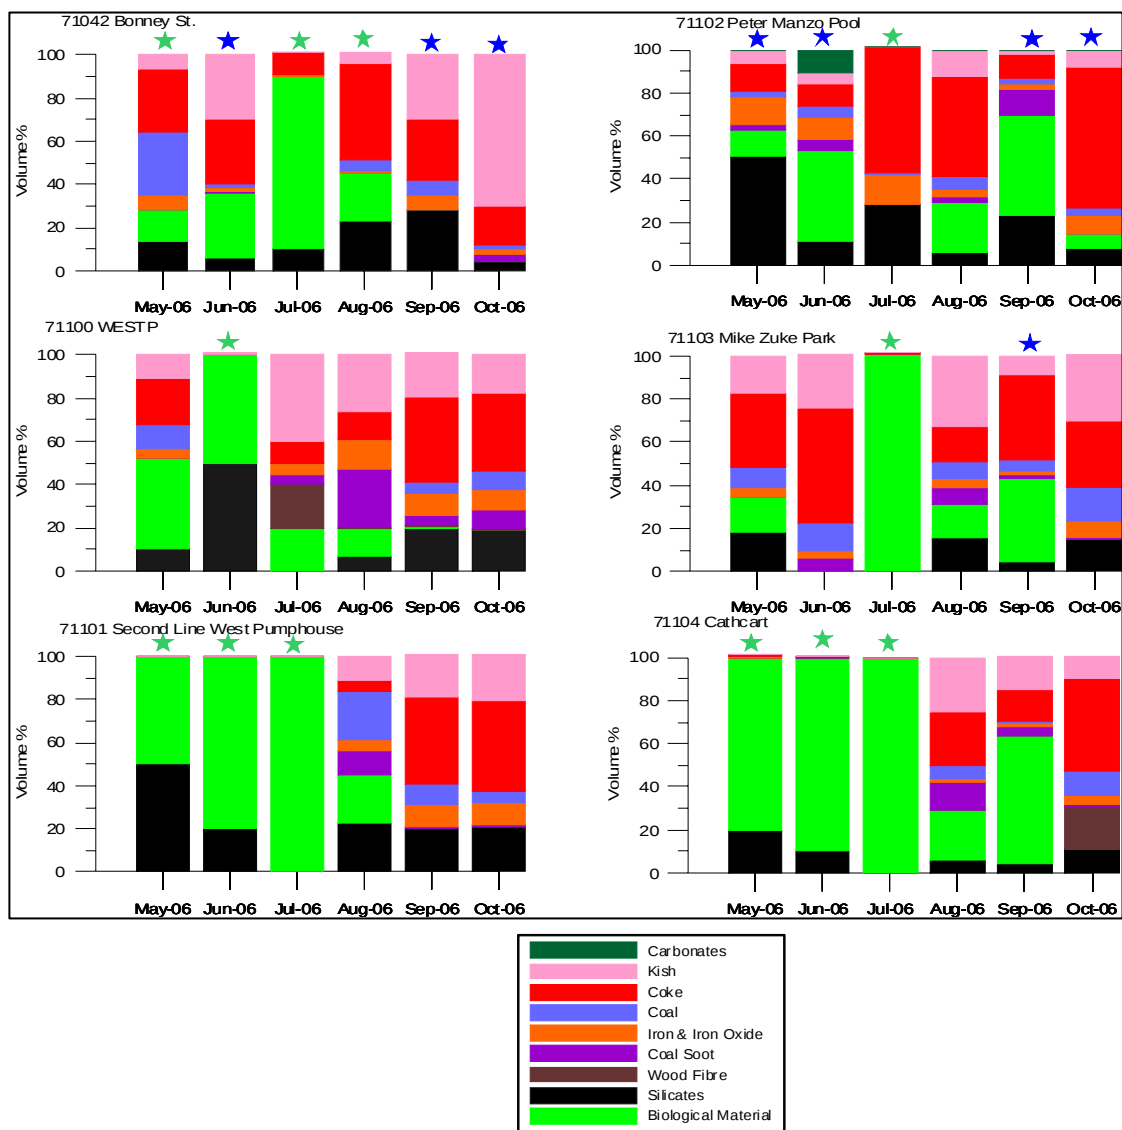
Figure 13: Optical characterisation results of dustfall samples collected at the 6 sampling locations. Blue stars identify exceedance samples. Green stars identify exceedance samples which contained algae.

Table 12: Summary of dustfall exceedance samples which did not contain algae and likely particle sources. Major particles must sum to more than 50% of identified particles. Information extracted from Fig. 13.

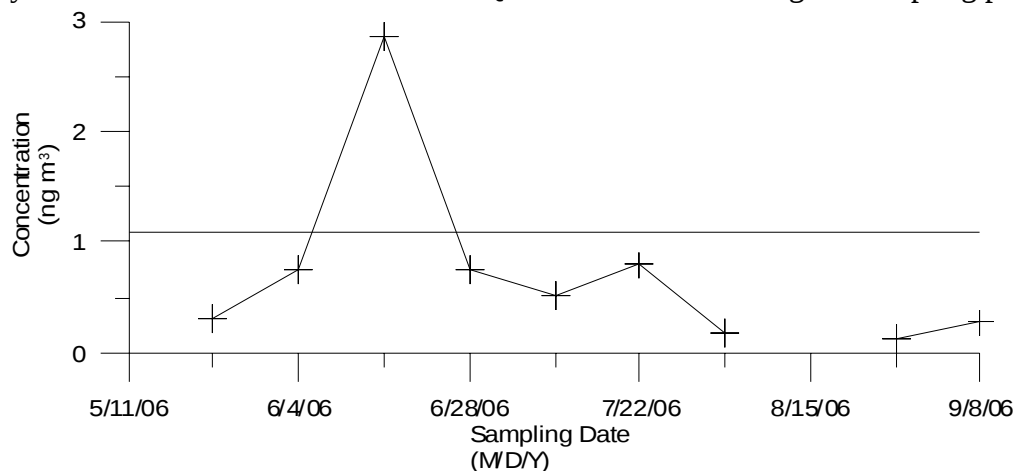
Fig 14 presents the Benzo-a-pyrene results BaP obtained between 11 May 2006 and 08 Sept 2006 at 71042 Bonney St. Table 13 presents a summary of statistics for the various PAHs that were quantified. Benzo-a-pyrene is the only PAH for which the ministry has an AAQC ( $1.1 \text{ ng m}^{-3}$ ). Only 1 exceedance of the 24-hr BaP AAQC was measured during the sampling period.

Figure 13: Benzo-a-pyrene sampling results for 71042 Bonney St. 11 May 2006 to 08 Sept 2006

PAH sampling was conducted only at the 71042 Bonney St. sampling location. 9 samples were collected on a 12-day schedule. One exceedance of the benzo-a-pyrene 24-hr AAQC was noted. The data has not been compared to the soil and vegetation sampling conducted by EMRB.

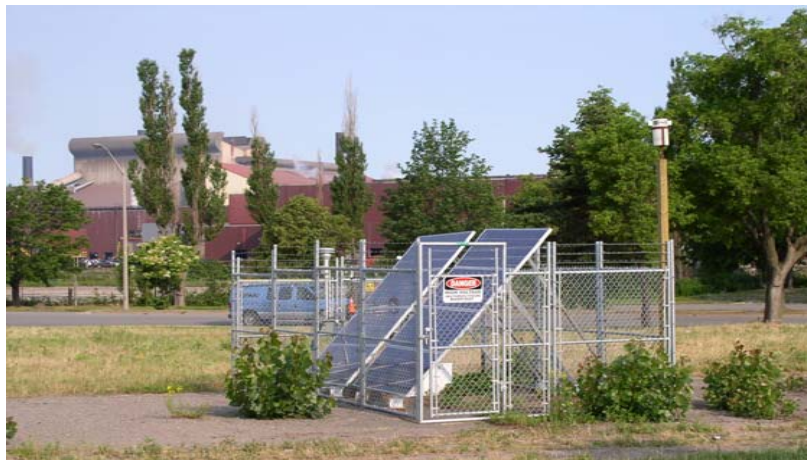
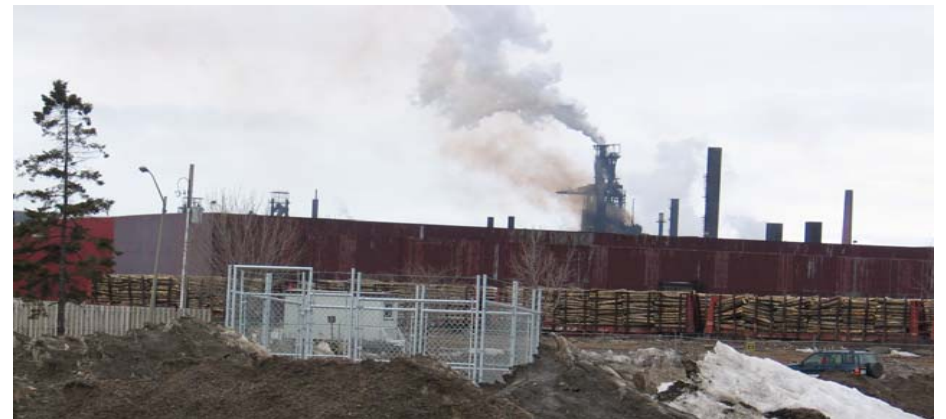
Figure A7: 71104 – Cathcart monitoring station with off-grid solar system

Hydro was readily available at 5 of the 6 sites. At the 71104 Cathcart St. location, the cost of installing hydro would have been prohibitive: an off-grid solar system was installed at this location.

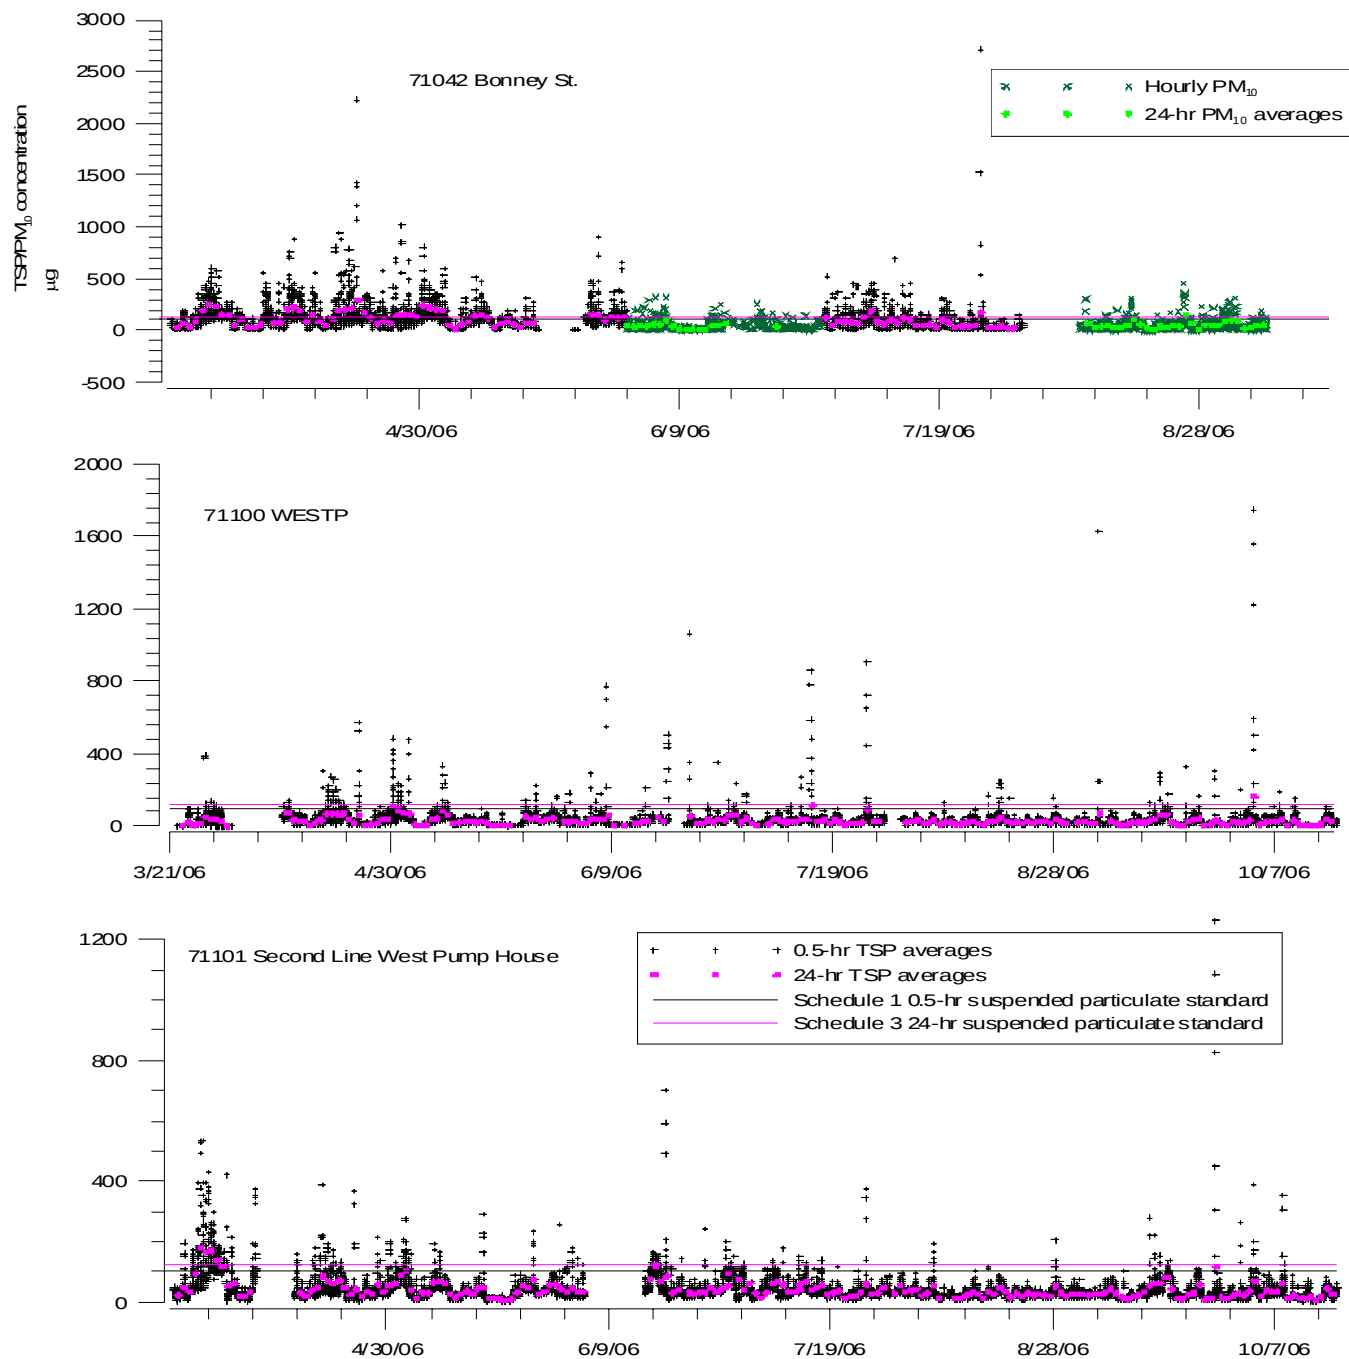
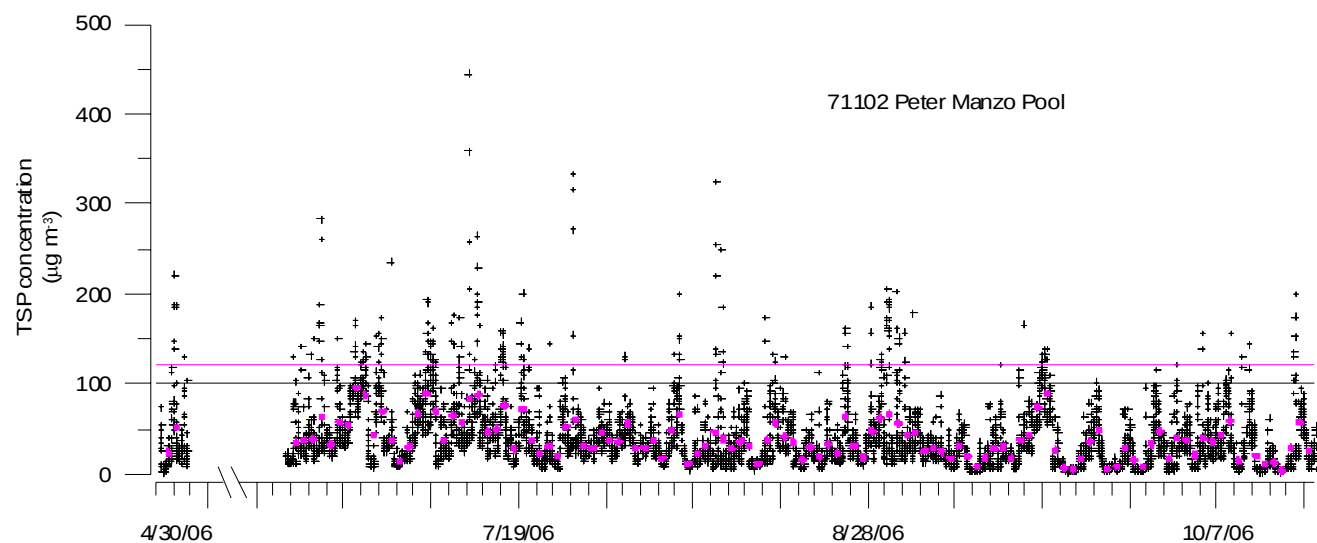
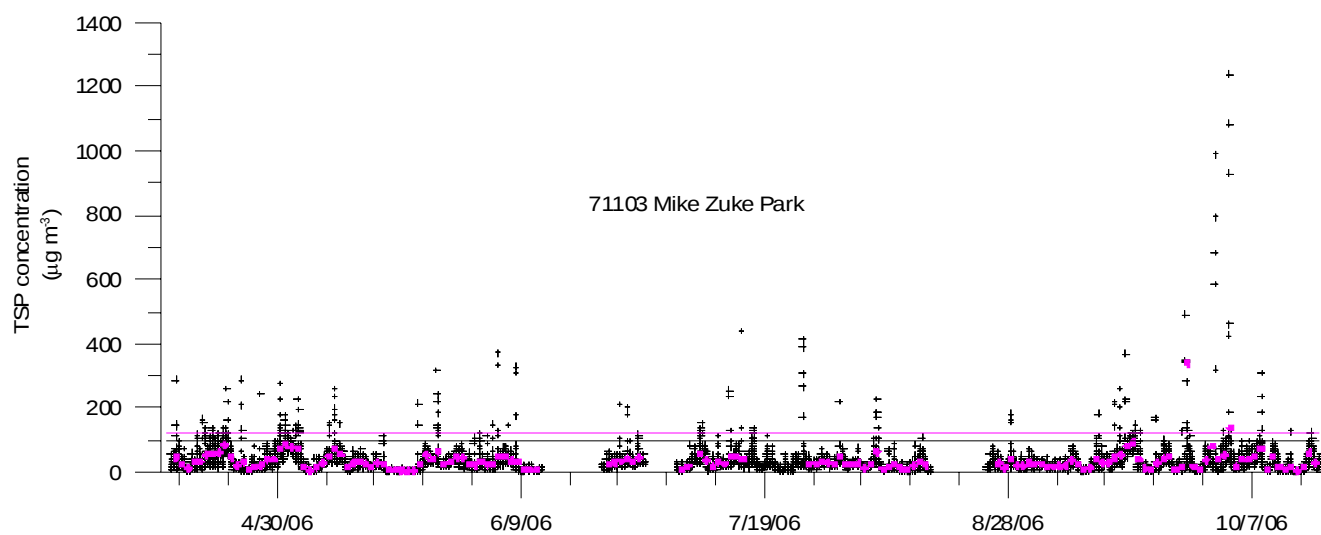
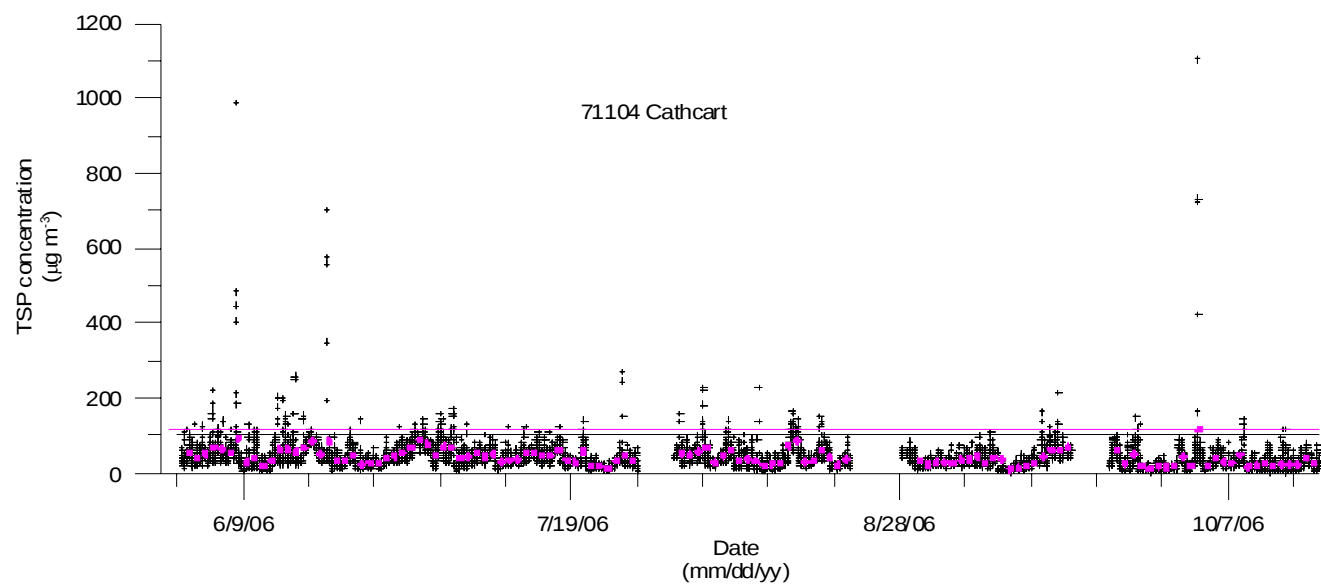
## Appendix 2: Time series of 15-min and 24-hr average data collected from continuous particulate monitors

note different ranges of vertical axis on graphs

Appendix 2 graphically presents all the 0.5-hr and 24-hr averaged data for the study period in time series format. Light scattering particulate monitors are limited when temperatures are close to the dew point as particulate concentrations can rise to unrealistic levels. The Aerocets do not have ambient relative humidity sensors, therefore dew point temperatures could not be calculated, although there were occasions when particulate concentrations rose to very high levels. An examination of particulate and wind speed showed that most high particulate concentrations occurred at calm wind speeds ( $< 3\text{ km hr}^{-1}$ ). For these reasons, values of TSP greater than  $1000\text{ }\mu\text{g m}^{-3}$  were excluded from the analysis and not used in the discussions below.
