Re: Report on Sault Ste. Marie 2006 Particulate Monitoring Special Study

## Background

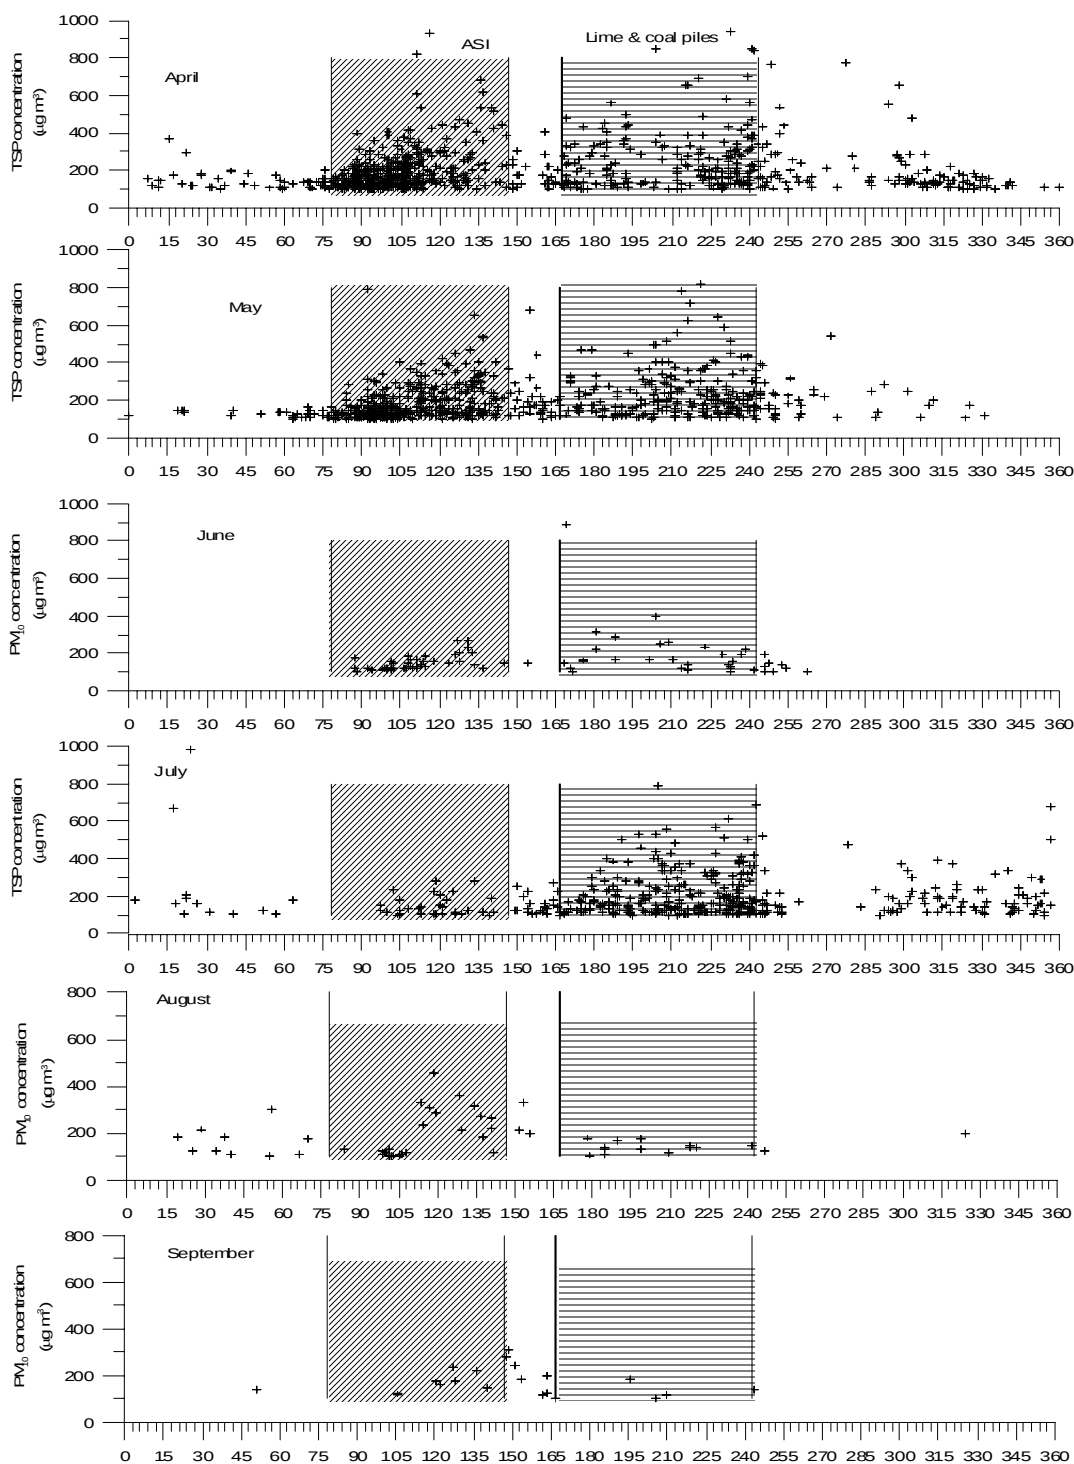
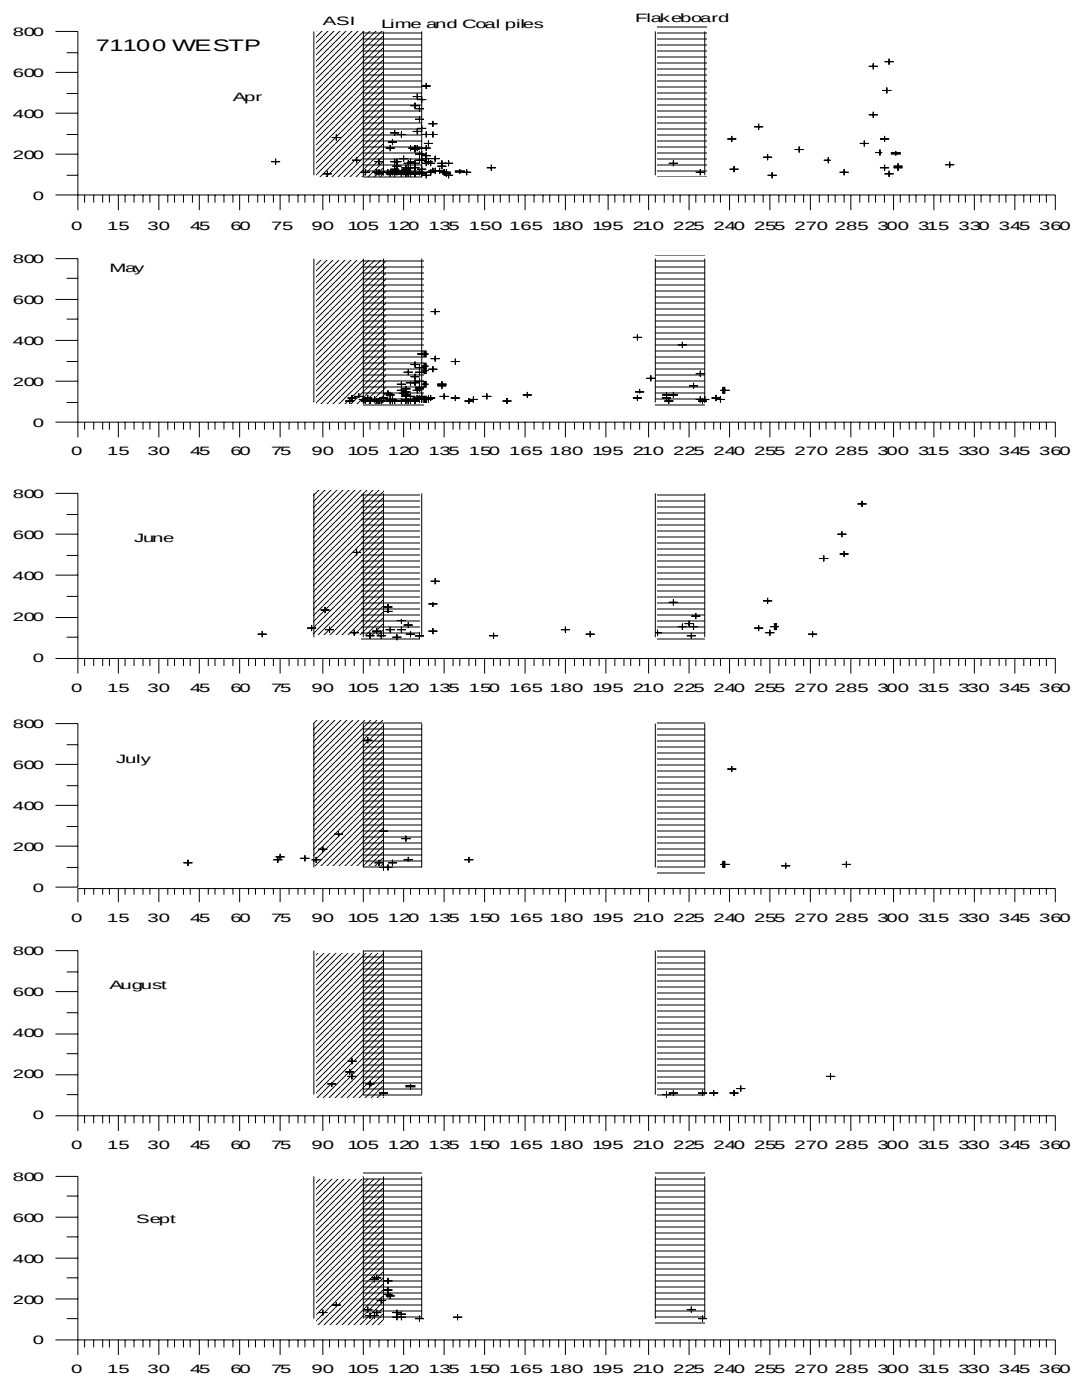
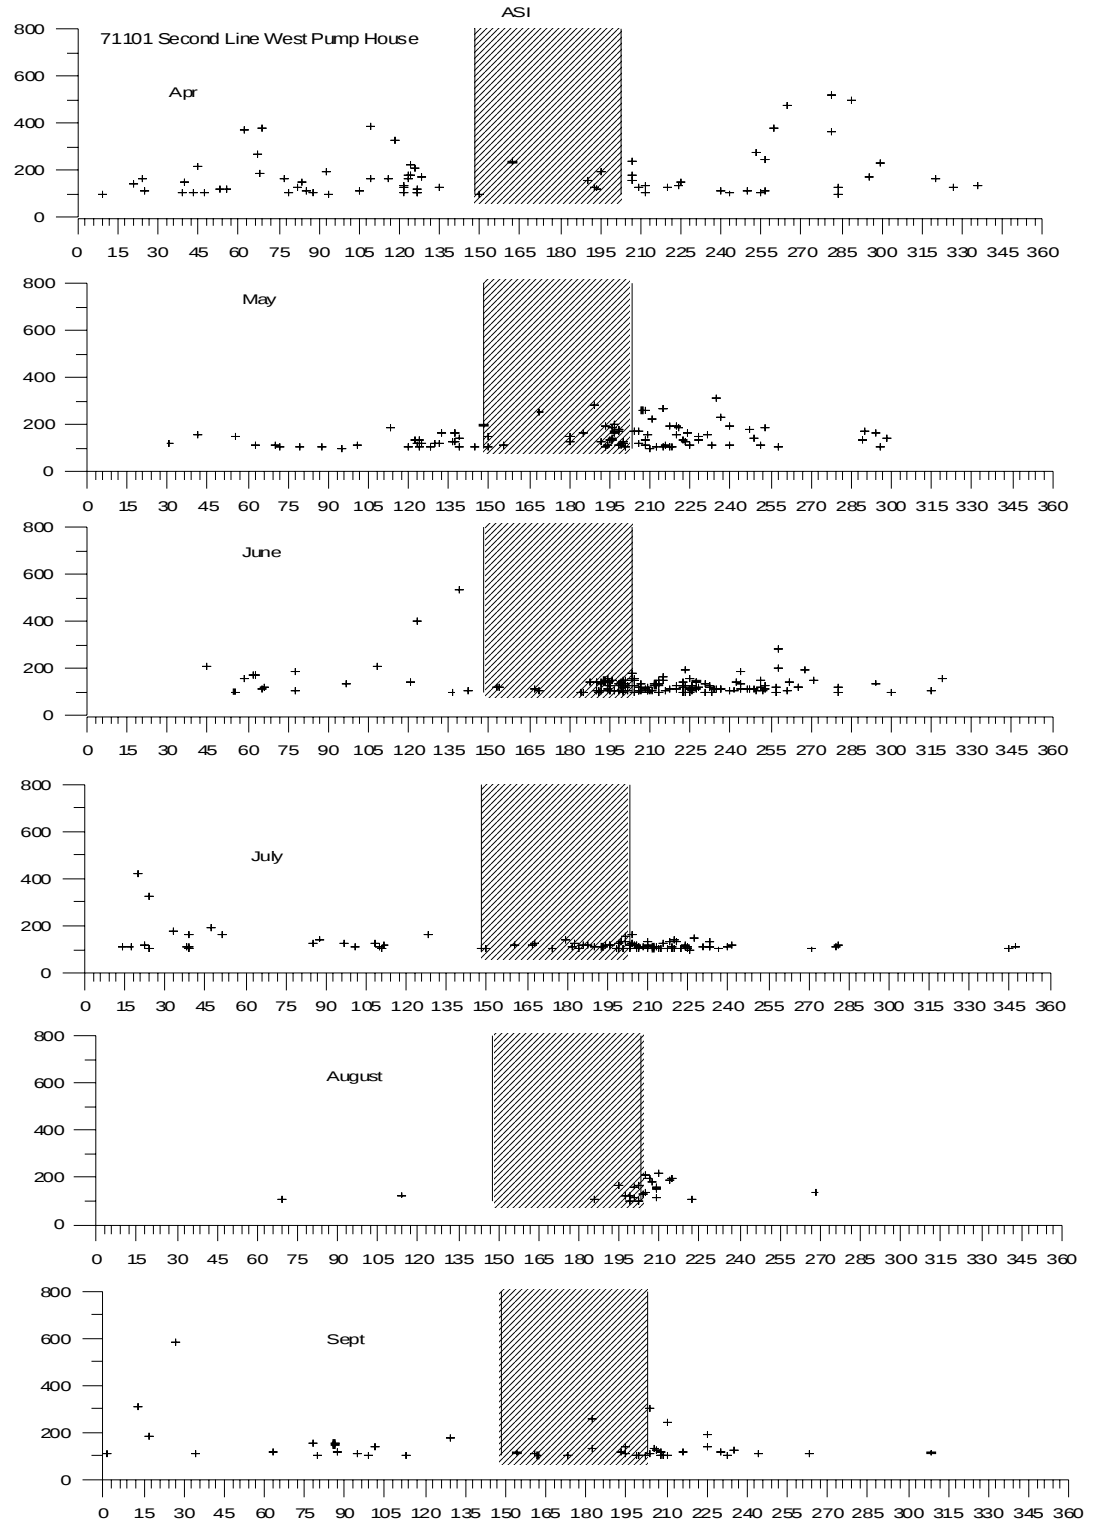
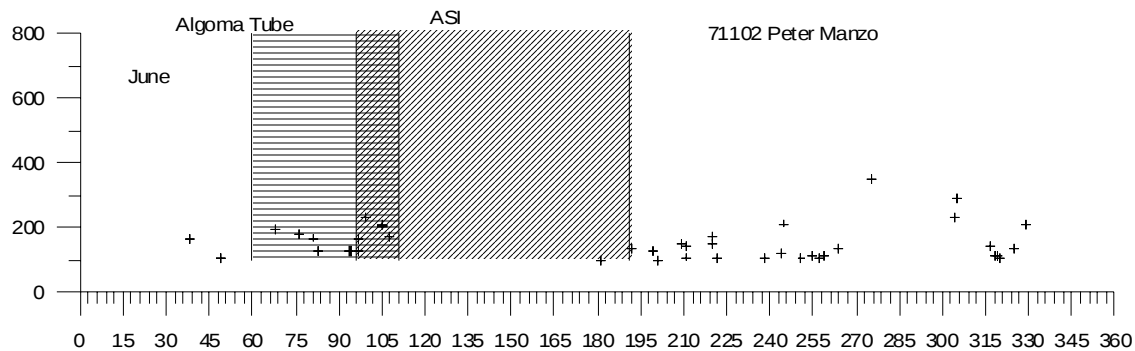
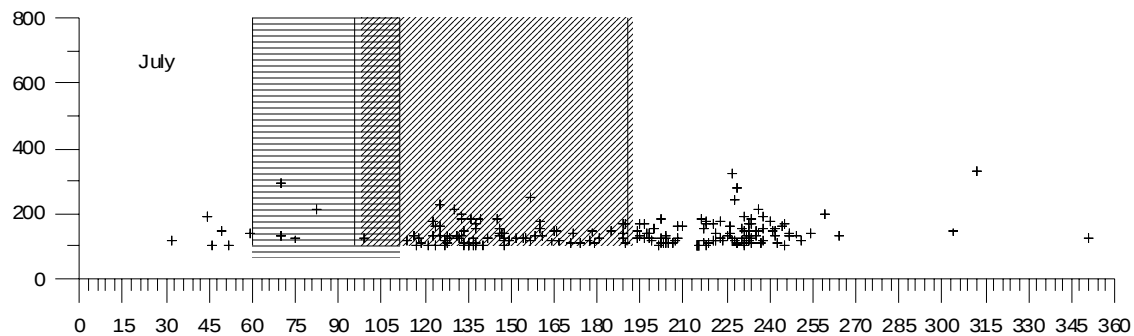
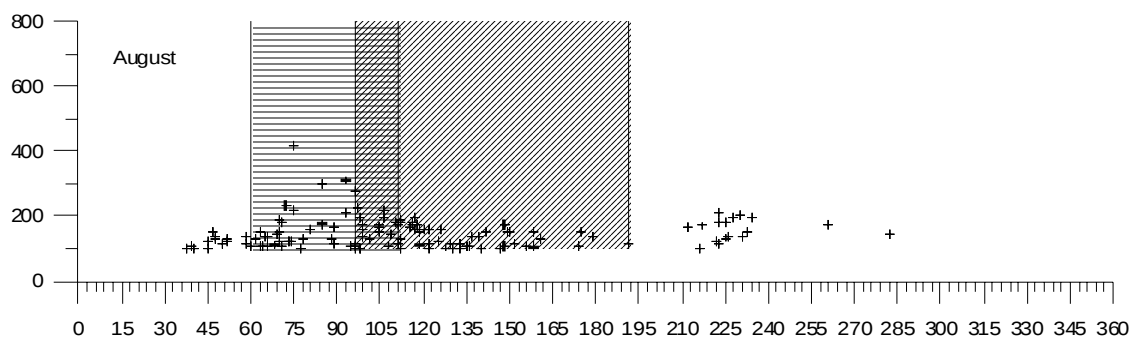
### Appendix 3: Continuous particulate data (15-min) correlated by wind direction by month

Note: June, August & September data are hourly PM<sub>10</sub> BAM values

Not all airborne particulate in the vicinity of Algoma Steel Inc. is a result of activities at the facility. Other sources include additional industries in the area (e.g., Algoma Tubes Inc., Praxair, Flakeboard), vehicular traffic, heating exhaust, burning, road dust, and construction activities (e.g., Bonney St. construction ongoing for most of summer). Wind direction analysis of the continuous particulate data can help identify sources around the monitoring locations. Table 6 summarizes the approximate distances and wind directions from the stations to the various sources: sources within 1.5 km were the primary focus. Fig. 10 presents all 15-min concentrations greater than  $100 \mu\text{g m}^{-3}$  correlated with wind direction. Calm winds less than  $3 \text{ km hr}^{-1}$  were filtered out since wind direction measurements are not reliable under calm conditions. Monthly breakdowns of the particulate versus wind direction are located in Appendix 3.

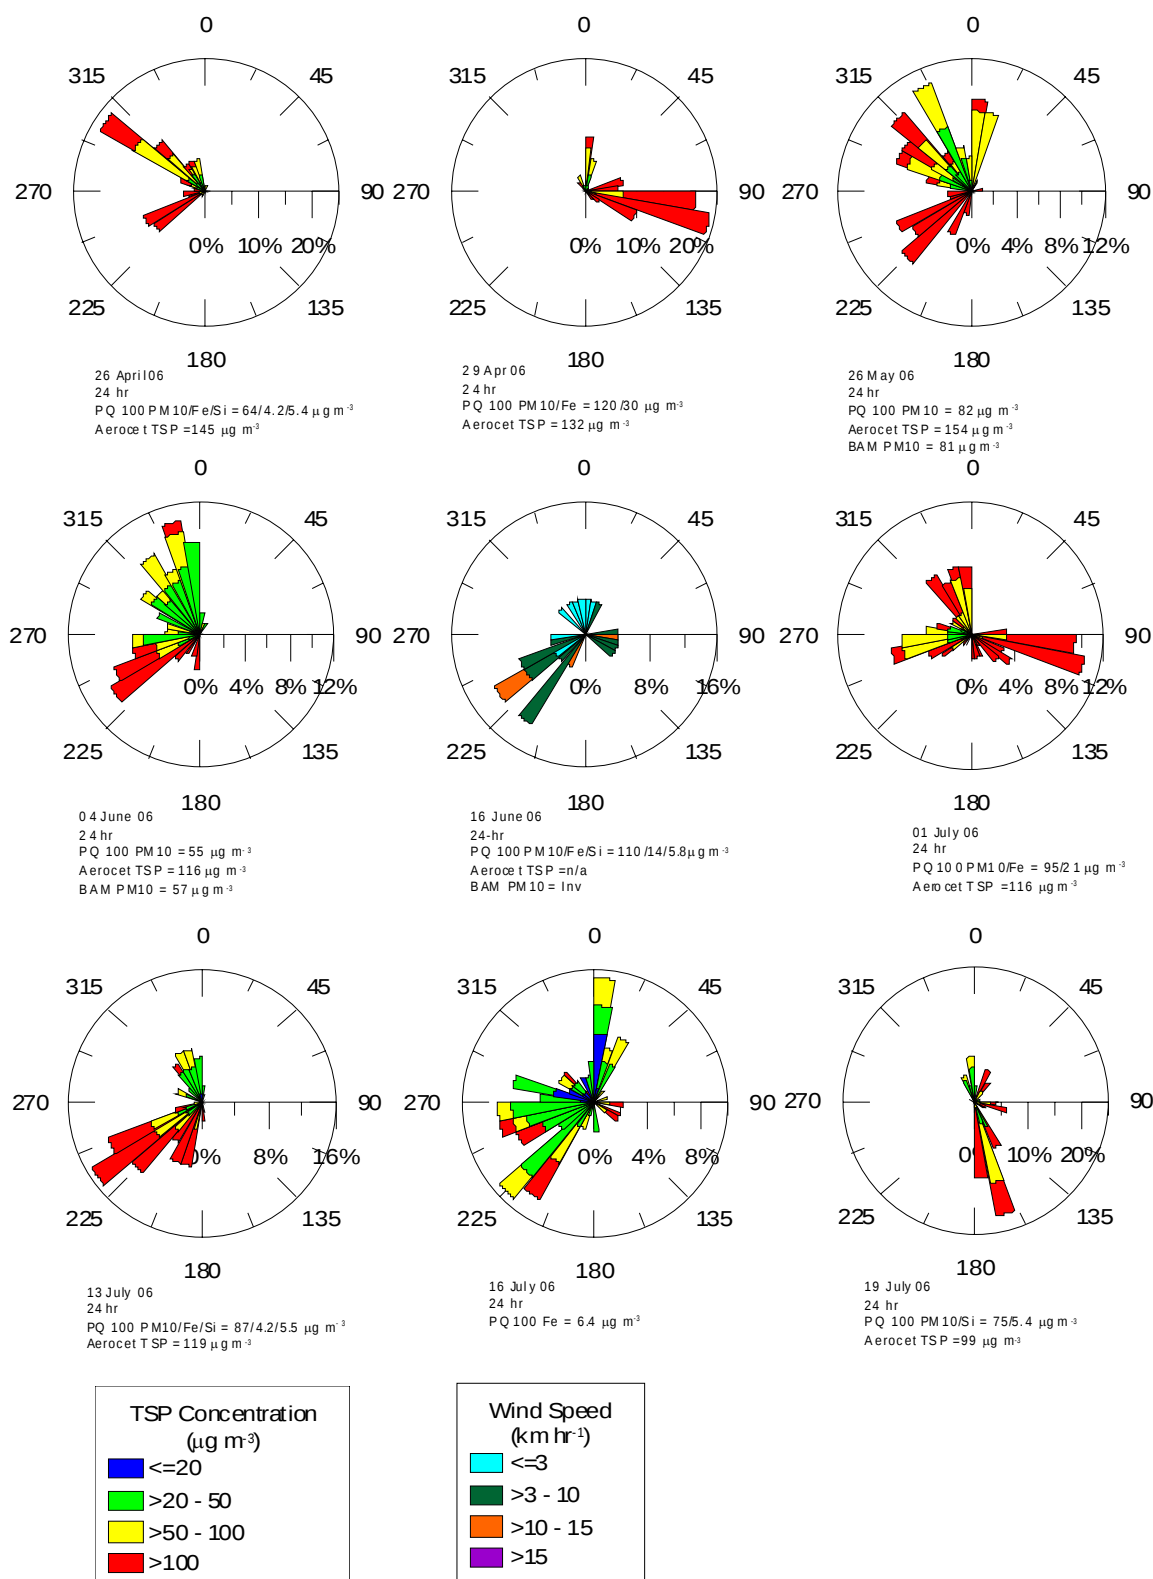
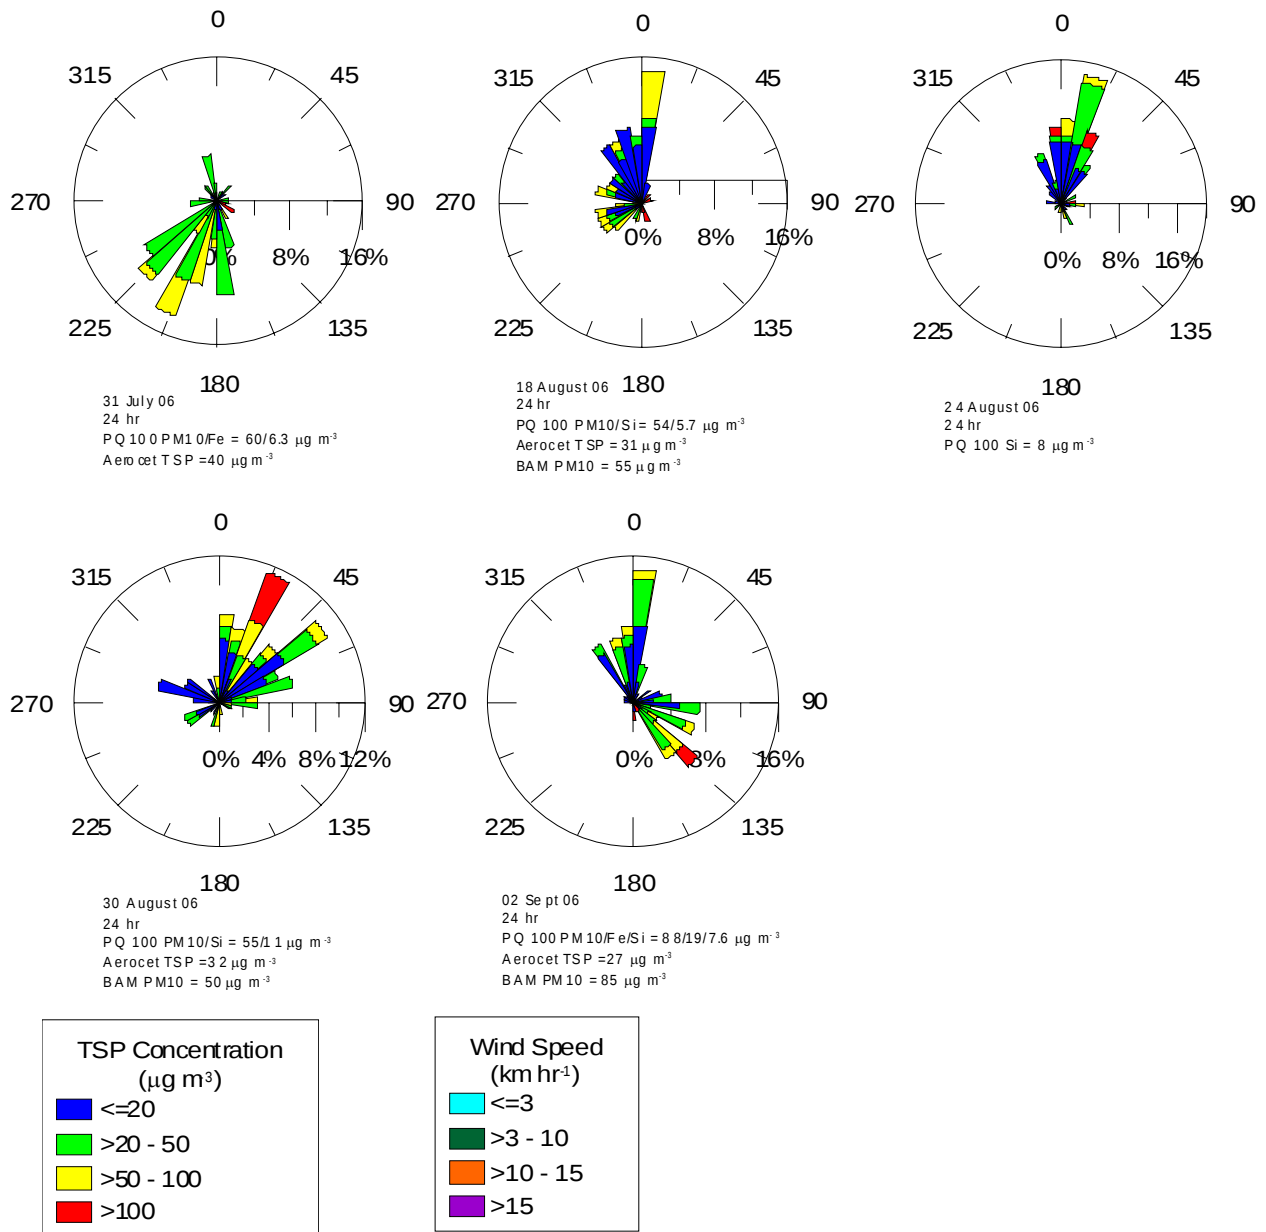
Particulate/Wind Roses for dates on which there were PQ 100 PM<sub>10</sub>, iron and/or Silica exceedances.

**71042 Bonney St.:** All roses are particulate roses, except 16 June, which is a wind rose.

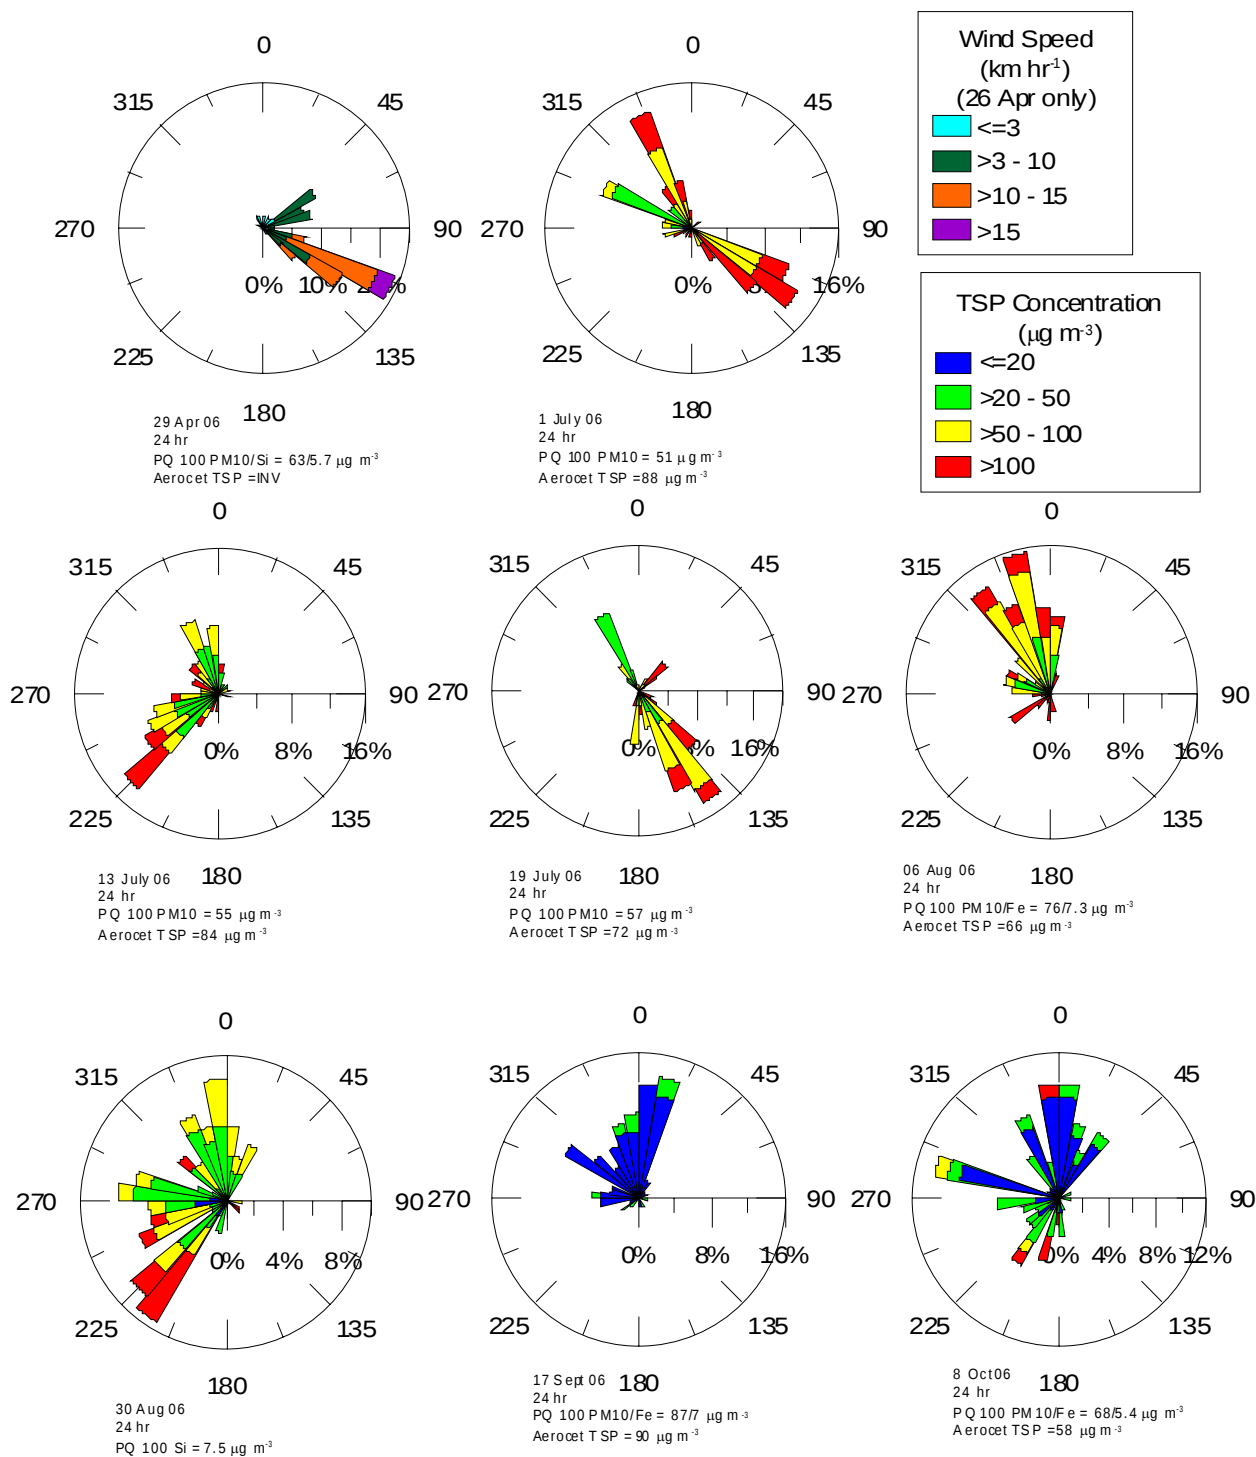
**71102 Peter Manzo Pool:** All roses are particulate roses, except 29 April, which is a wind rose. Continuous particulate/wind data is not available for 07 June, 16 June or 30 August.

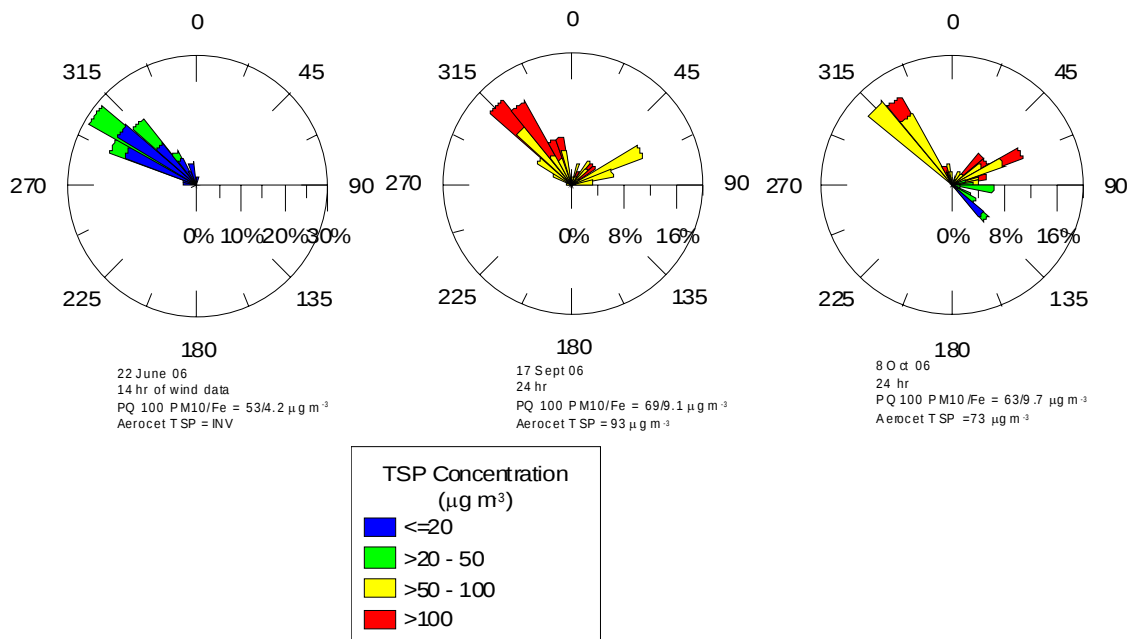
**71103 Mike Zuke Park.** Continuous particulate/wind data not available for 01 July.
