Grease Interceptor Treated with BioPro FOG and BioPro SRL Reduced Fats, Oils, and Grease Build Up

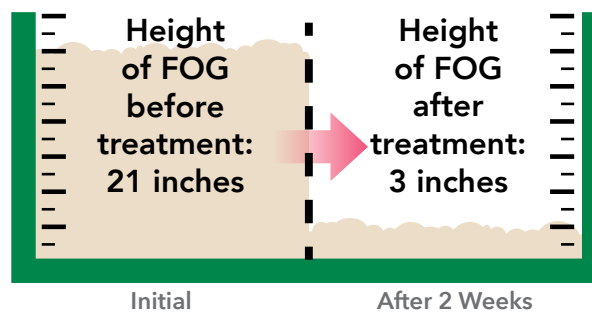
Fats, Oils, and Grease (FOG) Levels in Grease Interceptor Before / After Treatment

After two weeks of treatment, the FOG level dropped considerably. Prior to treatment, the plant had to frequently pump out the grease interceptor. After two weeks of treatment, the grease interceptor had **86% less FOG** than when treatment started despite continuous loading. These low levels were maintained for the rest of the month.
