LOGAN FAMILYSEARCH CENTER REMODEL
 165 EAST 2200 NORTH, LOGAN, UTAH

PERMIT SET
 DATE: 08.26.22
 PROJECT NUMBER: 2141
 PROPERTY NUMBER: 594-2217

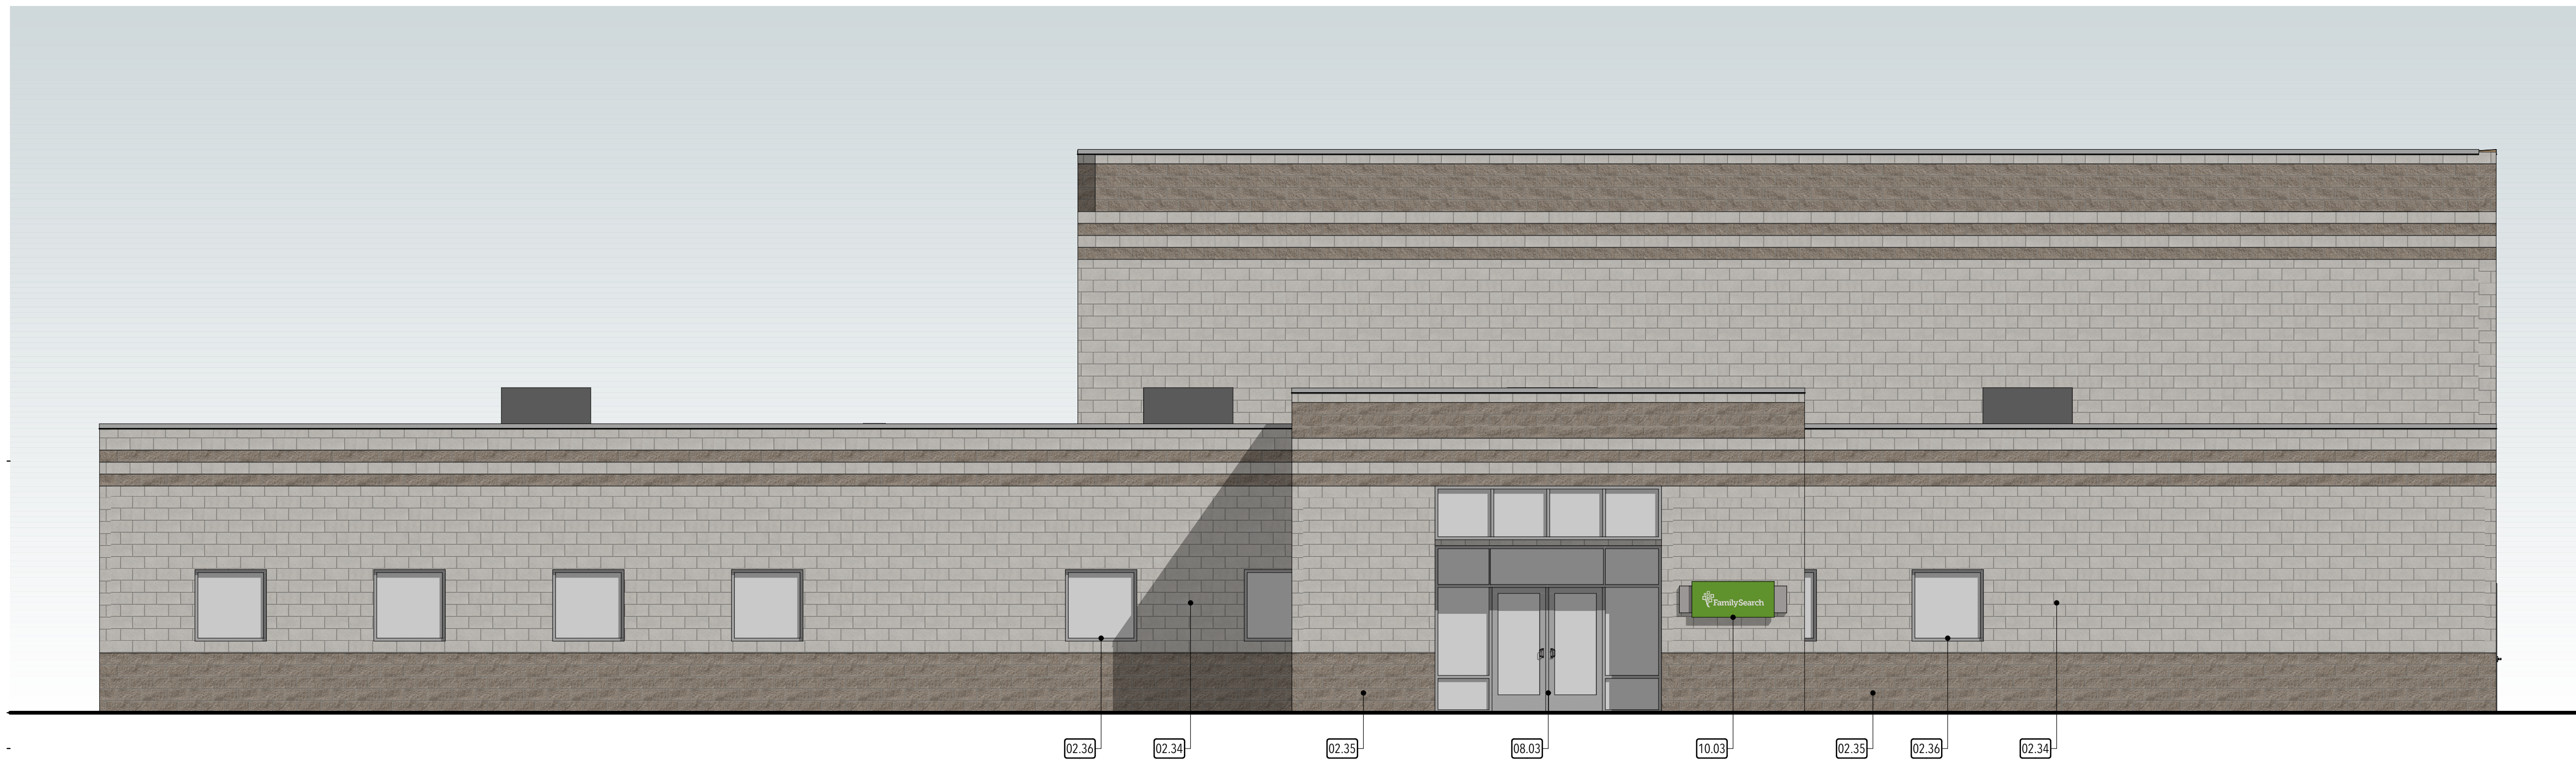
EAST ELEVATION

- 02.34 Existing painted cmu
- 02.35 Existing split face cmu
- 02.36 Existing storefront window
- 08.03 Scheduled aluminum storefront system
- 10.03 Building mounted signage provided by Owner and installed by Contractor

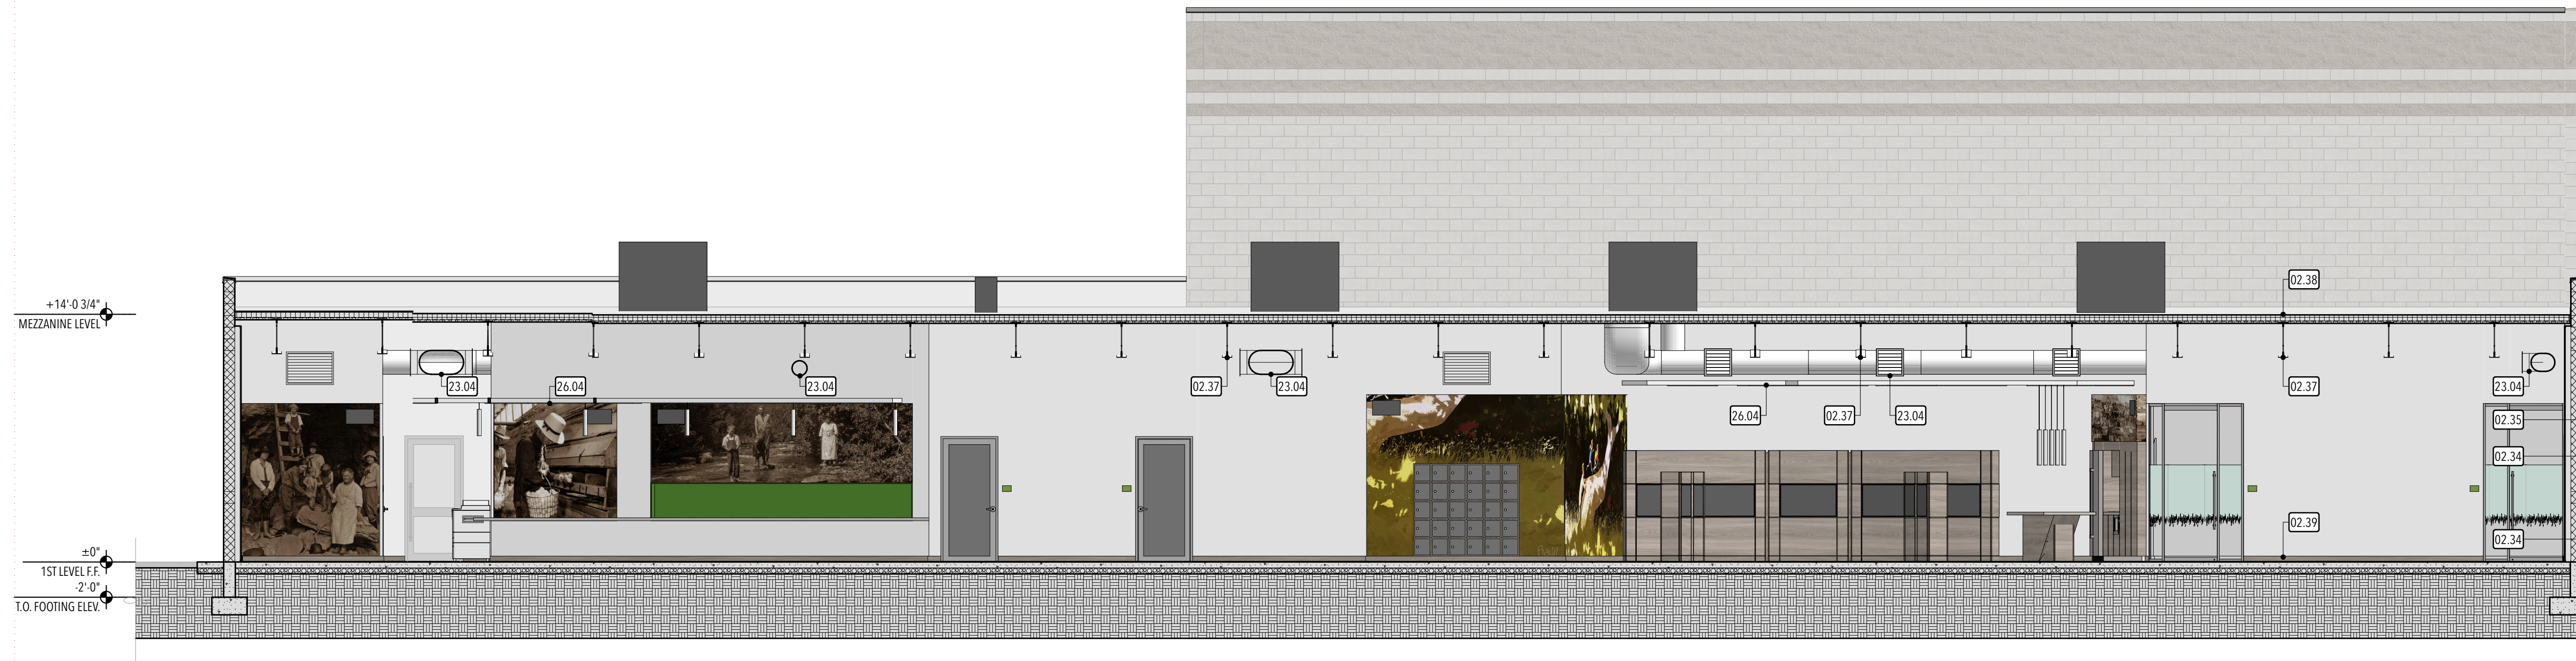
BUILDING SECTION 01

- 02.34 Existing painted cmu
- 02.35 Existing split face cmu
- 02.37 Existing steel open web roof joist - paint where exposed
- 02.38 Existing single ply roofing system over metal roof deck - paint all exposed metal roof deck
- 02.39 Existing concrete floor slab
- 23.04 Exposed mechanical duct - re: mechanical. Paint all exposed ductwork to match Architect's sample.
- 26.04 Axis StencilFlex framework and lighting system - re: electrical. Install height = 10'-0" to bottom of framework.
