# Geotechnical Evaluation Report

**Proposed Farr West Meetinghouse**  
**Southwest of 3650 West and Plain City Road**  
**Farr West, Utah (41.3111°, -112.0683°)**  
**LDS Property Number: 502-1933**

Prepared by  
**GSH Geotechnical**  
November 1, 2024

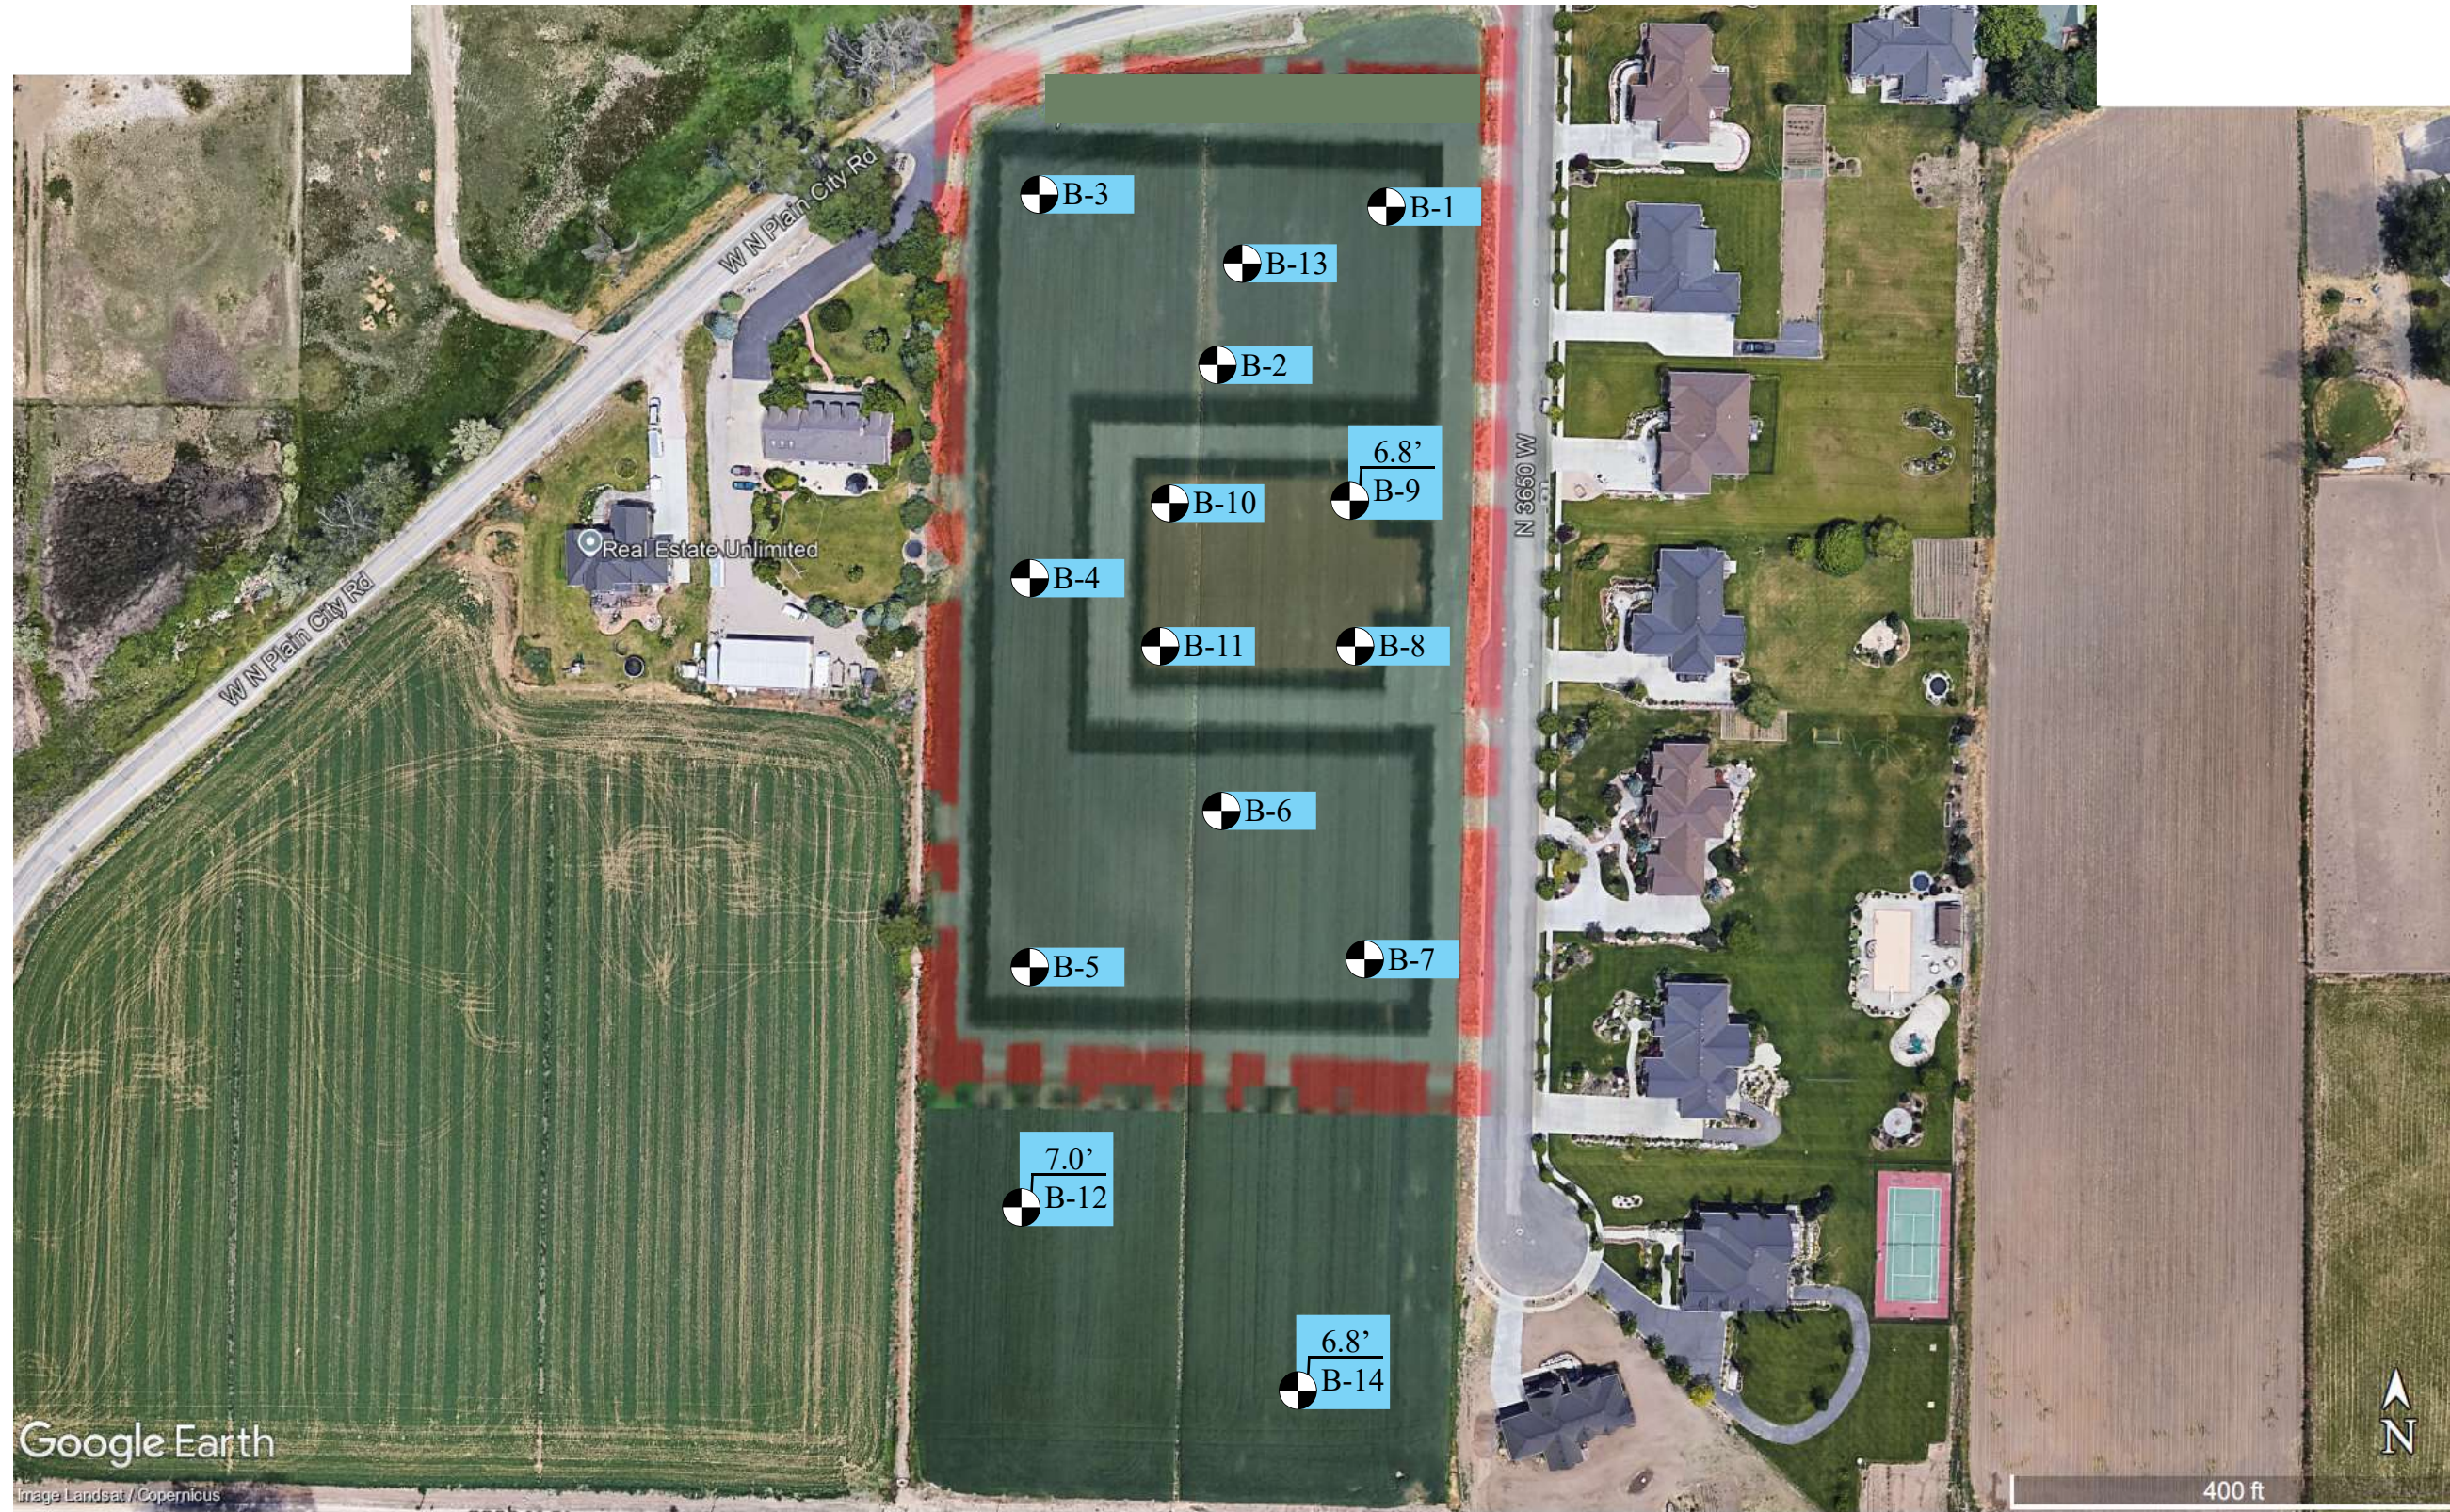
KEY:  
Measured Depth to Groundwater (feet)  
/ Boring Number (feet)

REFERENCE:  
ADAPTED FROM AERIAL PHOTOGRAPH  
DOWNLOADED FROM GOOGLE EARTH  
IMAGERY DATED 6/2023

In order to define and evaluate the subsurface soil and groundwater conditions across the site, 14 borings were extended to depths ranging from 5.5 to 31.5 feet below existing grades. These borings were completed using a truck-mounted drill rig equipped with hollow-stem augers. Heaving sand soils causing auger refusal terminated Boring B-10. The approximate locations of the borings are presented on Figure 2.
