Case Study:

FLORIDA APARTMENT COMPLEX LIFT STATION 96 I

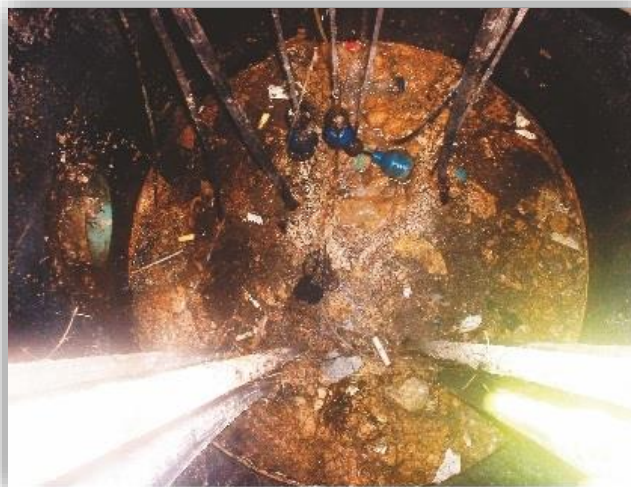
BEFORE

BACKGROUND DATA: 50 apartment units, one office, one laundry, and one car wash. The lift station was equipped with two 5 hp grinder pumps. The station is located in an area that was difficult for a Vac Truck to get to. Also one to two days after expensive pump-out, severe grease accumulated again.

Solve a sewer grease problem

Floats sticking, pump-outs are expensive and not working, odor complaints

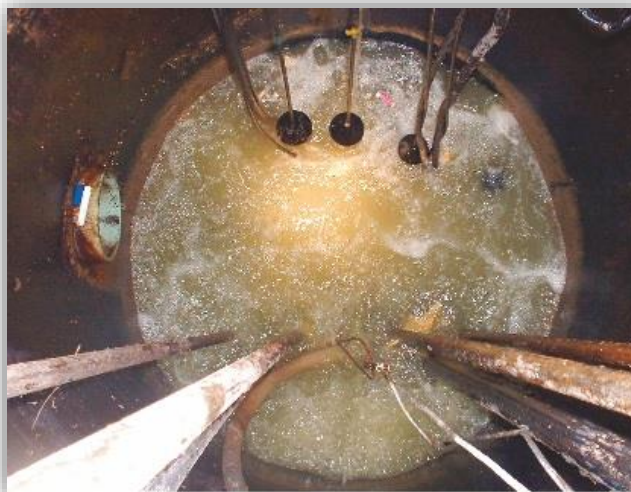
AFTER

100% satisfaction. No grease, BOD, or TSS moved downstream and 100% of the odors were eliminated. Pump-out contract was cancelled. **PX-700®** biostimulant outperformed and cost less than all other systems.

Enviro-Tech proposed injecting **PX-700®** biostimulant and installing **System 1000** grease reduction and odor control.
