Asbestos and Building Materials 2018

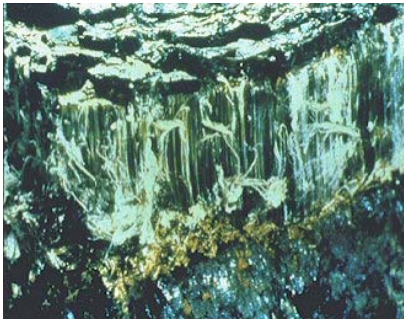
“Serpentine Rock” – showing white asbestos veins.

There are over 3,000 products that contain asbestos including construction related products. Homes and buildings built prior to 1980 should be presumed to contain asbestos unless otherwise tested. Asbestos is the name of a group of naturally occurring minerals that separate into strong, very fine fibers. Serpentine rock (California's State Rock) has Chrysotile veins which are an asbestos material. Asbestos minerals are added to increase the overall strength of the product as well as provide heat resistant capabilities.

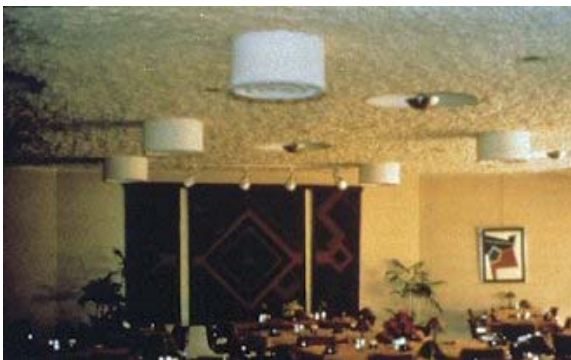
Acoustical Ceiling Material – Ceiling of a restaurant

Acoustical ceiling material	Ducting
9 x 9 Floor Tile	Thermal System Insulation
12 x 12 Floor Tile	Roof Felt
Linoleum	Roof patching
Vinyl Flooring	Roof Penetration Tar
Mastic	Roofing Layers
Base Coving	Window Putty
Blown on Fireproofing	Sheetrock/Joint Compound
Ceiling Tiles	Stucco
Theatre Curtains

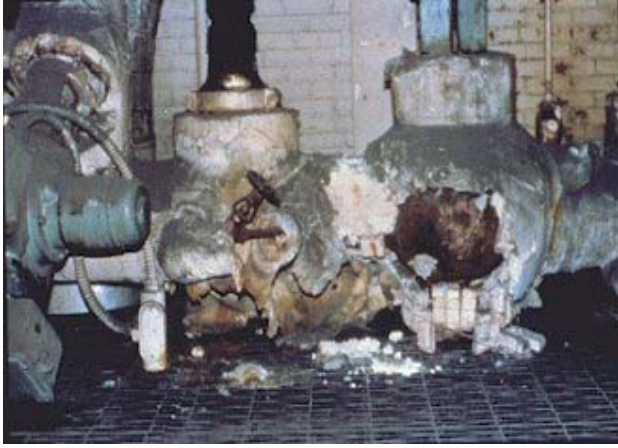
Valves insulated with asbestos

1. Friable ACM – Asbestos containing materials that can reduce to powder by hand pressure such as, thermal system insulation and acoustical ceiling material.
2. Category I non-friable ACM – Asbestos containing resilient floor covers or VAT, asphalt roofing product, packing and gaskets.
3. Category II non-friable ACM – Any material, excluding Category I materials, that when dry, cannot be crumbled, pulverized or reduced to powder by hand pressure.
