Plus 8 Refit By Dave Berridge

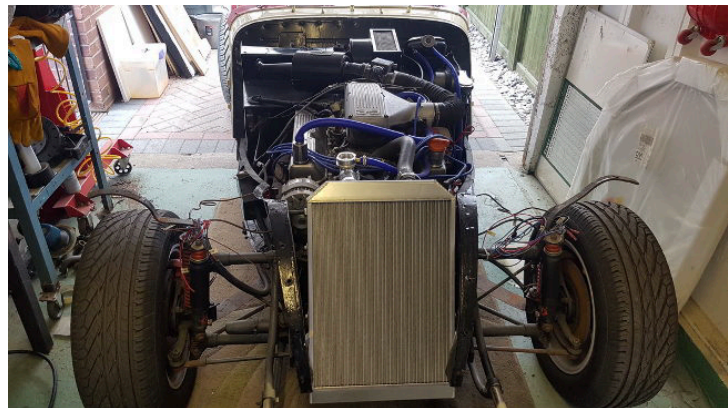
The engine was removed from the car. For those of you who don't know, the engine and gearbox have to come out together and there is very little room to work with. It takes a lot of wriggling to get it out. It was at this point I decided to remove the front wings to avoid damaging them and to give more room to work. The removal of the front wing is quite straight forward if you are lucky.

Along the running boards there are 5 x M5 captive screws and a couple of wood screws. If you are lucky, as I was, the captive screws hold and life is a lot easier. The next thing is to remove the cowl and the bolts along the wing edge These bolt through the inner wing and then it's just a case of lifting it off. With the engine out and gearbox separated the new 3-part clutch was fitted and there it stayed on the garage floor as I had to go into hospital and have a triple heart bypass. When I returned home after my operation, I could not do any lifting or virtually anything for the next three months so the car just had to wait.

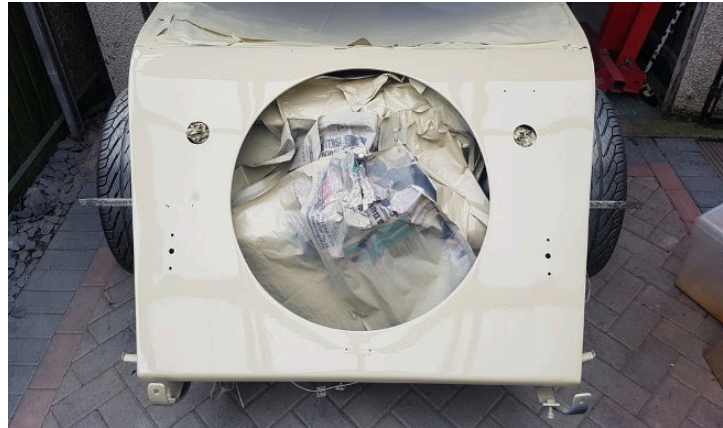
We are now left with the tub as the windscreen and hood fittings etc were all removed. Then the hard work began, the rubbing down. I used an air sander to do most of the work starting with 400 grit wet and dry going down to 1000 grit. Just a tip using air sanders you can use water whereas not with electric ones for obvious reasons. I was going to use two pack paint so a proper face mask was required as it is nasty stuff to breathe in. Two coats of primer, sanding between coats. If using two pack make sure you use two pack primer and not cellulose as the two types react with each other. Three coats of top coat were applied and left to harden.

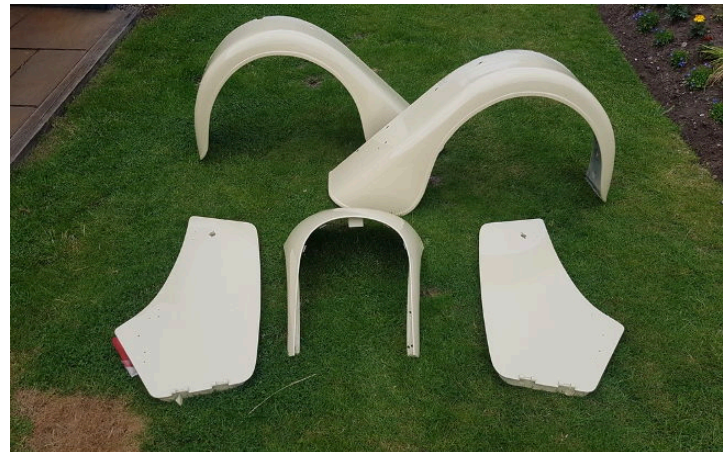
With the tub paint left to harden it was time to tackle the wings. Both front wings needed attention to the arches but the off side needed some welding doing and I have not tackled aluminium before so this was to be a challenge. I used aluminium solder rods as they were easy to use. They worked a treat and with a bit of filling out it looked the part. Now this is where my troubles started as the paint takes some time to dry, I had problems with dust landing on the paint and spoiling the finish. After a couple of attempts to paint without success I had the rest of the wings and panels professionally painted.

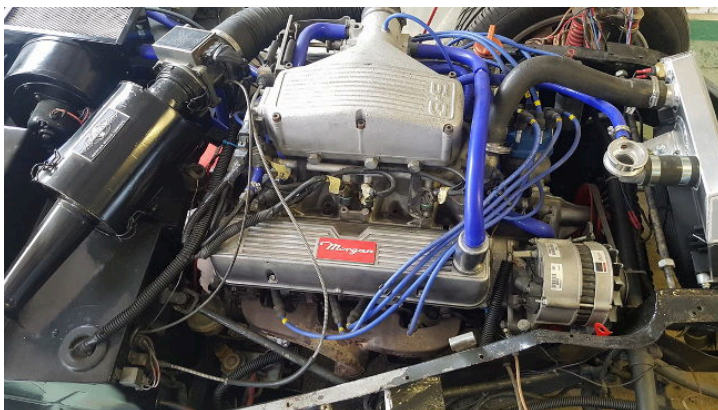
The engine and gearbox were the first thing to be refitted and this was going to cause me problems as I was still not supposed to lift anything but with the help of a good friend of mine the engine was back in place and a new aluminium radiator fitted with new silicone pipe work all round.

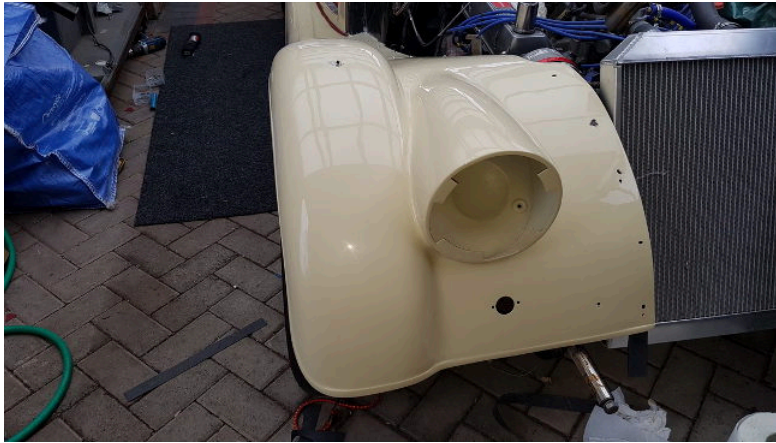
The jigsaw puzzle was all ready now for assembly which was a lot easier to do than the disassembly as all new stainless steel nuts and bolts and washers were used and this I would recommend. Assembling the wings is a two man job as you don't want to scratch the new paint work so Kevin Biddle stepped up

to assist with the wing and bonnet assembling.

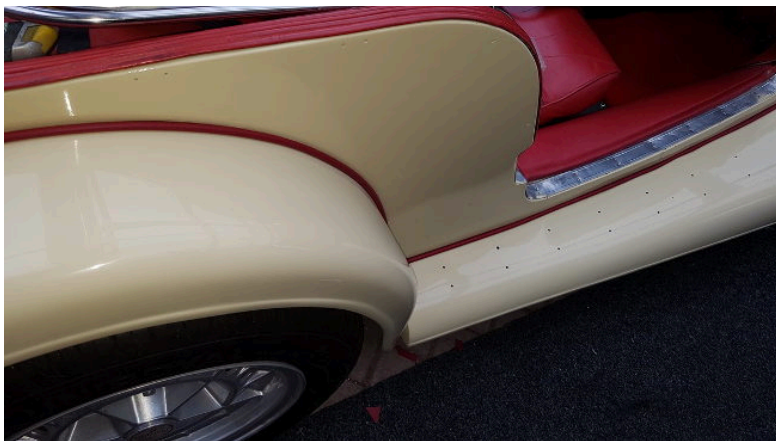
I used rubber gasket between the inner and outer wings with new wing beading that I had made for me to match the upholstery and I think it has made a good contrast with the cream paint work.
