Reserve Funding

Dave's View at Martin's Bluff

Dave's View Drive
Kalama, Washington
February 18, 2018

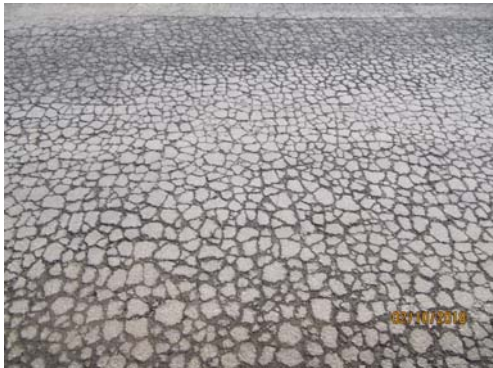
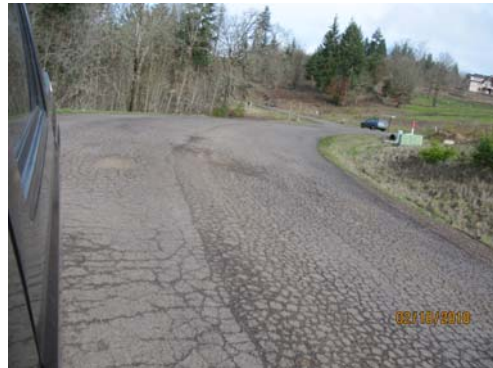
Asphalt: Overlay-One-Time-Repair-Phase 2

This component is an estimate for the replacement of approximately 18,535 square feet of the asphalt common area roadways in Phase 2 and repair (filling of cracks and potholes) of the remainder roadway in phase 2. The cost includes replacement and compaction of the aggregate subbase and placement of 2" to 3" of asphalt.

The Association understands the original development of the roadway was completed at County Road specification instead of Residential. During the build-out of each lot, the roadways endured excessive weight due to the transportation of various heavy equipment, causing significant deterioration to the roadway from minor to major levels.

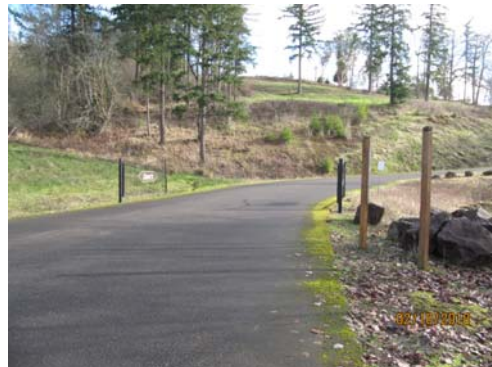
Asphalt: Overlay-Repair-Phase 1

This component is an estimate of the Association's share for the repair (filling of cracks, potholes and sealcoat) of the asphalt overlay on the common area roadways in Martin's Bluff Homeowners Association (phase 1). The repair work should be completed prior to sealcoat being applied. This work is coordinated by the Martin's Bluff Homeowners Association.

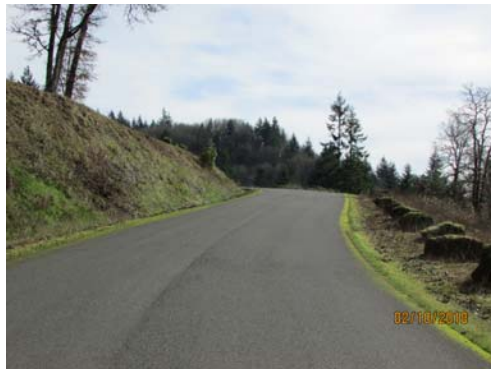
Asphalt: Overlay-Repair-Phase 2

This component is an estimate for the repair (filling of cracks and potholes) of the asphalt overlay on the common area streets in phase 2. The repair work should be completed prior to sealcoat being applied.

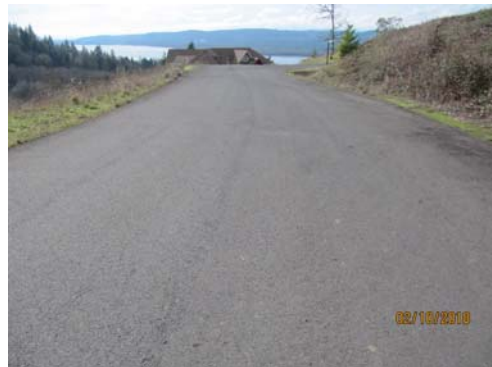
Asphalt: Overlay-Repair-Phase 3		117,334 SF	@ \$2.15
Asset ID	1013	Asset Cost	\$12,613.40
Group	Capital	Percent Replacement	5%
Category	Asphalt	Future Cost	\$12,613.40
Placed in Service	January 2009		
Useful Life	5		
Adjustment	4		
Replacement Year	2018		
Remaining Life	0

This component is an estimate for the repair (filling of cracks and potholes) of the asphalt overlay on the common area streets in phase 3. The repair work should be completed prior to sealcoat being applied.

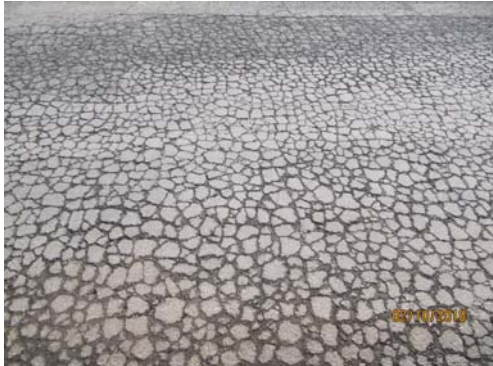
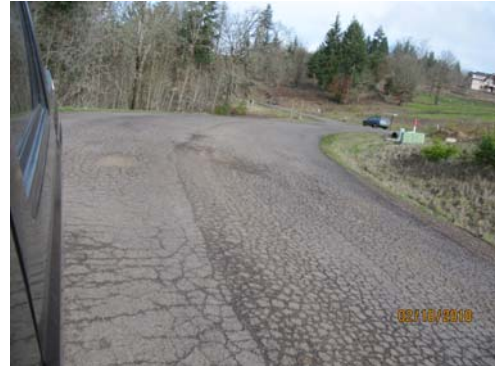
Asphalt: Overlay-Replace-Phase 2

This component is an estimate for the replacement of the existing asphalt common area roadways in Phase 2.

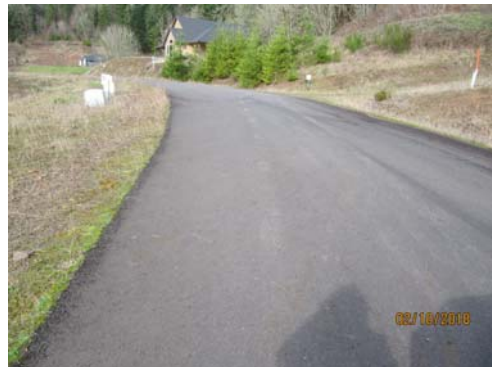
Asphalt: Overlay-Replace-Phase 3		117,334 SF	@ \$4.50
Asset ID	1002	Asset Cost	\$528,003.00
Group	Capital	Percent Replacement	100%
Category	Asphalt	Future Cost	\$732,835.04
Placed in Service	January 2009		
Useful Life	25		
Replacement Year	2034		
Remaining Life	16

This component is an estimate for the replacement of the overlay on the existing asphalt common area roadways in Phase 3.

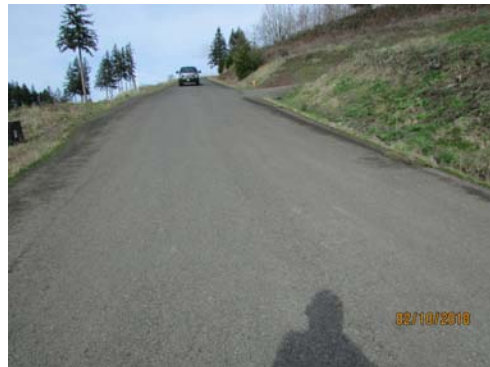
Asphalt: Overlay-Sealcoat		215,648 SF	@ \$0.45
Asset ID	1004	Asset Cost	\$97,041.60
Group	Capital	Percent Replacement	100%
Category	Asphalt	Future Cost	\$97,041.60
Placed in Service	January 2018		
Useful Life	5		
Replacement Year	2018		
Remaining Life	0

This component is an estimate for the application of sealcoat to the asphalt of all the common area roadways in phases 2 and 3. The sealcoat should be applied after the repair work is completed.

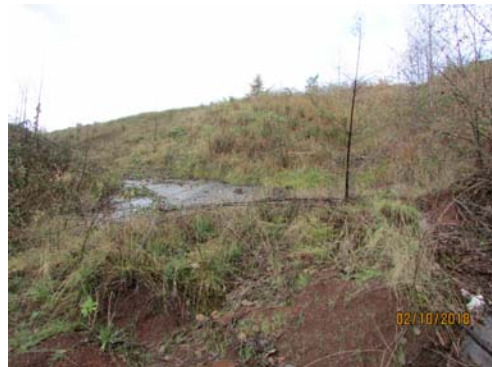
Contingency		1 Total	@ \$10,000.00
Asset ID	1006	Asset Cost	\$10,000.00
Group	Capital	Percent Replacement	100%
Category	Contingency	Future Cost	\$10,000.00
Placed in Service	January 2018		
Useful Life	3		
Replacement Year	2018		
Remaining Life	0

This component is a one-time cost as a contingency for the Association to secure the services of a engineer to develop a report on how to deal with the removal of debris from the landslide that began in 2009 at the Windy River Road cul-de-sac and continued downhill to Dave's View Drive covering the roadway. The report should also contain engineering specification on how to secure the hillside to prevent the landslide from occurring again and the costs to perform the recommended work.

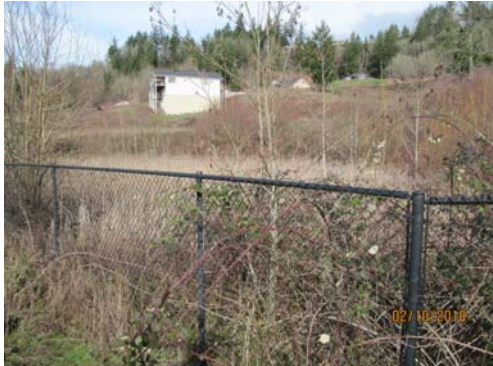
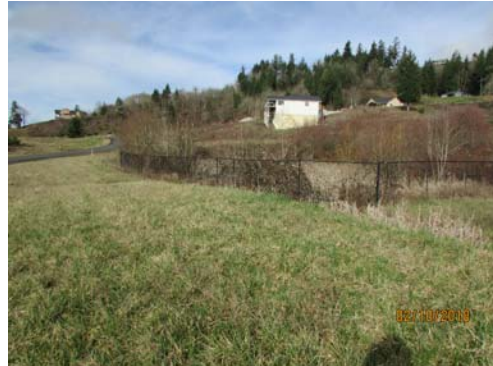
Fence: Chain Link-Repair/Replace

This component is an estimated cost for the maintenance, repair, or replacement of the black chain link fence surrounding the storm water pond. This component exceeds the 30 year term of the Reserve Study, therefore it is identified as unfunded until the year 2019.

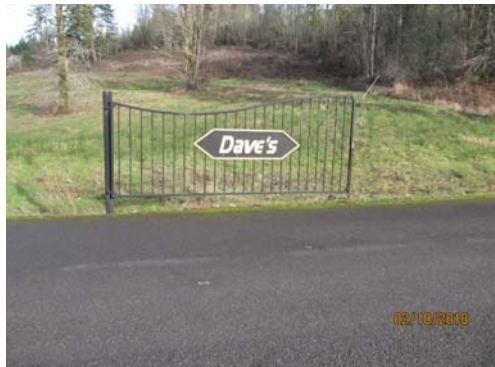
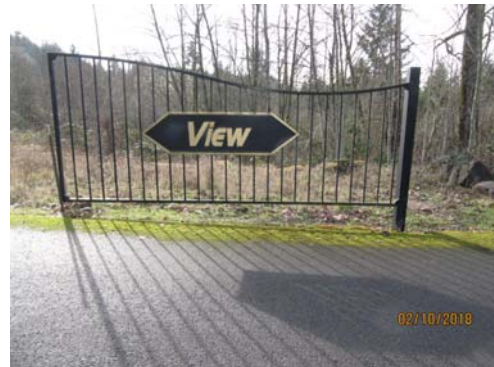
Gate: Wrought Iron-Repair/Replace

This component is an estimated cost for the maintenance, repair, or replacement of the wrought iron decorative entry gates with sign identifying the Association.

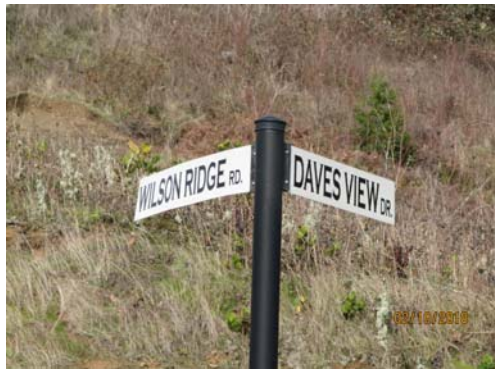
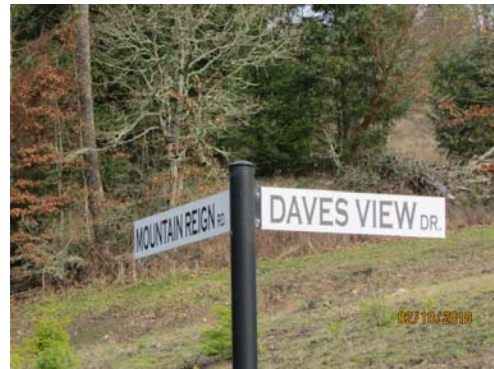
Signs: Roadway Identification-Repair/Replace

This component is an estimated cost for the maintenance, repair, or replacement of the roadway identification signs.

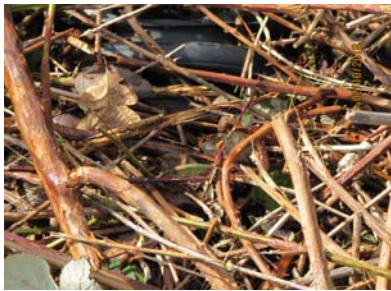
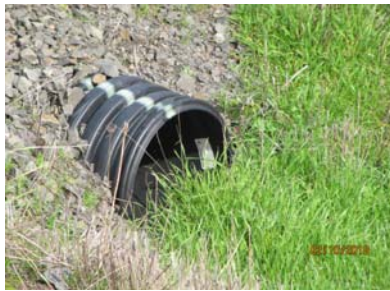
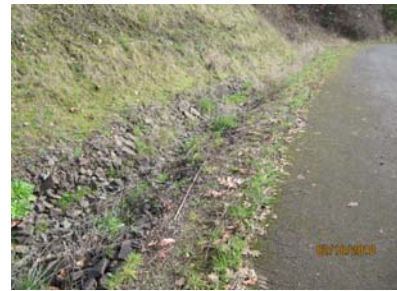
Storm Water Drainage: Maintenance

This component is an allowance for the maintenance of the storm water drainage, gutters and culverts. According to the Plat Maps, there are storm drain easements on lots 39, 40, and 65, the Association is responsible for maintaining.

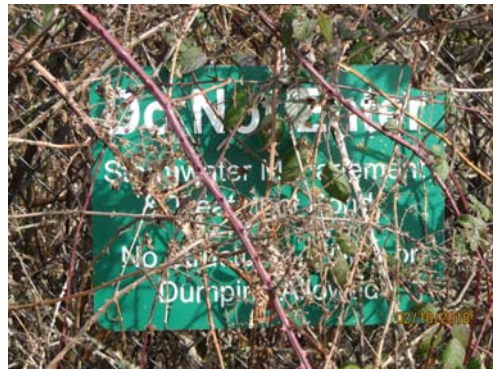
Storm Water Pond: Maintenance

This component is an allowance for the maintenance and/or replacement of vegetation located in the storm water pond area. This area sits near the roadway at lots 75 and 79.
