SAFETY ALERT

Safety Alert: Excavation Hazard *Immediately Dangerous to Life and Health (IDLH)*

Date of Incident: August 7, 2024

Location: Texas Project

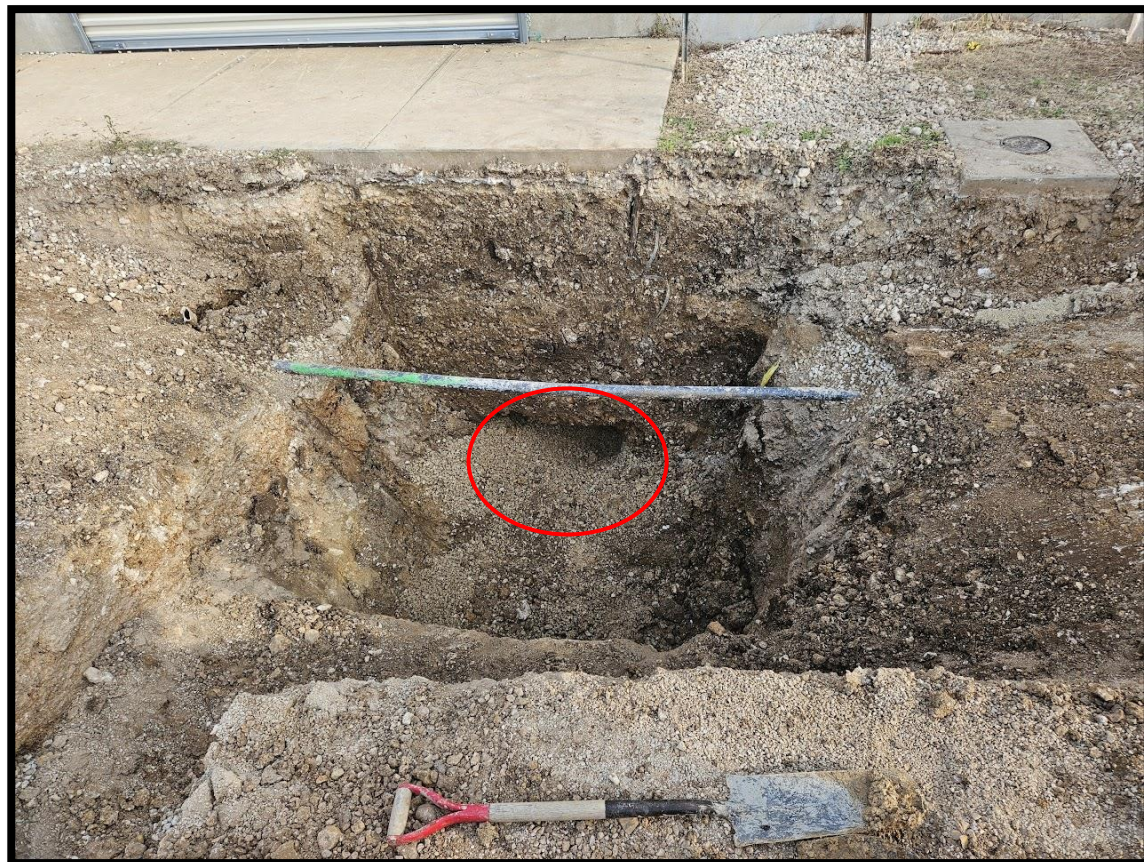
During a routine site visit on August 7, 2024, a safety team member identified a serious safety violation at a Texas project. Two workers were found inside an excavation, actively undercutting a Class-C vertical soil wall measuring approximately 7 feet tall while searching for an underground aeration line. Alarming, the workers were positioned directly beneath the undercut portion of the soil wall, further exacerbating the danger. The situation was immediately recognized as highly dangerous.

- **Excavation Conditions:**
 - The soil was classified as **Class-C**—the least stable type of soil.
 - The trench had a **7-foot vertical wall** with no protective systems in place.
 - The trench was **undercut** by the workers, further destabilizing the excavation.
- **Worker Actions:**
 - The workers were attempting to locate an aeration line by undercutting the trench wall, significantly increasing the risk of a cave-in.

- **Failure to Implement Protective Systems:**
 - The excavation lacked proper sloping, shoring, or shielding, which are critical in preventing trench collapses.
- **Inadequate Supervision:**
 - No competent person was on-site to ensure that the excavation was carried out safely.

A safety standdown was conducted on-site to address the violation. All personnel involved were informed about the critical risks and the necessity of adhering to proper excavation protocols.

- **Training and Reinforcement:**
 - All teams will undergo additional training on excavation safety, focusing on the importance of protective systems, the role of a competent person, and the JHA process.
- **Strict Enforcement of Protocols:**
 - Going forward, excavation activities will not commence without the proper completion of an excavation permit and the presence of a competent person.
