Conigliaro Blocks In Action Along the Charles River

A complex site on the Charles River in Waltham, MA. The project involved permitting with several city and state regulators and included installing a new retaining wall, drainage structures and a guard rail.

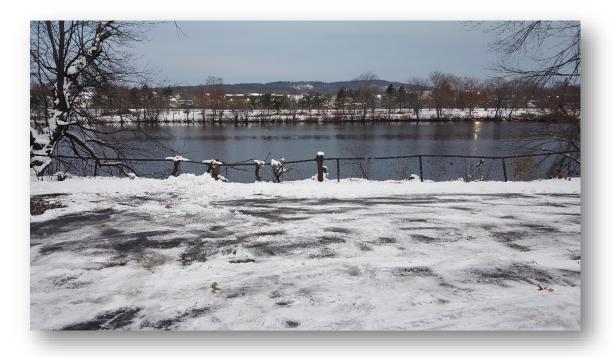
Before – a failing retaining wall and sinking parking lot just feet away from the Charles River

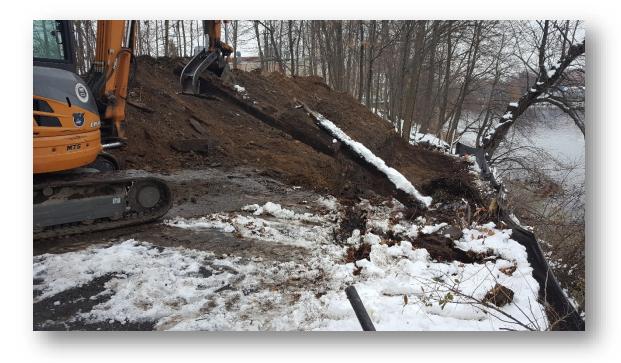
Demolition of failing creosote timber wall within two feet of the river

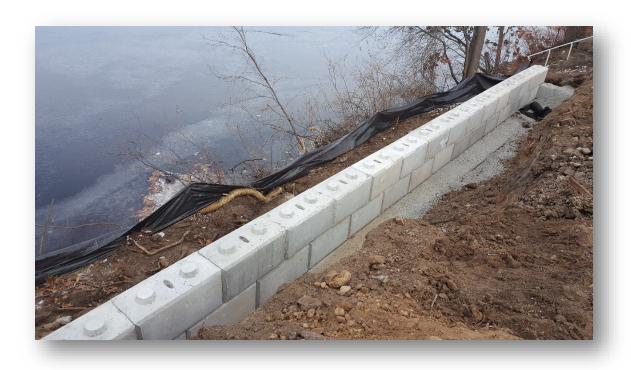
Installation of new retaining wall base blocks using Conigliaro Blocks

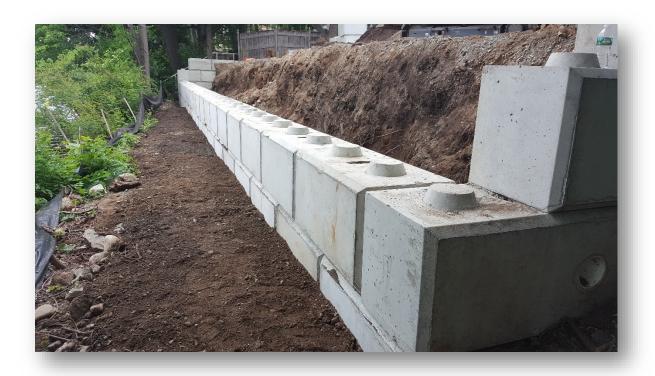
Backfilling of first block

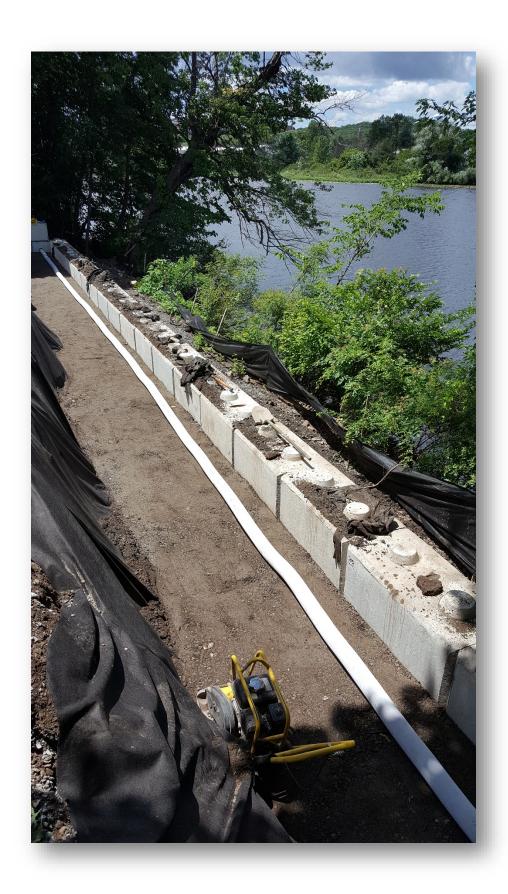
Installation of Behind Wall Drain Pipe

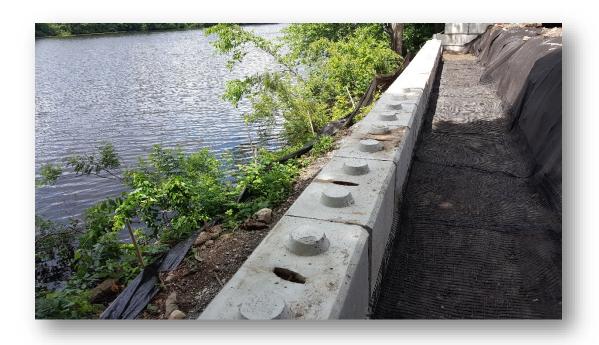
Installation of Reinforcing GeoGrid

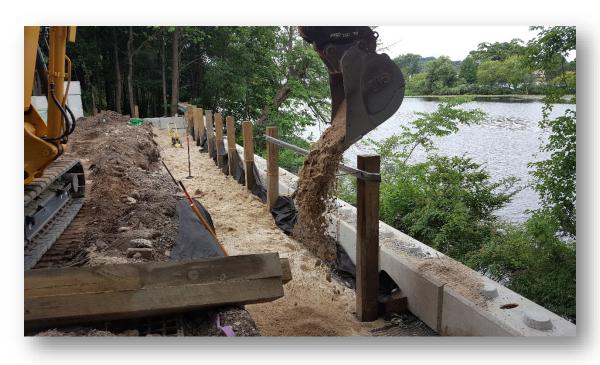
Installation of Guard Rail System

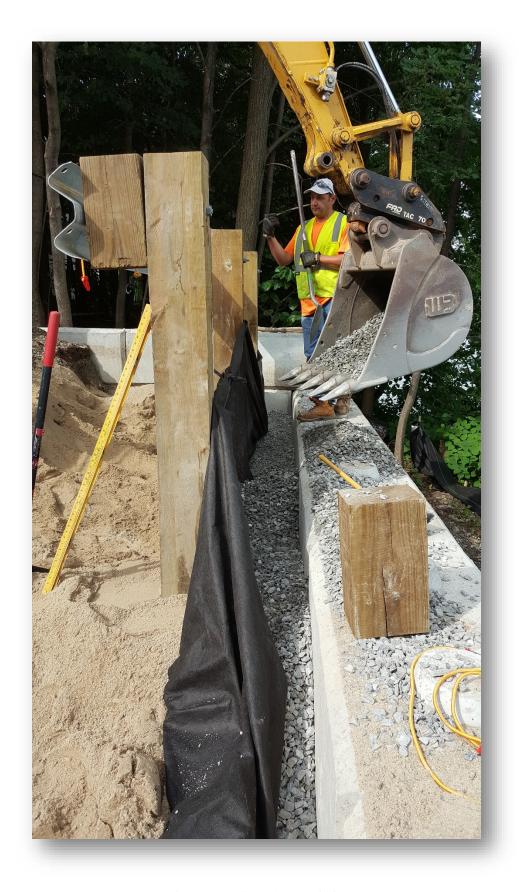
Creation of Drainage Column

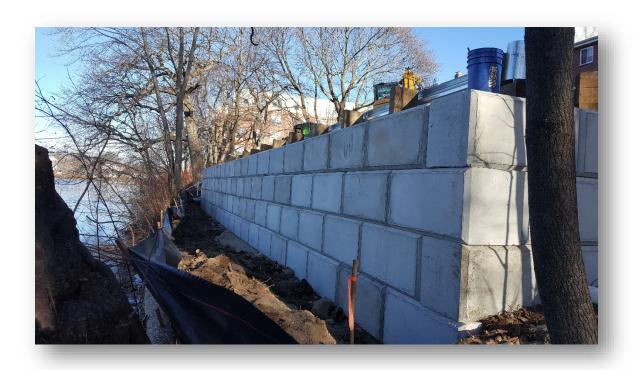
Completed Retaining Wall

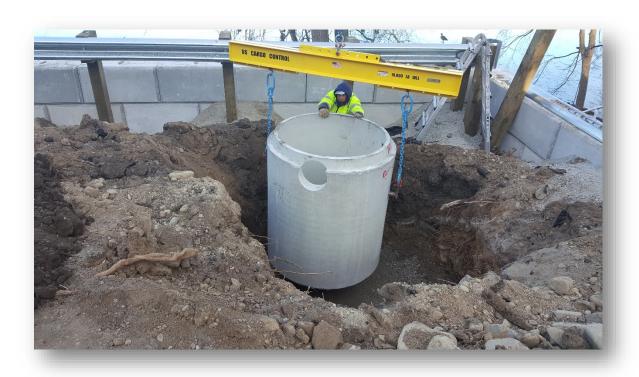
Installation of precast catch basin manholes

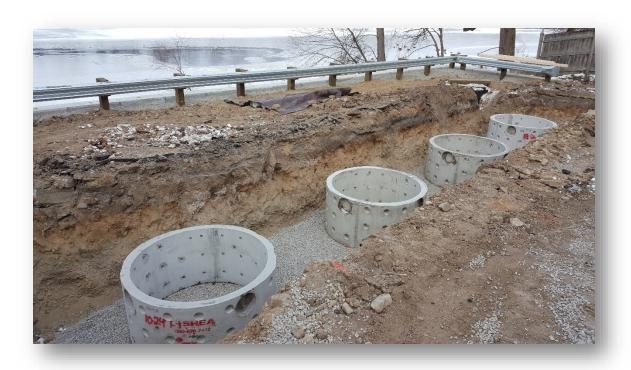
Installation of precast leach pits

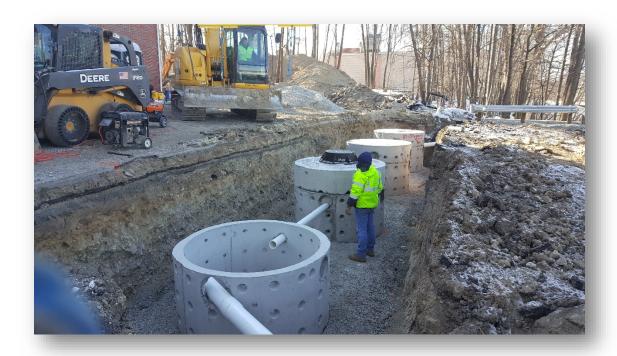
Installation of below grade connecting piping

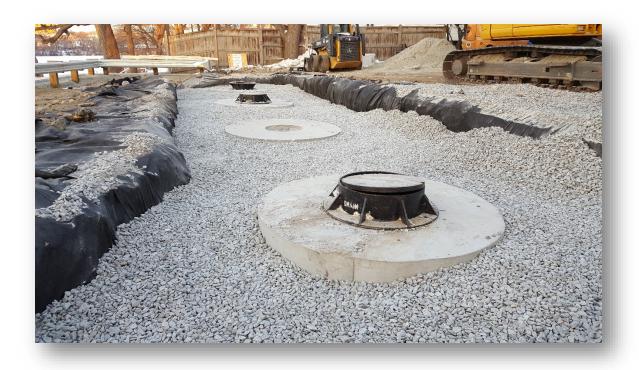
Backfill of leach pit and installation of manhole covers

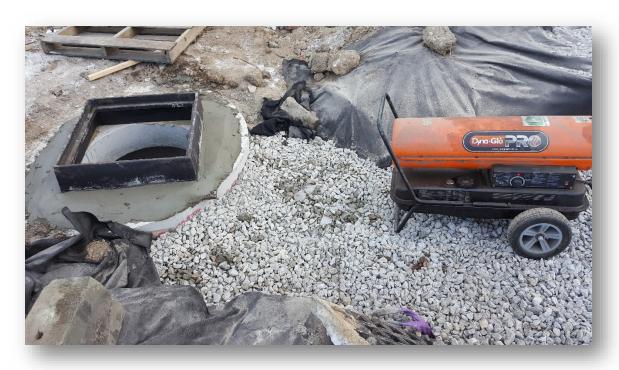
Mortaring of catch basin covers

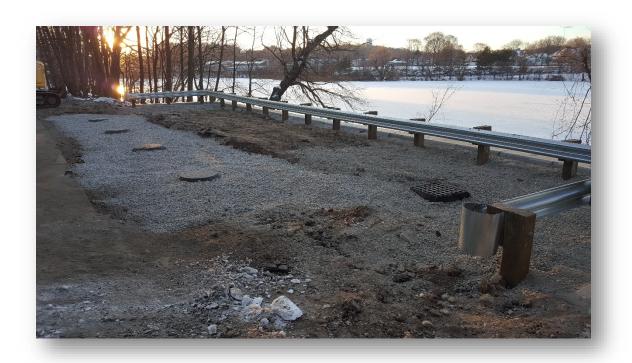
Completed site awaiting final grading and pavement
