: 220501ST220118(6)A

# REPORT ON DETERMINATION OF MECHANICAL FASTENER - NAIL

Client : Fountain WPC Company Limited
Project : Testing of Recycled Timber

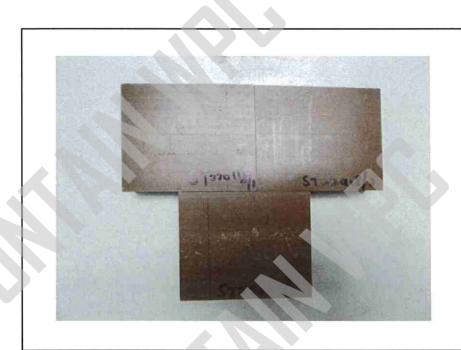
Test Sample Sample I.D.: ST220118/A1-A3

- 1.) The test results relate only to the samples tested.
- 2.) The results apply to the sample as received.
- 3.) The test samples are shown in the photograph on page 2 of this report.
- 4.) This report is to supersede our previous test report no. 220501ST220118(6).
