Lotus Elan Sprint

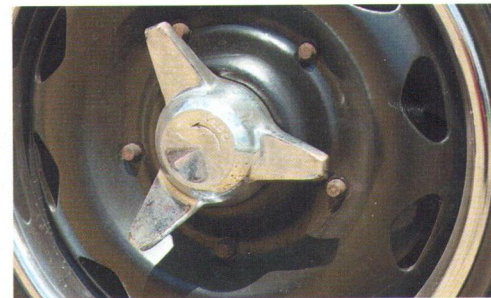
Lotus steel wheels fitted with knock-off spinners.

Wheels/tyres: 13x4.5in Lotus steel wheels finished in black with knock-off spinners throughout.
