# COMMUNITY MONITOR COMMITTEE

## Altamont Landfill Settlement Agreement

### AGENDA

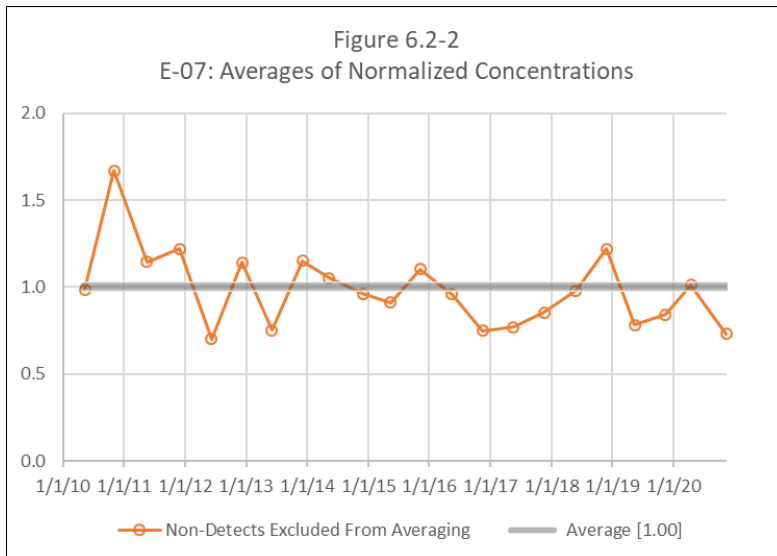
At well E-07, in the same location but sampling at a greater depth, the November 2020 sample was slightly below average and showed a decrease with respect to the previous sampling event. No clear trend is observed for this well, and we will continue to monitor the normalized concentrations over time.

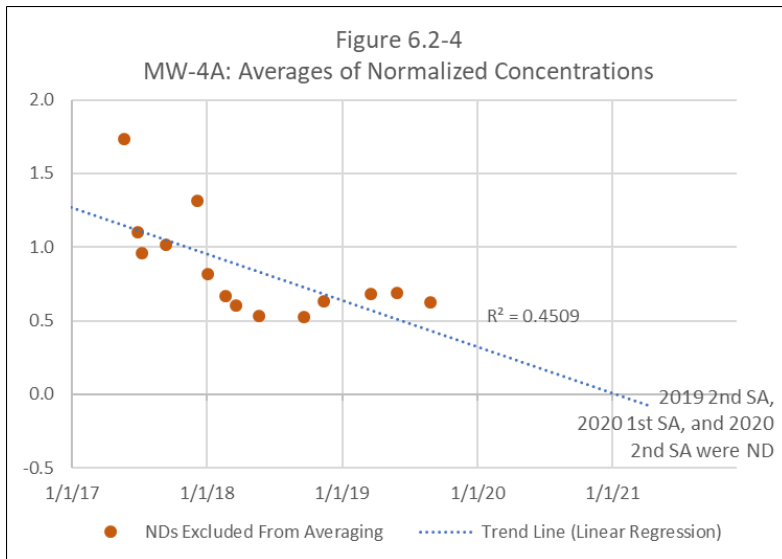
At well MW-4A, at the northeast corner of Fill Area 1, the three 2020 samples had no detections and therefore it appears that the downward trend continues.
