BECOSAN[®]

CONCRETE FLOORS - MADE BETTER

BECOSAN® is more than just a brand. It is a treatment, where we can guarantee an enhancement to and a better performing industrial concrete floor. In this folder we will explain in detail what BECOSAN® consists of, showing some references and case studies. Our team of specialists are ready to give advice and support on how to integrate BECOSAN® into future projects.

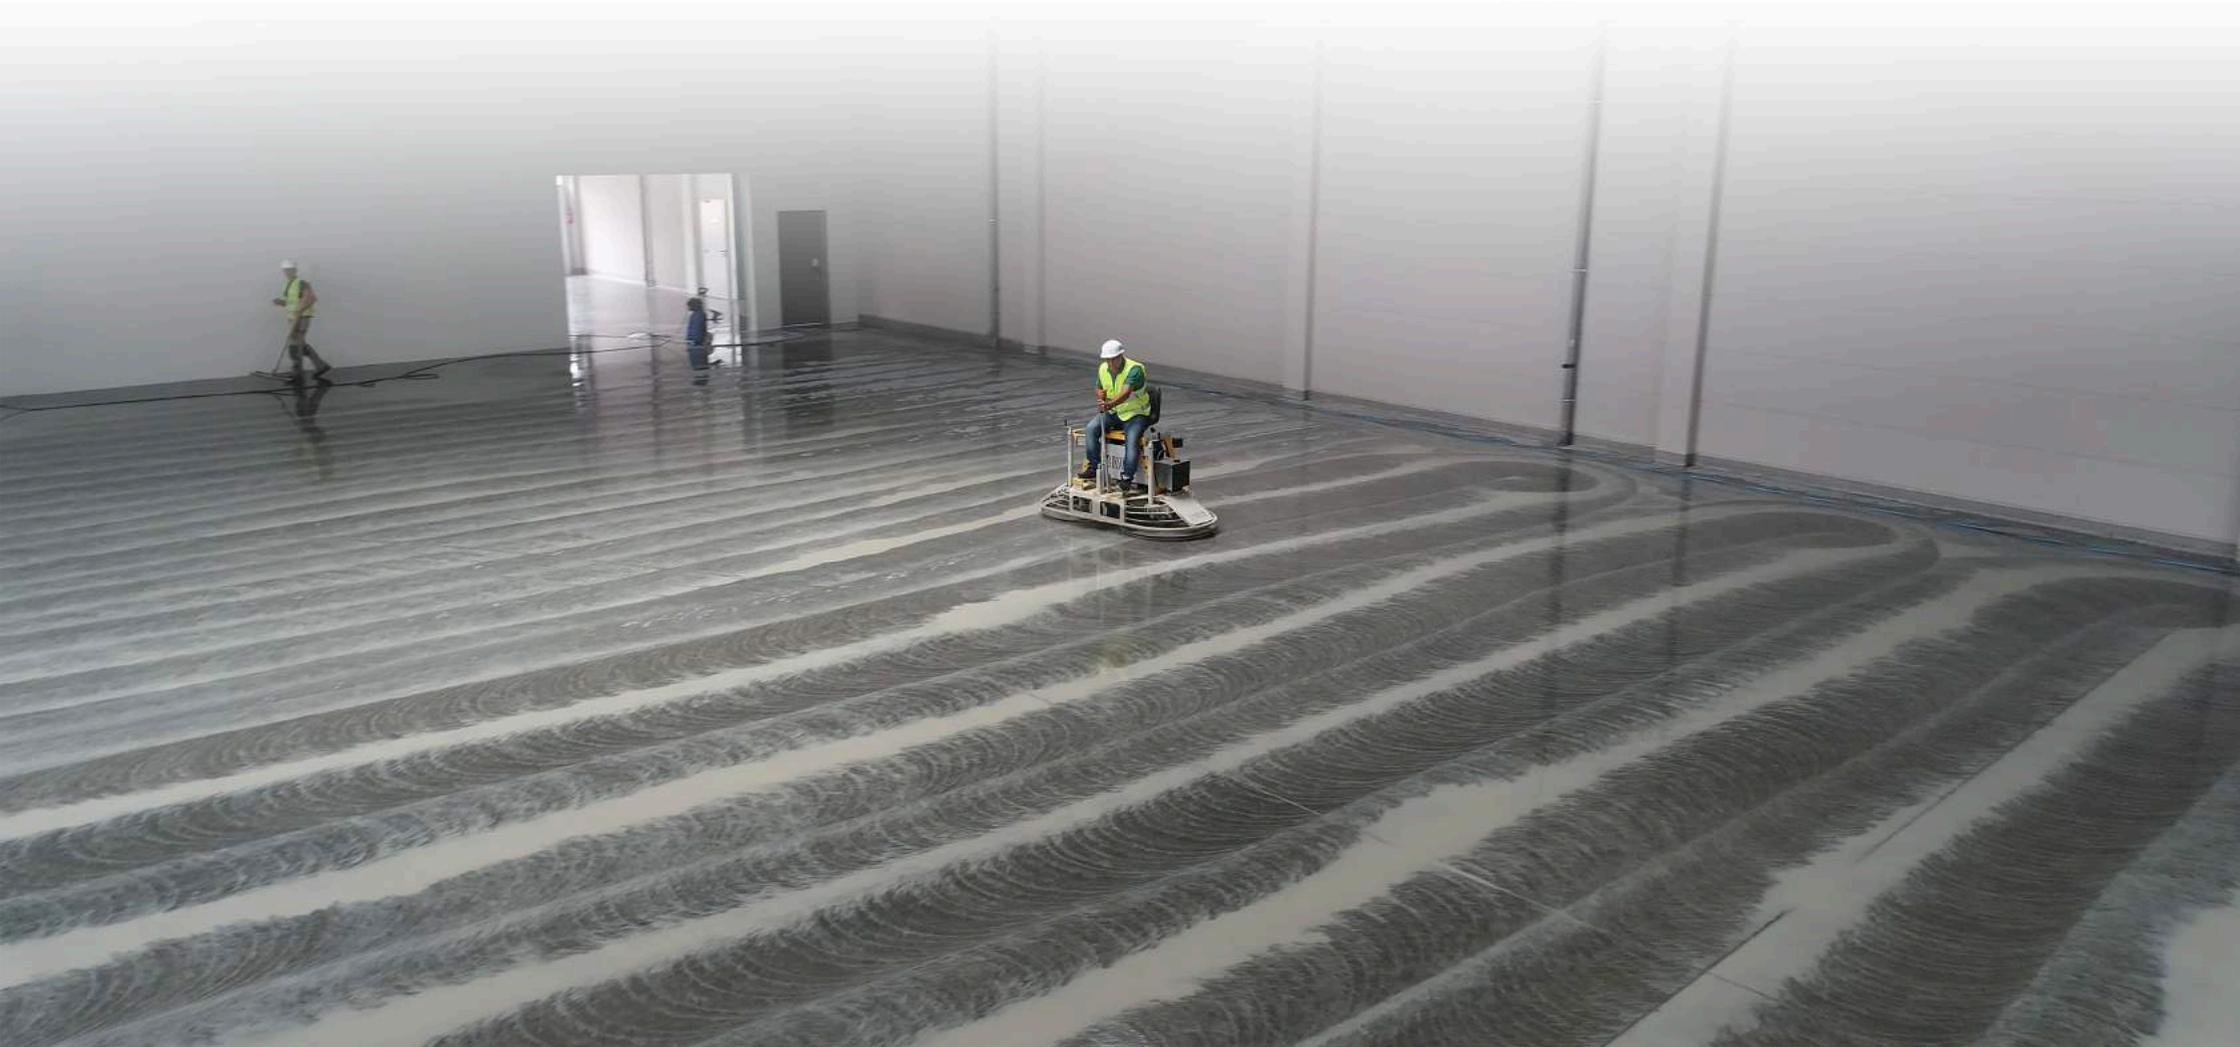
First step:

Removing Micro-roughness By Grinding

The 3 step grinding process removes the top layer of the concrete. The floor will become more dense providing a smooth surface where the dust particles will not settle. The BECOSAN® system has its advantages compared to other traditional grinding systems, as it is fast, efficient & very cost-effective.

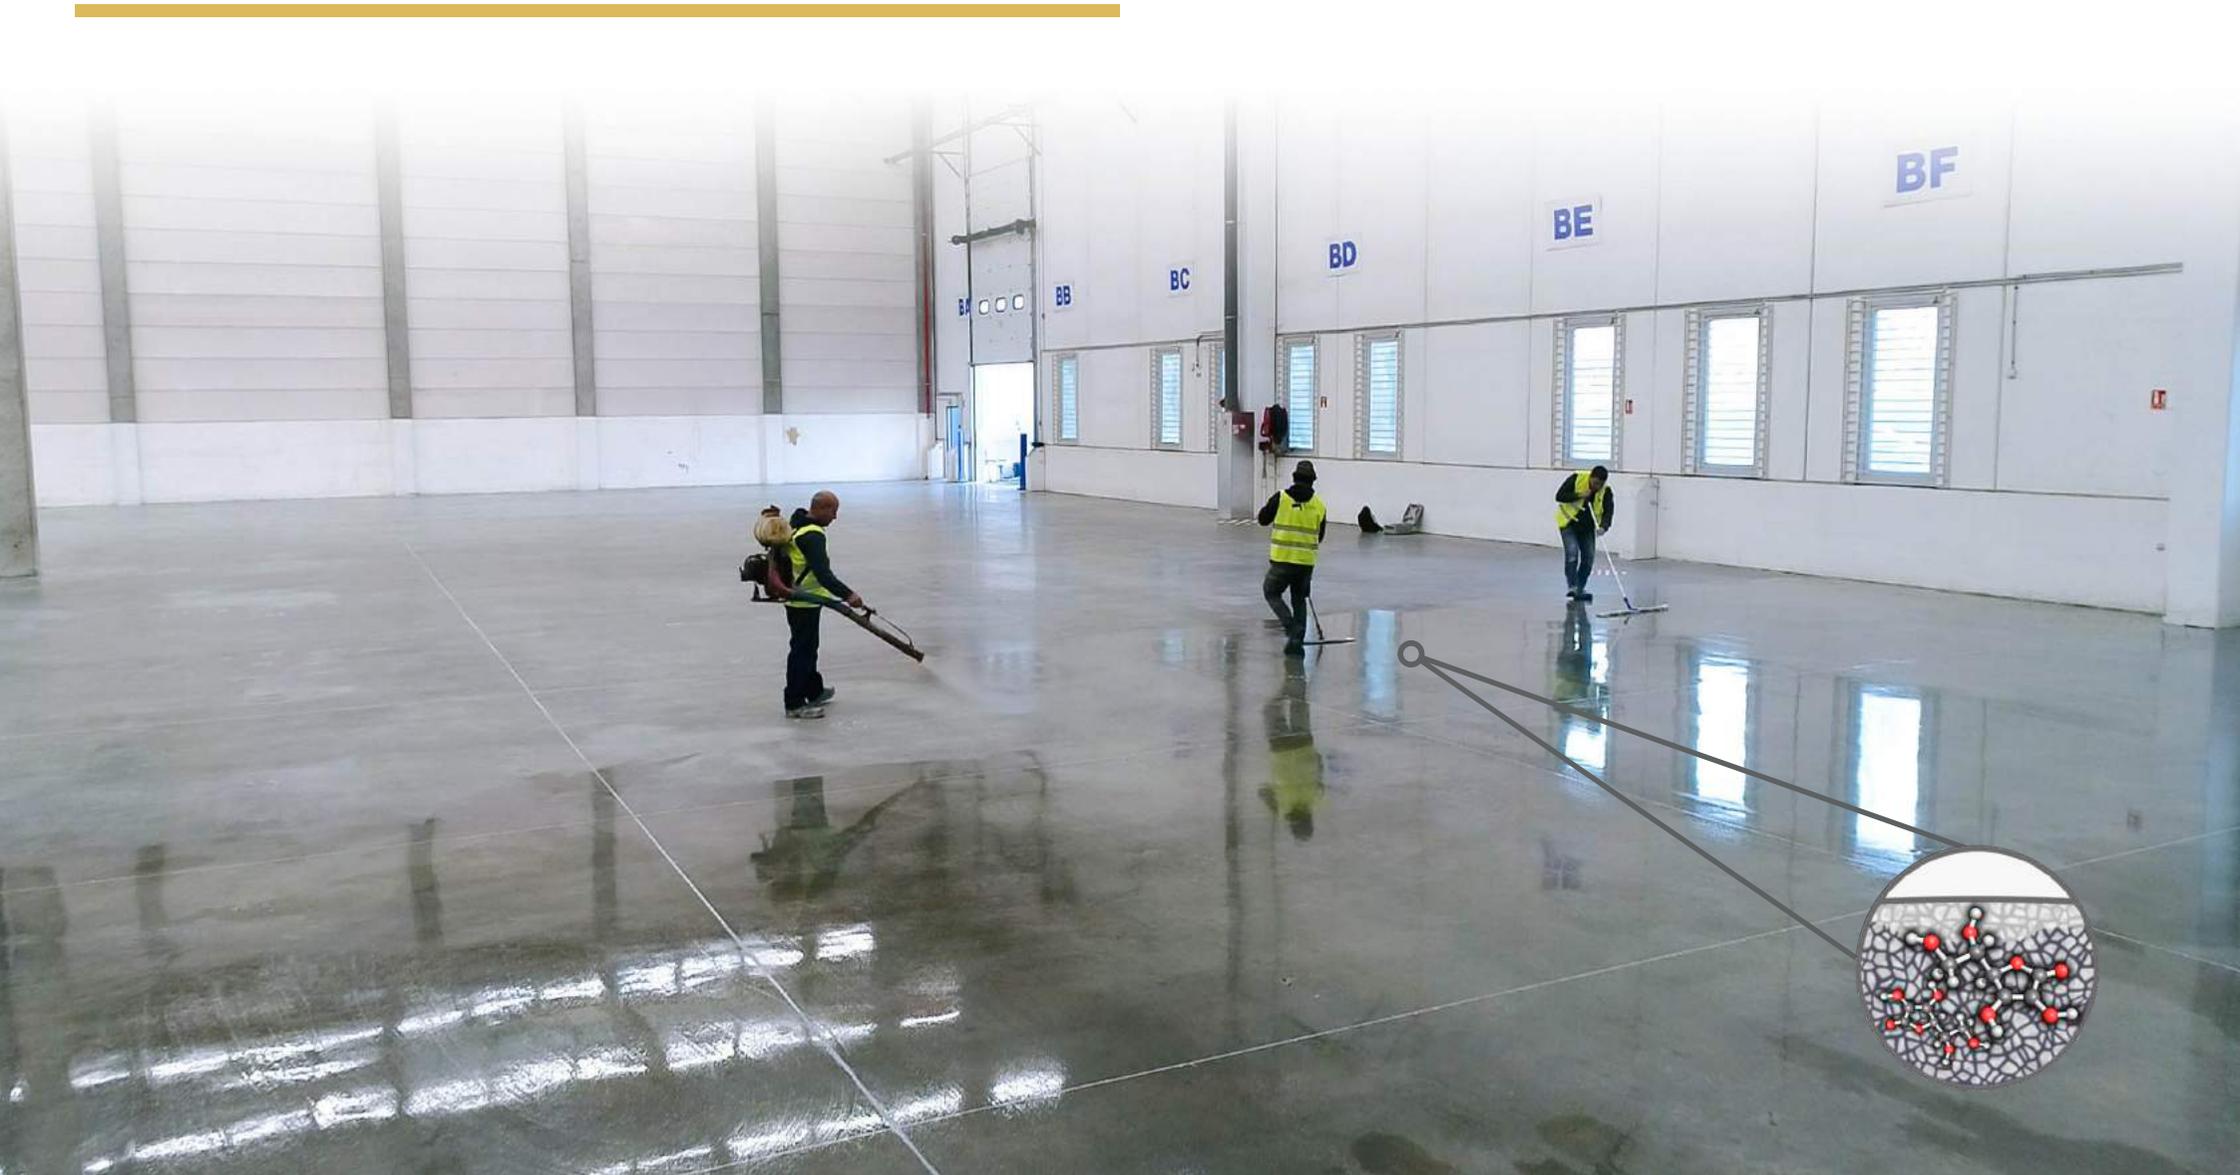
Second step: **Densification**

With BECOSAN® Densifier

A special lithium concrete impregnator is used to bind the free lime particles in the concrete. It will also create a more compact and dense surface. The lithium impregnator is water based solution which is designed to penetrate deep into the concrete pores of the surface. It is very different from other similar products as it is not a film forming coating, meaning that its performance on industrial concrete floors is much more durable.

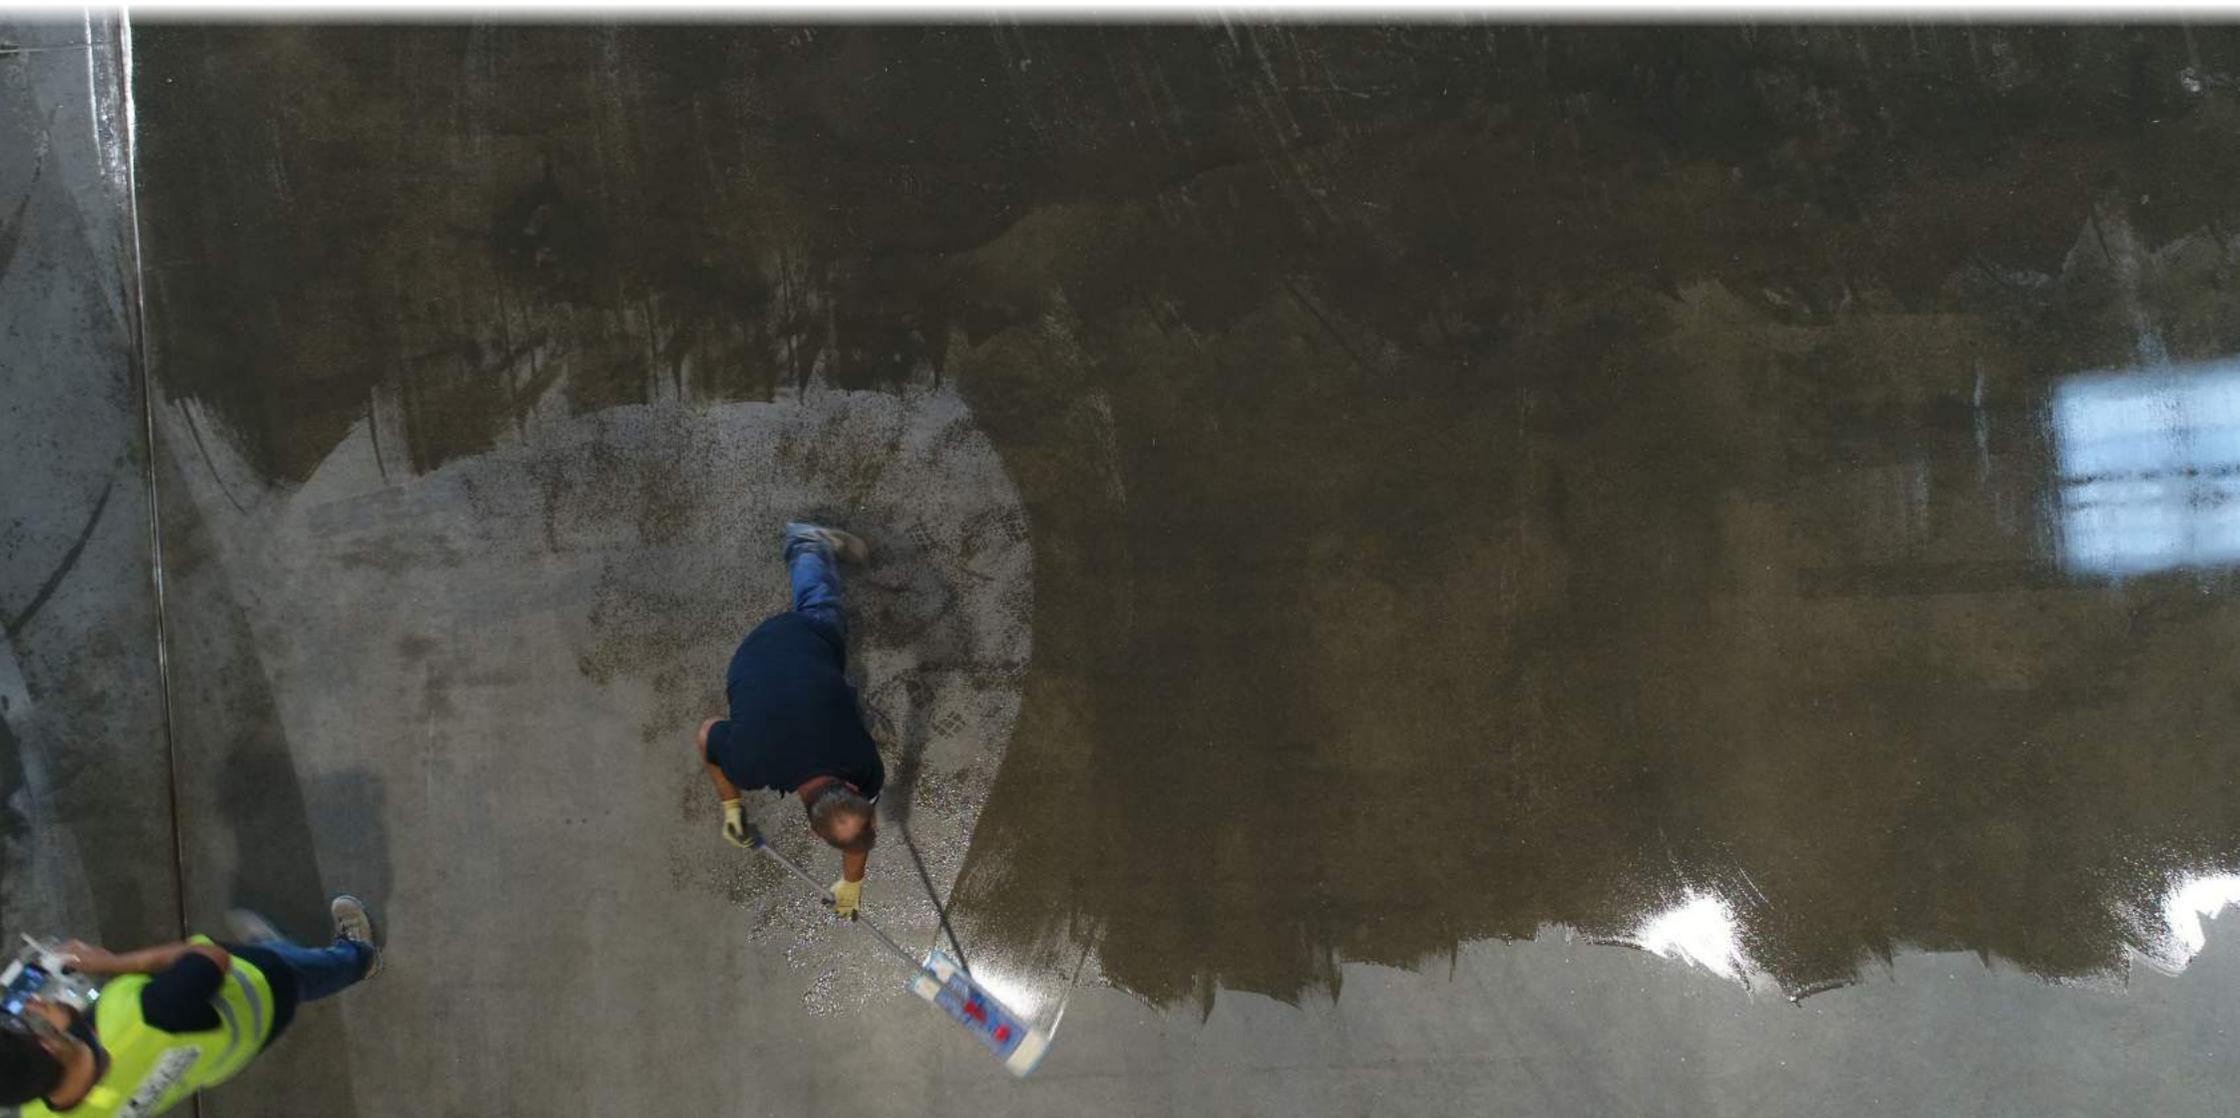
Third step:

Sealing the pores

With BECOSAN® Protective Sealer

This step of the process is the application of the protective sealer. It is a water based chemical which penetrates into the concrete surface. This treatment is not a film forming coating and will protect industrial concrete floors for an extended amount of time.

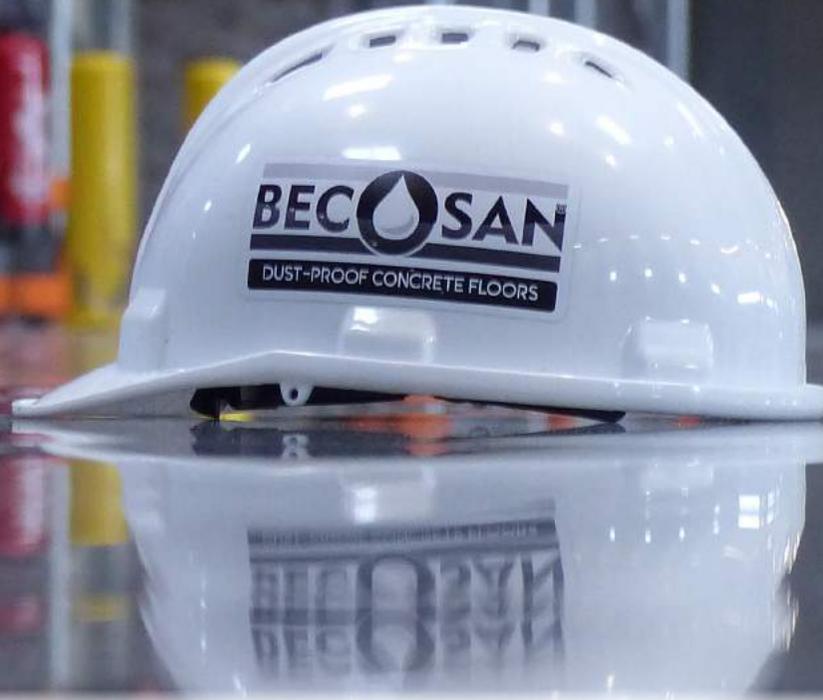
Fourth step:
Polishing
Until desired finish

Semi-Gloss

The 4-step process creates a semi-gloss finish. The floor will be smooth, abrasion resistant, dust proof and easy to clean. The surface is protected against water, oil or grease stains.

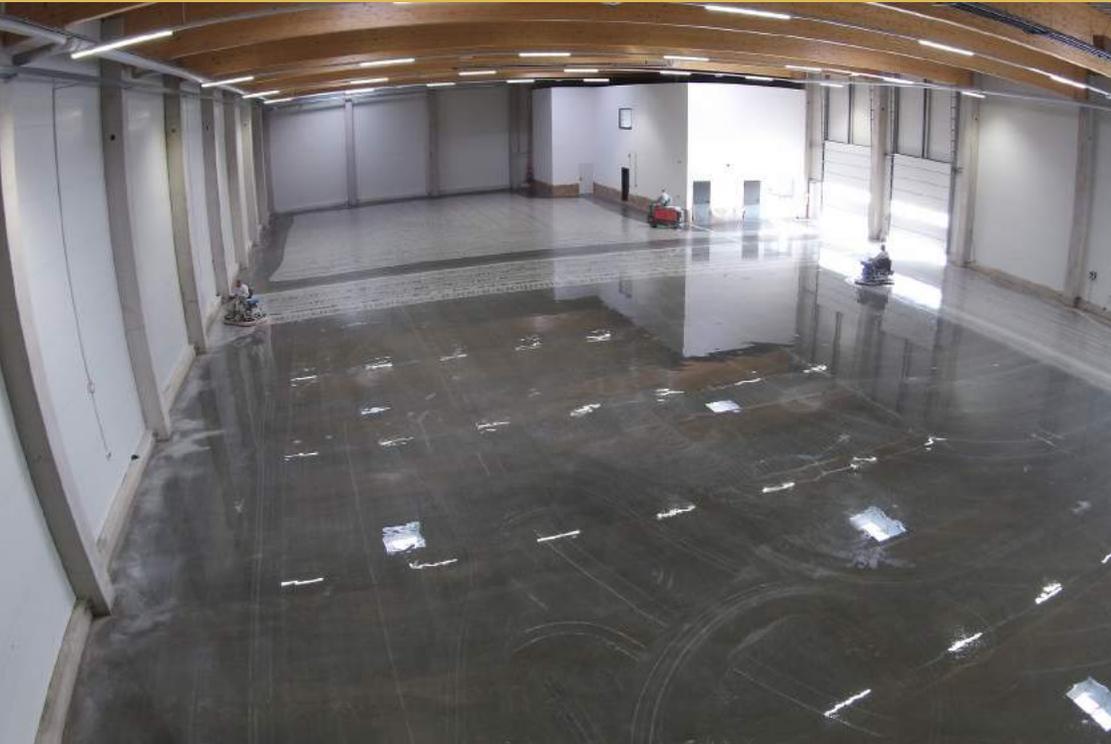
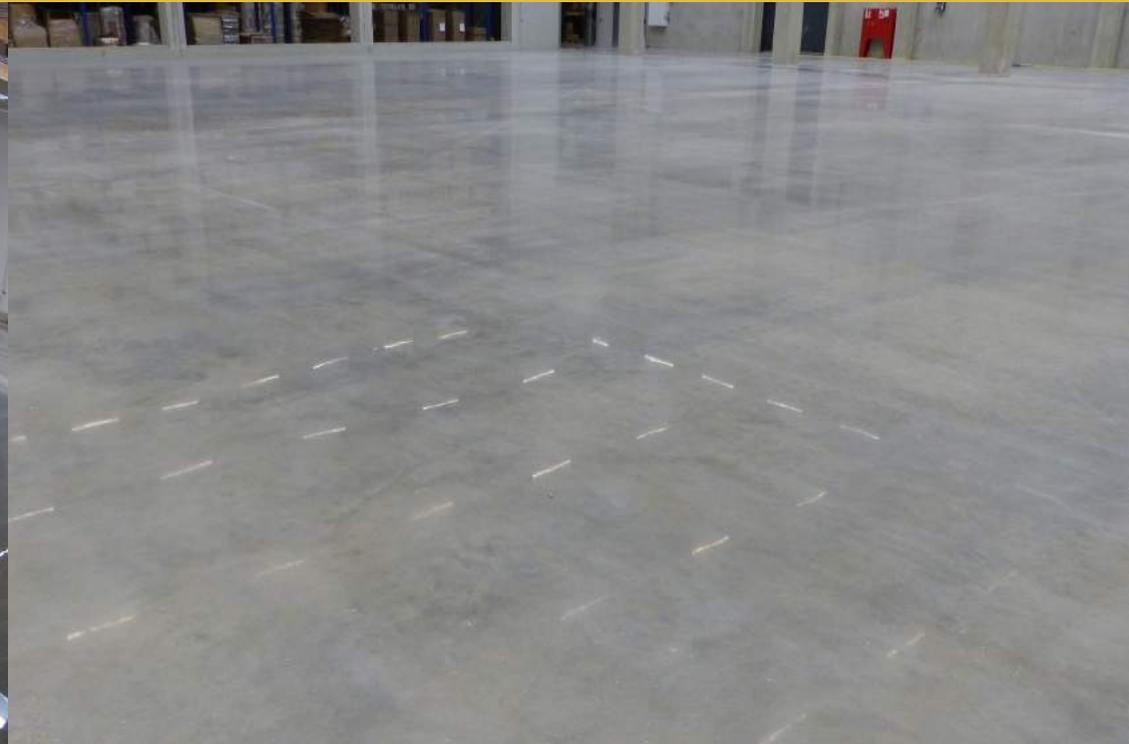
Solution

BECOSAN® Treatment

Working with one of our partners in Germany, the new concrete floor was laid. After a 30-day curing period all micro roughness was eliminated from the concrete surface leaving a high gloss finish. The floor was then treated with BECOSAN® Densifier which significantly increased the hardness of the surface. The final stage was a comprehensive treatment with BECOSAN® Protective Sealer.

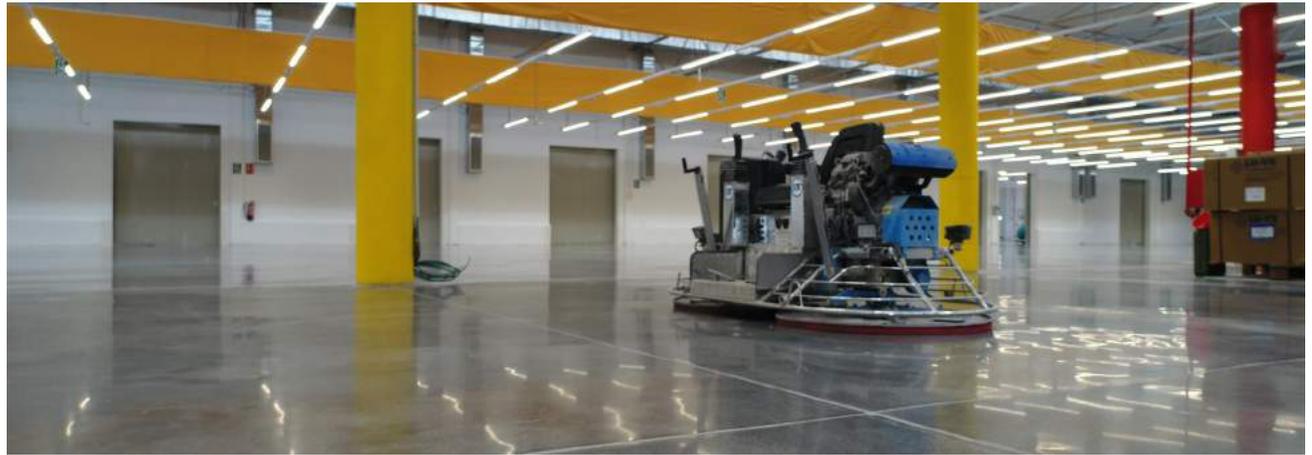
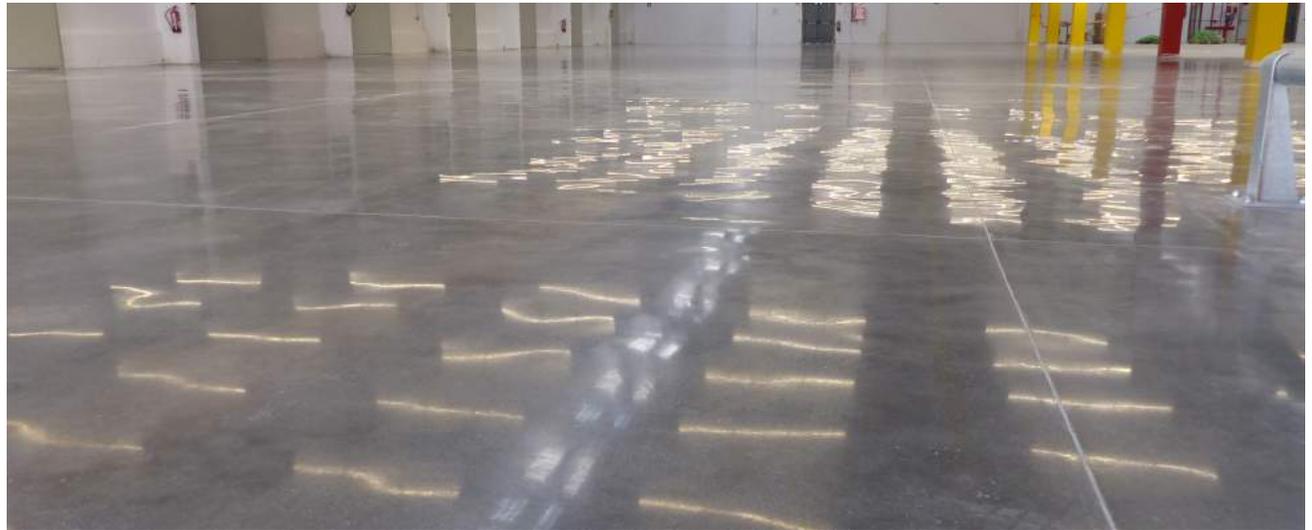
Solution

BECOSAN®

Working with one of our partners in Spain, the concrete floor was ground down with diamond hard BECOSAN® discs to remove all micro roughness from the surface leaving a high gloss finish. The floor was then treated with BECOSAN® Densifier which significantly increased the hardness of the surface. The final stage was a comprehensive treatment with BECOSAN® Protective Sealer.

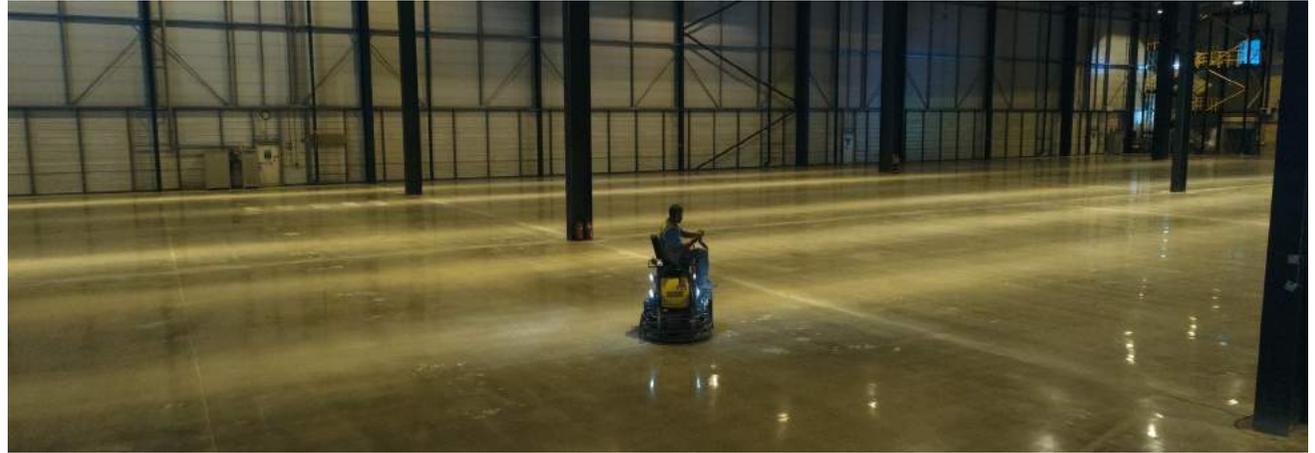
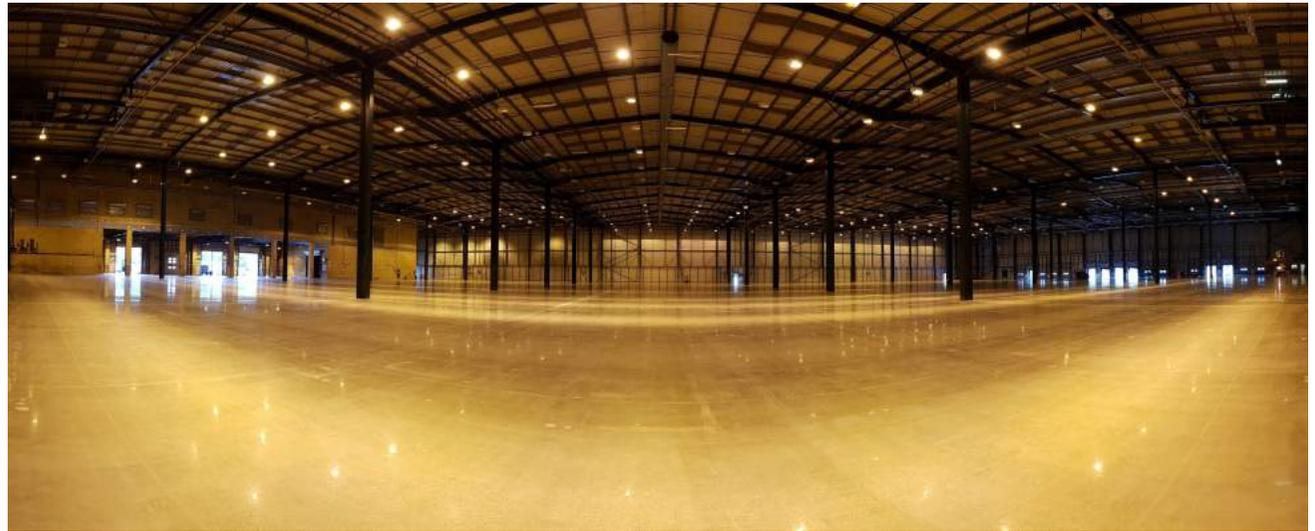
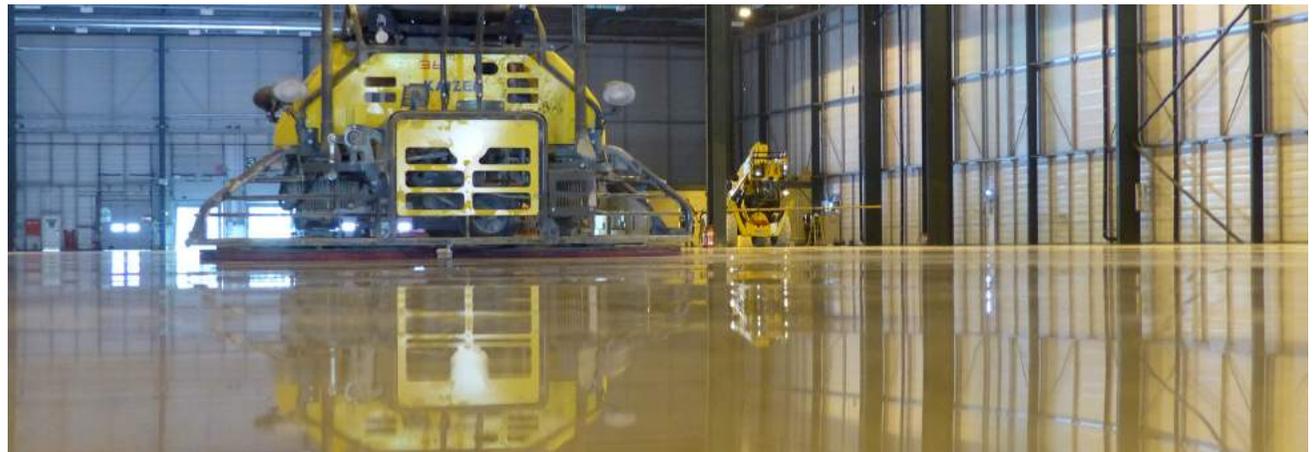
Solution

Polished concrete

Working with one of our partners in the UK, the concrete floor was ground down with progressively finer diamond hard Becosan grits (grade 50, 100 then 200) to remove all micro roughness from the surface.

The floor was then treated with Becosan Densifier to significantly increase the hardness of the surface.

The BECOSAN® applicator then commenced a further round of grinding with finer Becosan grits (400, 1000 and 3000) to bring the floor to a high gloss finish.

The final stage was a comprehensive treatment with Becosan Protective Sealer.
