Annotation Report

Project Progress Example

Report created on August 20, 2020

Captured: November 1, 2018

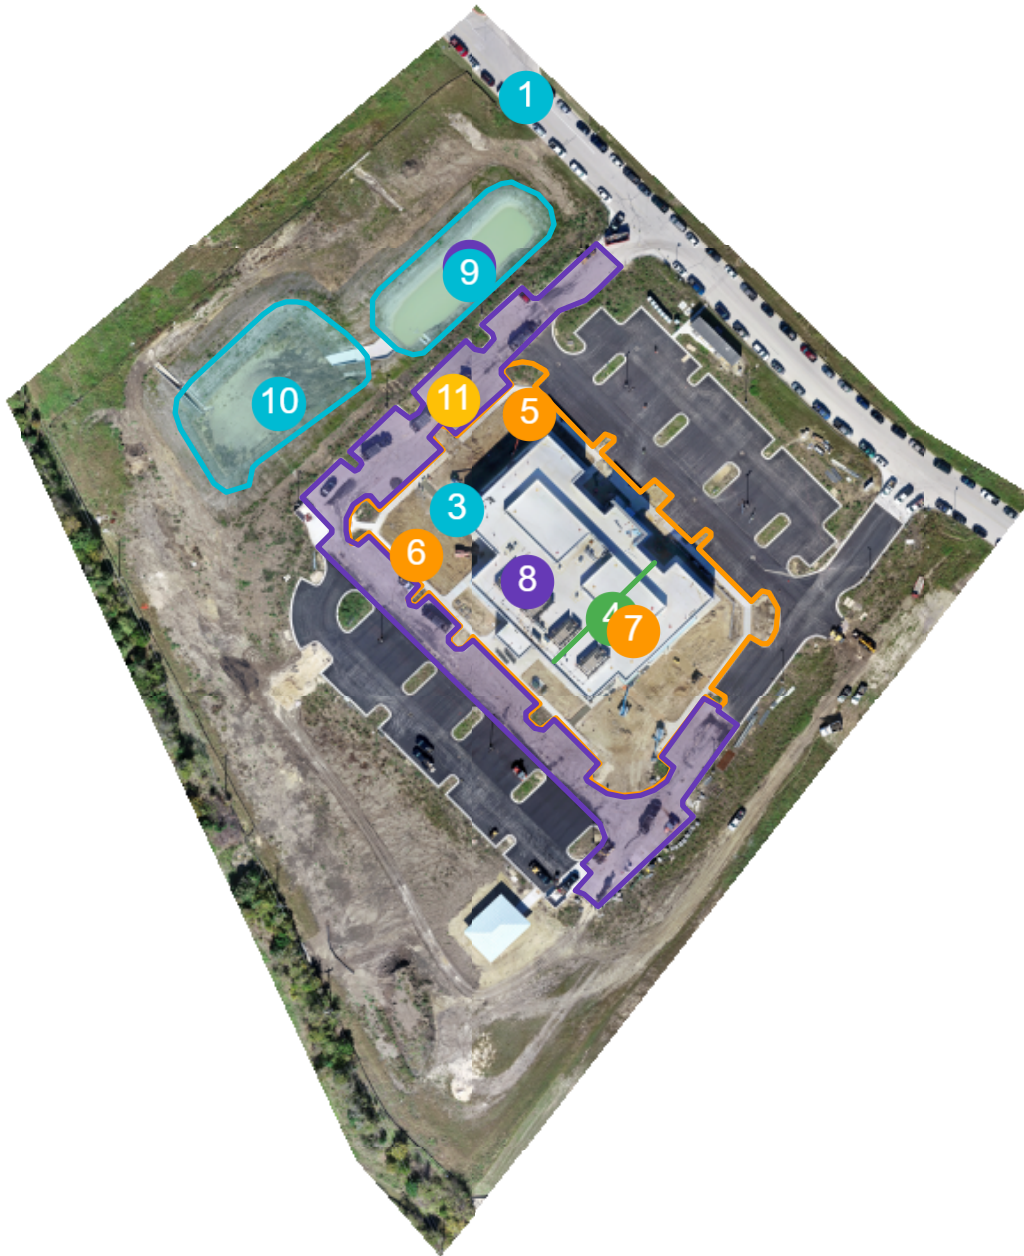
Untitled	-3.13 m	30.61705, -97.6587
2

Untitled	-2.75 m	30.6166, -97.65888
3

Untitled	-0.28 m	30.61597, -97.65891

Building Elevation Profile	41.02 m	56.28 m	-10.77°, 19.02%	-7.81 m
5

Curb and Gutter	100.1 m	4.8 m	-1.12°, 1.95%	-0.09 m
6

Curb and Gutter	115.1 m	25.28 m	-0.2°, 0.35%	-0.09 m
7

Curb and Gutter	267.7 m	27.38 m	-0.43°, 0.74%	-0.2 m

Remaining Asphalt Area	0.361 ha	0.386 ha

Label	Title	Area	Volume	Cut	Fill
9 ●	Retention Pond	0.129 ha	-878.7 m3	20.8 m3	-899.5 m3
10 ●	Retention Pond	0.175 ha	-1346 m3	5.1 m3	-1351.1 m3

Label	Title	Quantity
11 ●	Trucks	4
