<b>MEMORANDUM</b>	<b>Issued by:</b>	<b>Issue Date:</b> 3/9/2023
	<b>Subject:</b> Road 25 and Road 187 Fire Analysis	Chief Ben Lovell, OFC	<b>Page 1 of 2</b>
	<b>Special Notes:</b>

Fire Chief's Take Away Message

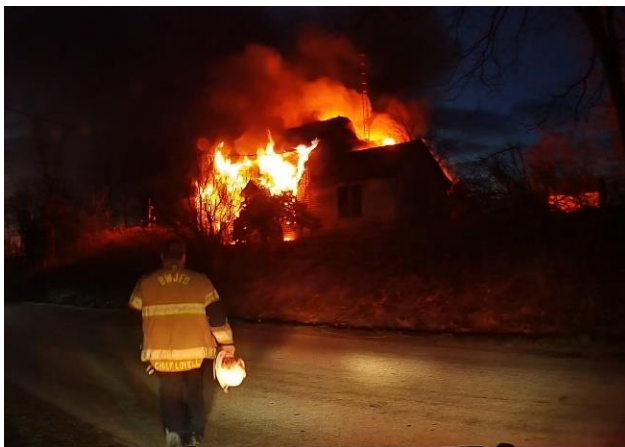
Road 25 Fire screenshot from Chief's DashCam

- An on-duty crew in Chesterville would have arrived at the Road 25 fire in less than 9 minutes from the 911 call and would have increased the victim's chance of survival.

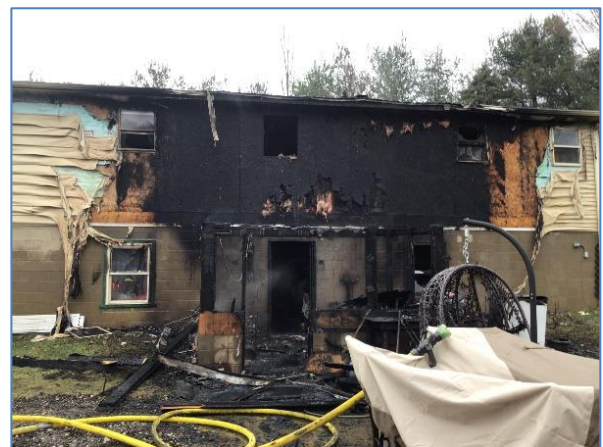
Road 187 photo from investigation

- Fire Cadet (no formal training certifications) arrived in 38 minutes and 26 seconds
  - Level 2 FF who arrived 40 minutes after dispatch.
- The on-duty crew in Marengo provided a faster response to Road 187 fire which resulted in less property damage and no civilian casualties.
