What Trucking Owners and Managers should know –

Single Vehicle Crash:

Figure 1: July 2018 rollover on Arizona SR 97

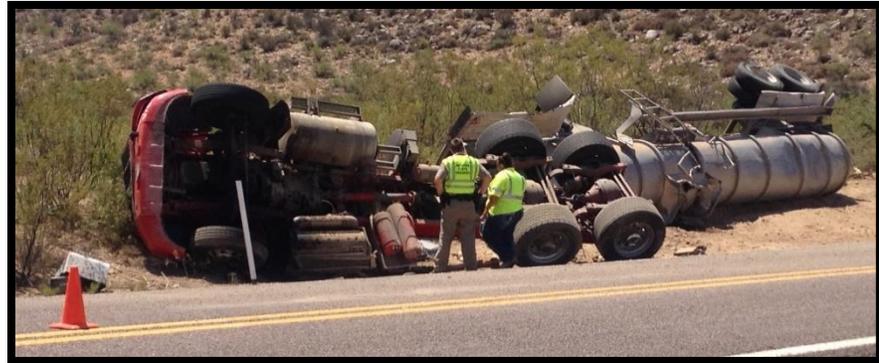
In July 2018, a semi-truck hauling an acid load rolled over on a curve going eastbound on Arizona highway SR 97. An Arizona Department of Transport official at the site noted that too many experienced drivers are involved in

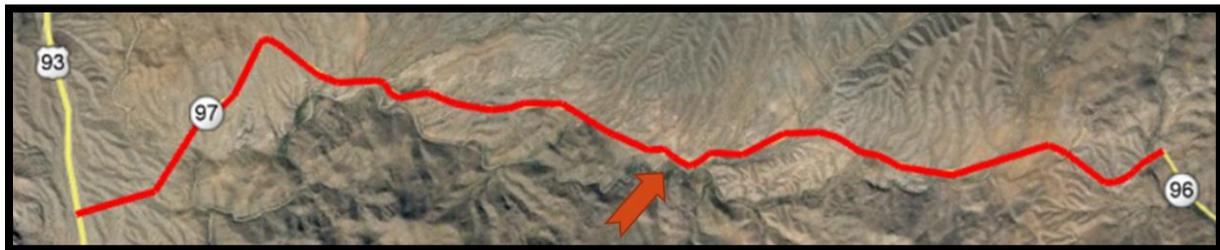
rollover crashes on the curves on SR 97. “They are just going too fast around these curves,” he lamented. This comment prompted an analysis of the curves on SR 97 with a detailed look at the curves where the rollover occurred, and to estimate the threshold speed at which a trailer would rollover and pull the tractor over as well. Figure 2: Curves along SR 97

State Route 97 (SR 97) is a 10.91-mile-long (17.56 km) state highway in Arizona. It runs from US 93 to SR 96 southeast of the town of Bagdad. Established as a state route in 1962, SR 97 was paved in the early 1970s. It is a two lane highway with virtually no shoulders on either side. There were 15 curves identified along SR 97 that could pose a problem for semi-truck drivers. Several rollover accidents including the one in July occurred on curves #9 and #10.

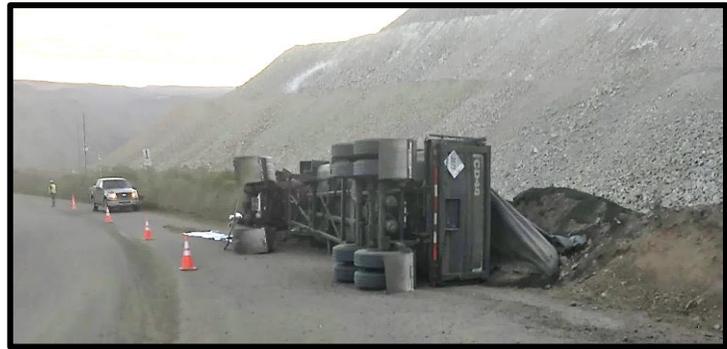
During the study, there was an opportunity to validate the tip over threshold calculations. In September 2018, a rollover occurred on a curve in an active mine property. The truck was loaded with approximately 25 tons of ore concentrate. The height to the C of G of the load was measured and after adjusting for the weight of the undercarriage the SRT was

estimated to be 0.46g. The compliance effects of springs, tires, undercarriage etc., that lower the tip over threshold, were estimated to be 0.11g and so lowering the rollover threshold to 0.35g. Using the radius of curvature of the curve, the tip over threshold speed at the crash site was determined to be **29 to 33 mph**. Later, the owner of the truck provided a readout from its GPS tracking system and the recorded speed, just 100 feet before the rollover, location was **34 mph**.
