Spring Lake Association Eurasian Watermilfoil Update June 15, 2022

Spring Lake Eurasian Watermilfoil Growth
June 8, 2022

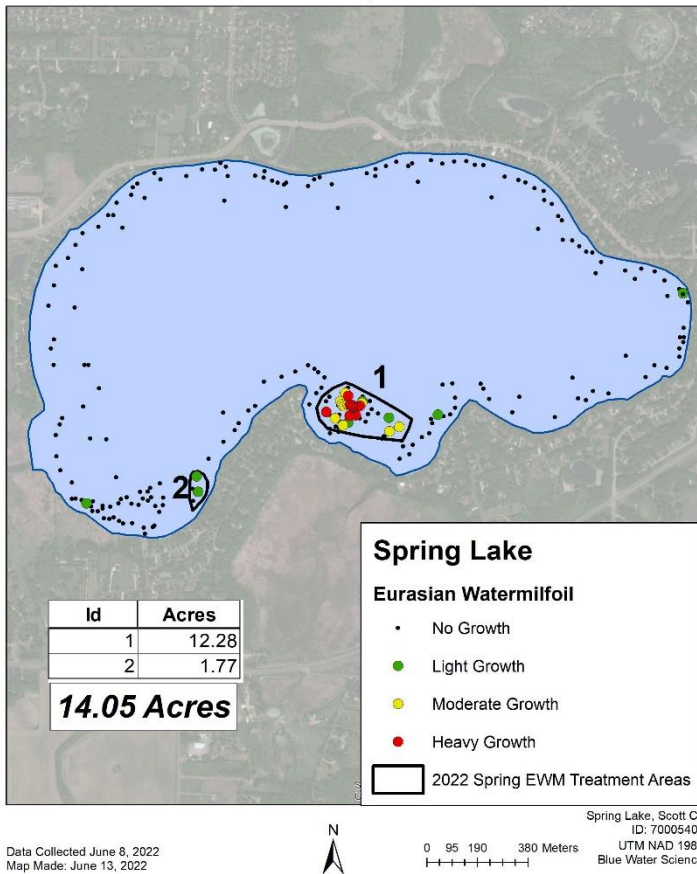
The bad news is there is a heavy infestation of EWM in the bay adjacent to Raymond Park and a light infestation near the boat landing. The right photo above shows a cluster of EWM which is distinguished by the reddish tint at the top of the plant. The map on the left shows the proposed treatment areas which are circled in Black.

In discussions with Steve McCommas, the circled area(1) is considered a bed(multiple patches together or heavy) and was the reason for treating. We included the area beyond the boat launch (2) due to the possibility of prop action and EWM spreading by fragmentation. A single green dot is considered a patch. The other patches will be monitored for treatment later this summer.

- **Area 1** | Total of 12.28 acres
- **Area 2** | Total of 1.77 acres
- **Total** | 14.05 Acres
- **Cost** | Treatment is estimated to be \$17,000. The costs for the treatment will be covered by the DNR grant.

We will follow this up with a Point Intercept Survey in July and then a possible second treatment later this summer.
