## Is your facility *prepared* for claims against ADAAG?

Volume 2014.06.20

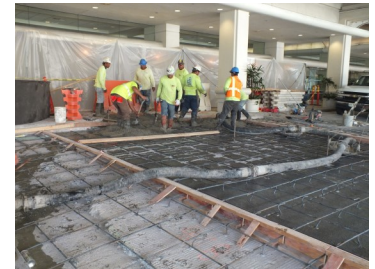
Forming and placement of concrete to adjust grades

Existing non-compliant pathways and the Porte-cochère were resurfaced with new slope adjusting concrete overlays, new ramps, signage and a new mechanical wheelchair lift. The facility now meets ADAAG Access Route requirements. The photos above depict a visual indication of that effort.

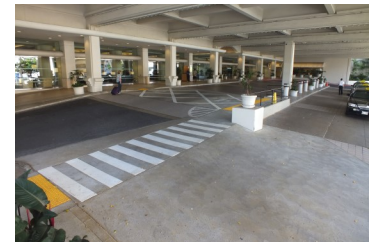
Completed grade adjustments that meet ADAAG regs.
