Case Study-Grain Bin

Deep Foamjection Stabilization and Raising Project

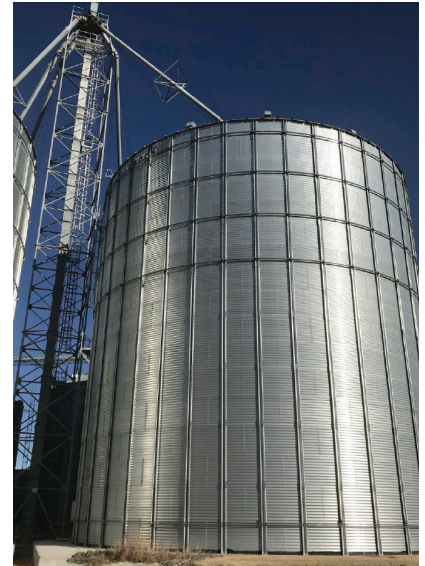
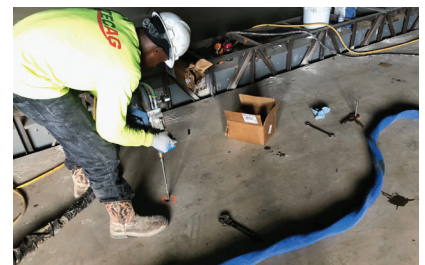
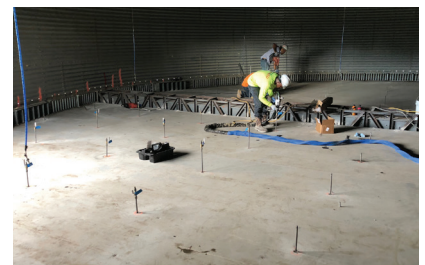
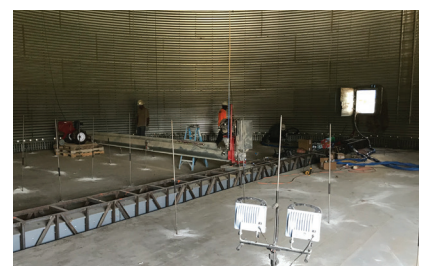
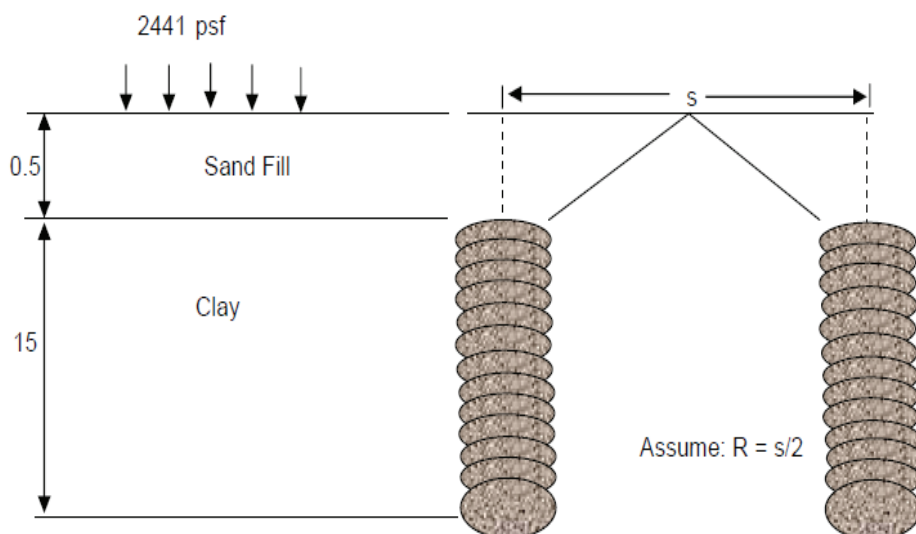
Previously installed geopiers had been installed at a depth of 15 feet. In conjunction with the weak subgrade, there was not enough strength to support the full weight of the filled grain bin, Half of the slab settled by 6 inches.

The full repair would require to first stabilize the subgrade, then attempt to lift the settled slab up to 6 inches. Alternative repair methods were bid exceeding \$1M with months of demolition and construction. With fall harvest approaching this repair was time sensitive.

A four foot grid pattern of 106 points were used to install Hydrofoam 402 at a depth of 12-15 feet to stabilize the soil. Each injection point accepted 15-75 pounds of material as noted in the color-coded chart below. Using an HMI EliteONE injection gun, a total amount of 4,500 pounds of HF402 foam was incrementally installed into the soil to stabilize the subgrade. HF402 was chosen for stabilization due to the potential water present, strength and the ideal reaction profile for Deep Foamjection.

After the soil was stabilized, 62 holes (5/8") were drilled to pump material for lifting through injection ports. To lift, 4,500 pounds of HF 402 Fast and 1,000 pounds of RR 401 were used, achieving a 5 inch lift. At this point, the slab was demonstrating signs of stress and the customer was pleased with conclusion of project. The foam used to lift the slab was equivalent to 1,375 cubic feet in volume.

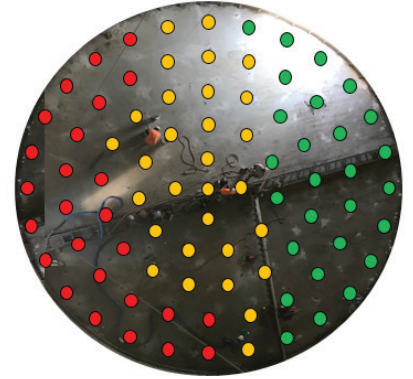
● 60-75 LBS
● 35-55 LBS
● 15-30 LBS
