Case Study

I-94 Milwaukee Highway Stabilization

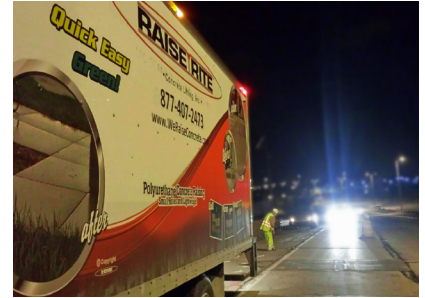
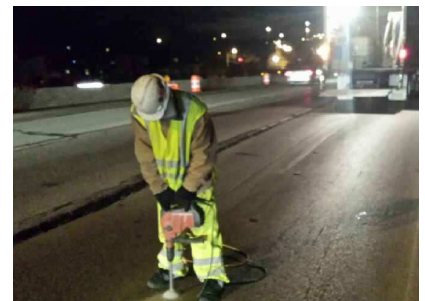
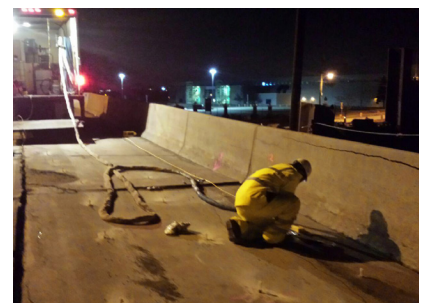
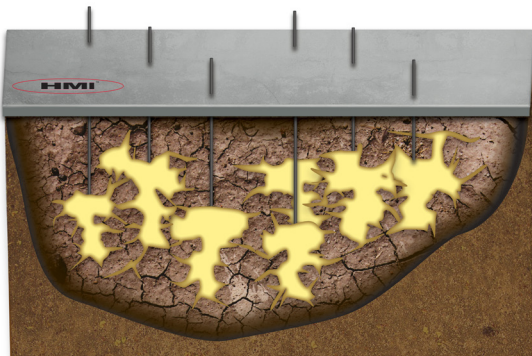
RaiseRite Concrete Lifting (HMI's Contracting Division) was called by a roadway contractor informing us that concrete roadway panels beneath the asphalt paving on I-94 in Milwaukee, Wisconsin had voids, leading to a rocking back and forth of the panels as trucks would drive over this portion of the road. The roadway contractor needed to stabilize the area within 36 hours. The work needed to be completed at night to avoid lane closures and traffic congestion.

The two man RaiseRite crew arrived onsite the next day at 11:00 p.m. The contractor provided and set up traffic control. The voids were filled and the roadway was stabilized with 955 lbs. of HMI 501 polyurethane material. After the voids were successfully filled, the crew lifted the shoulders to line up with the roadway. The project was completed at 4:30 a.m., for a total project duration of 5 ½ hours on deck. Once the polyurethane cure time of 15 minutes was complete and traffic barriers removed, the roadway was opened for traffic. Even upon short notice, RaiseRite was able to arrive to onsite and successfully complete another highway stabilization project.
