# Field Review Technical Advisory Report Long-Term Operation & Maintenance

**Site Name:** Chesapeake Drive - 035

**Report Date:** 2018-09-20

Stormwater Control Measure Field Review of Conditions and Compliance Activities performed through a Memorandum of Understanding in accordance with Ohio Revised Code, Chapter 940 and North Royalton Codified Ordinances

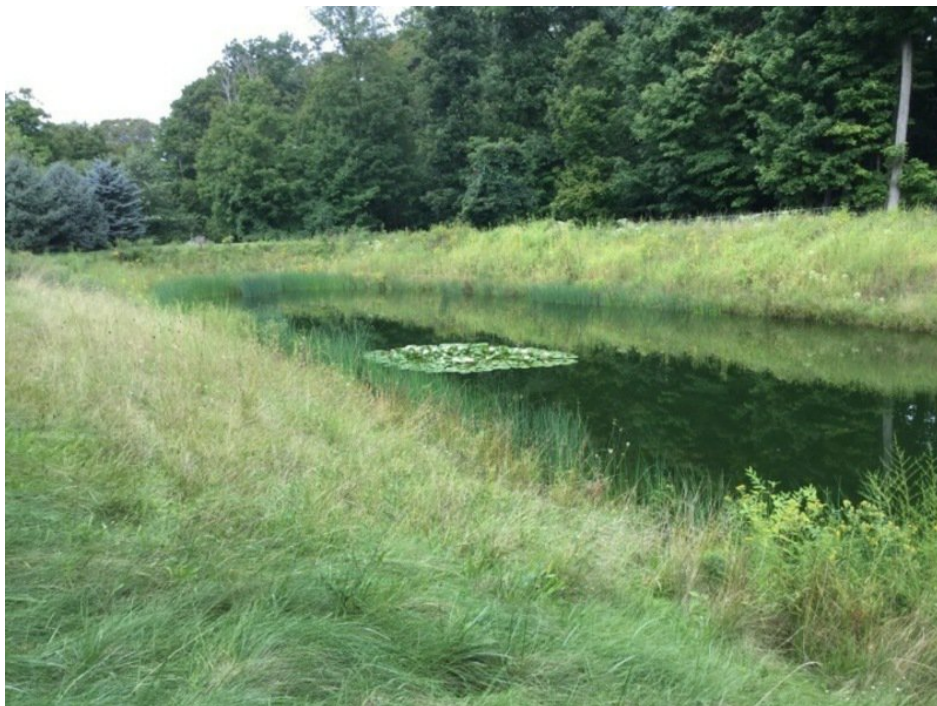
View of retention basin located north of Chesapeake Drive. Overgrown vegetation was observed at both the inflow and outflow for this basin. Erosion was occurring in the northeast corner of the basin.

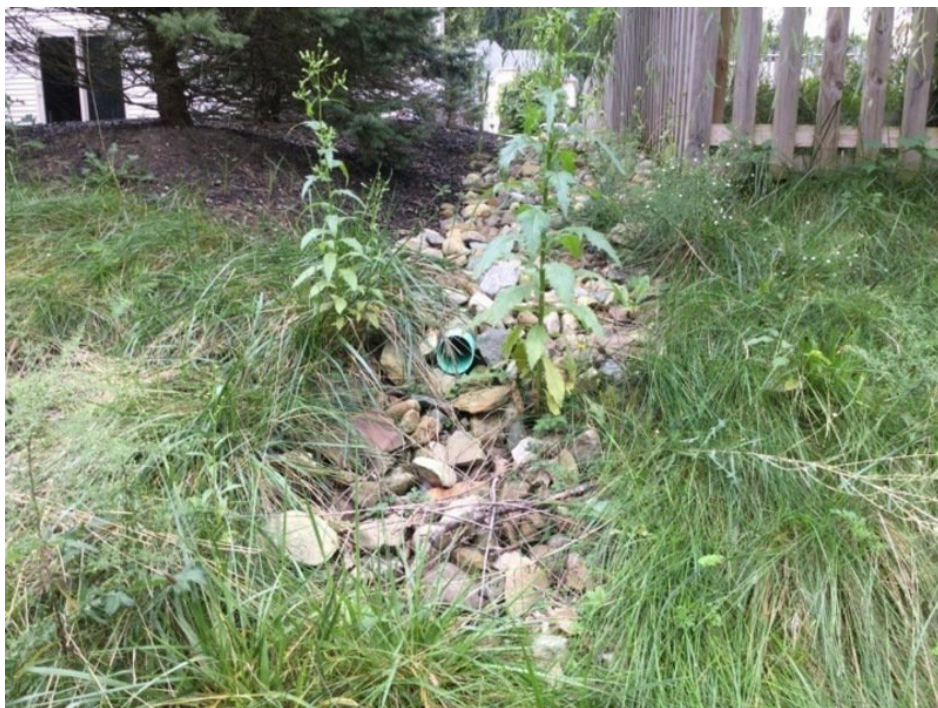
View of inflow structure located along the southern edge of the basin.

Ensure that inflow structures are kept clear of overgrown plants to minimize the blockage of flow.

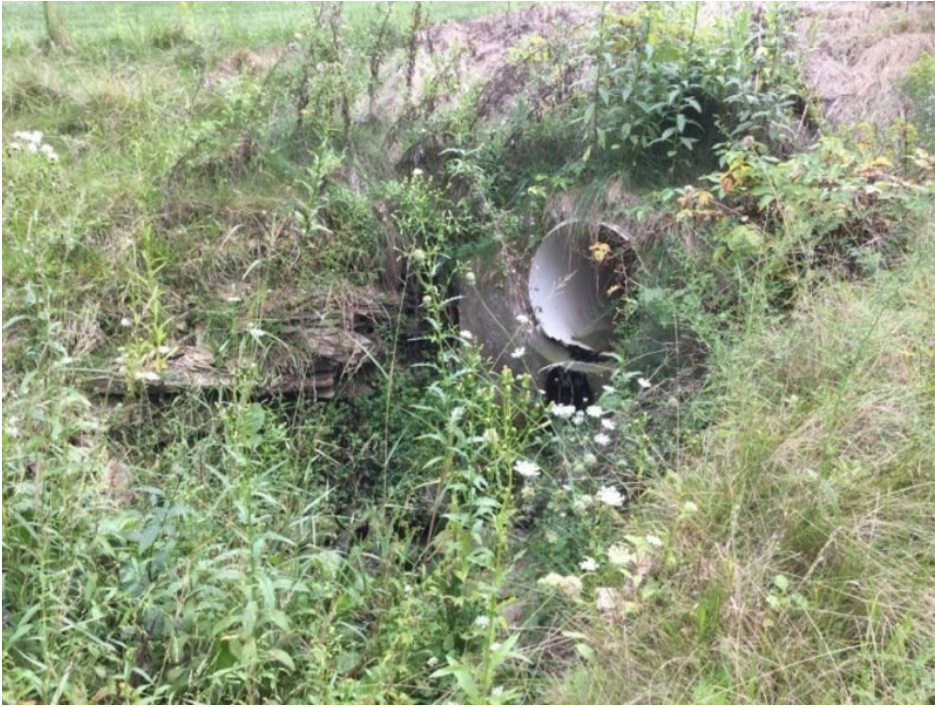
View of inflow structure in the southeastern corner of the basin.

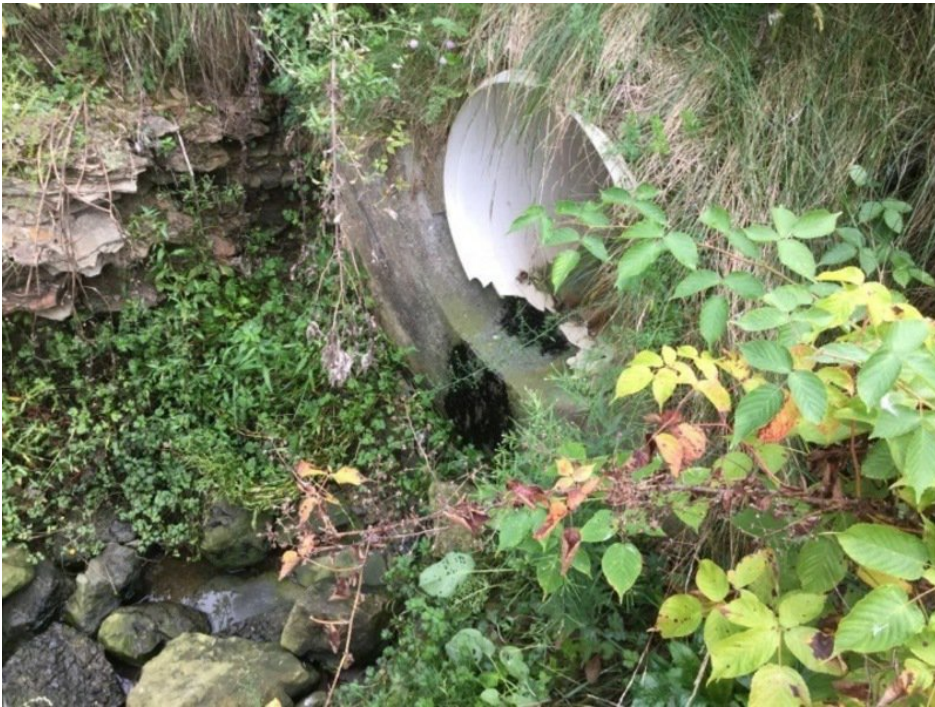
Up close view of damaged inflow pipe in the southeast.

Repair damaged infrastructure.

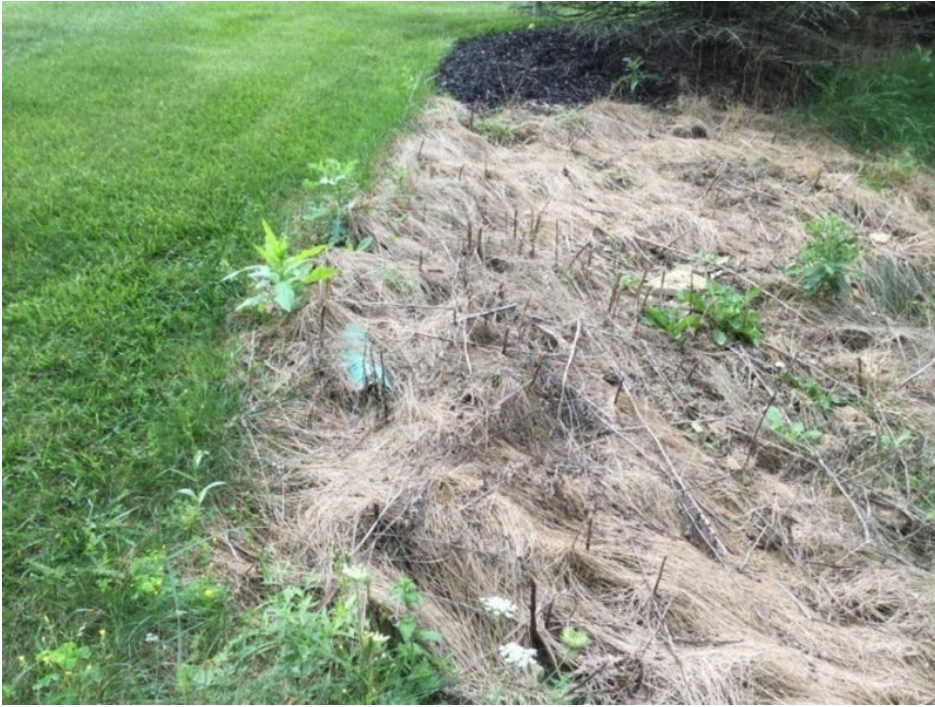
View of inflow pile along the eastern edge of the basin.

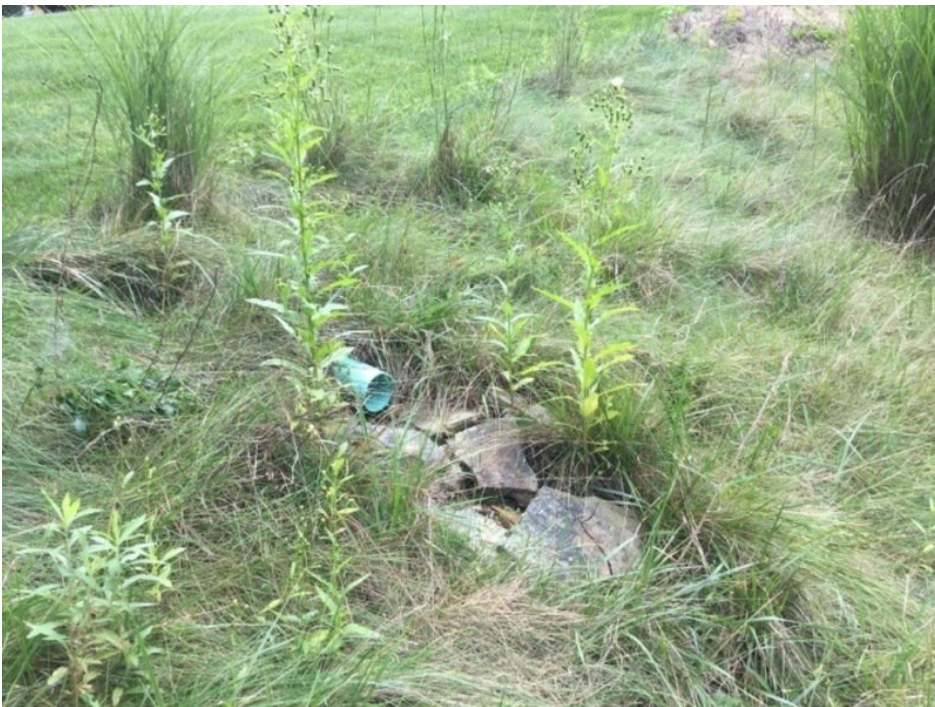
View of additional inflow in the southeastern portion of the basin.

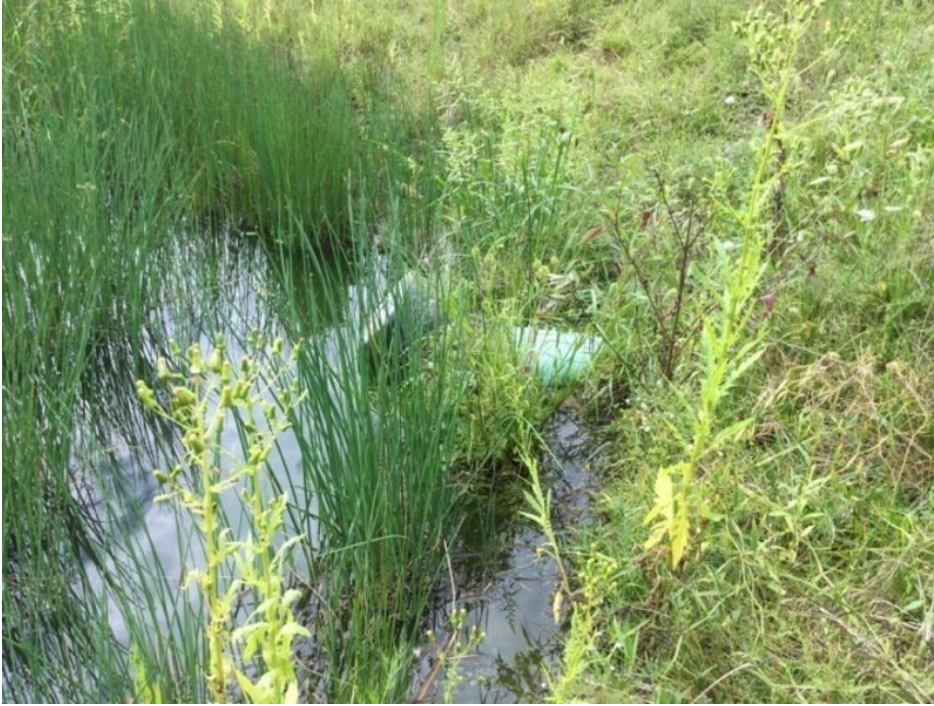
View of outlet structure in the western portion of the basin.

Ensure that outlet structures are kept clear of overgrown plants to minimize the blockage of flow.

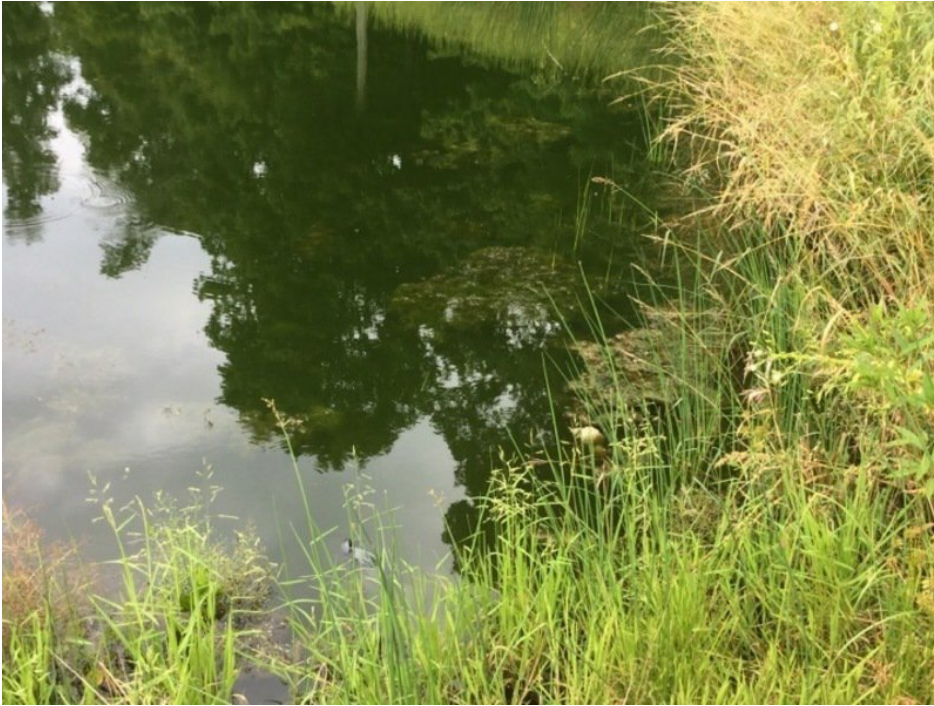
View of algae within the basin.

Remove accumulating algae to ensure proper function. This can be done by raking the surface of the water.

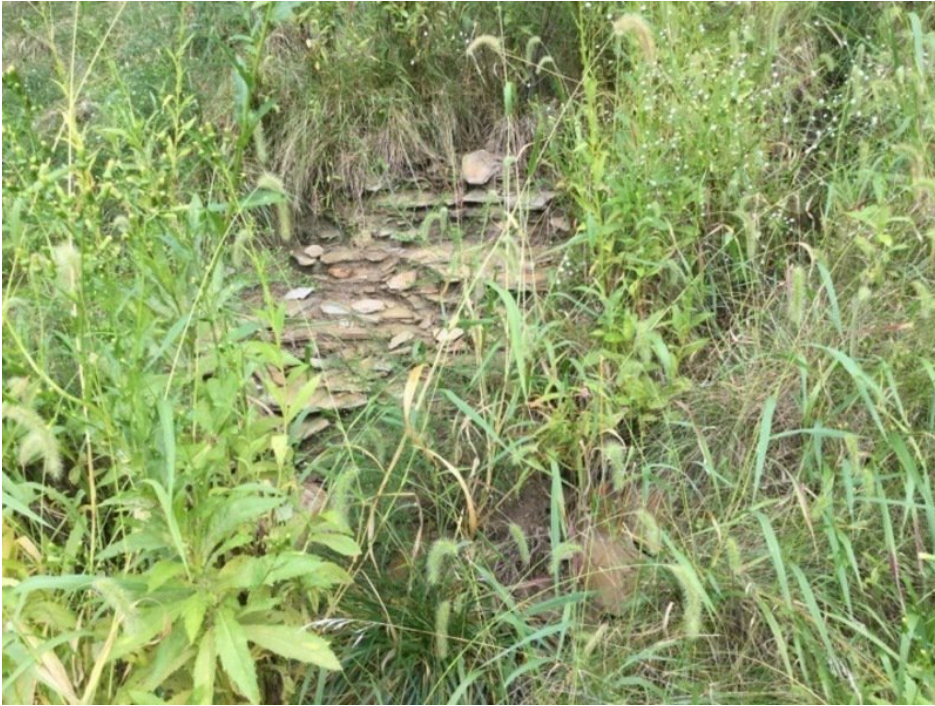
View of erosion occurring in the northeastern corner of the basin.

Stabilize eroding areas to prevent further erosion and sedimentation of the stormwater control measure.

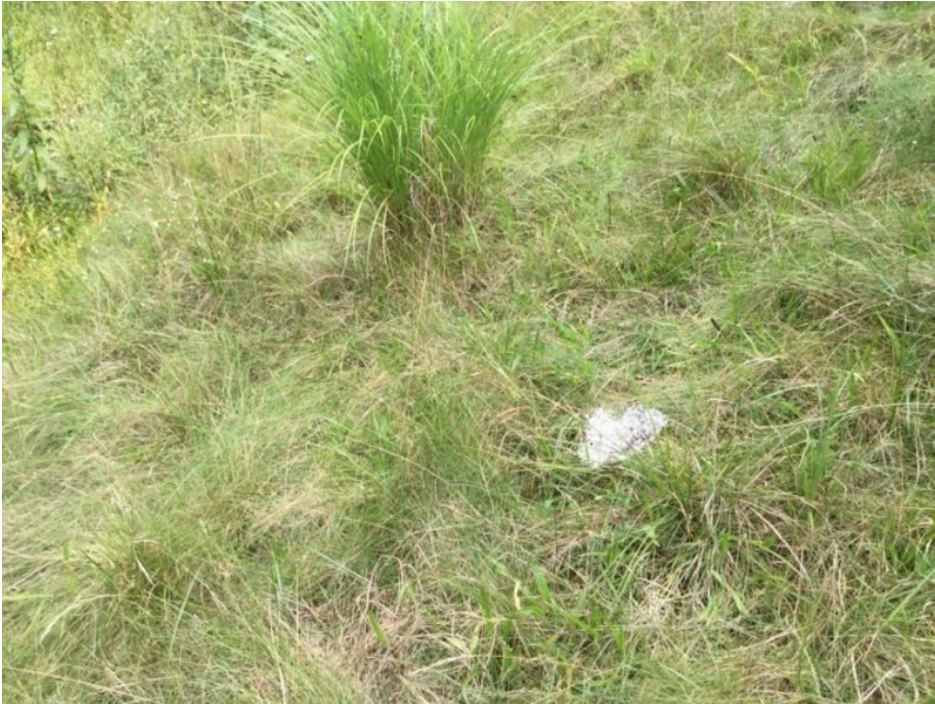
View of minor amount of trash within the basin.

Remove trash from the stormwater control measure as needed to ensure proper function and aesthetic quality.

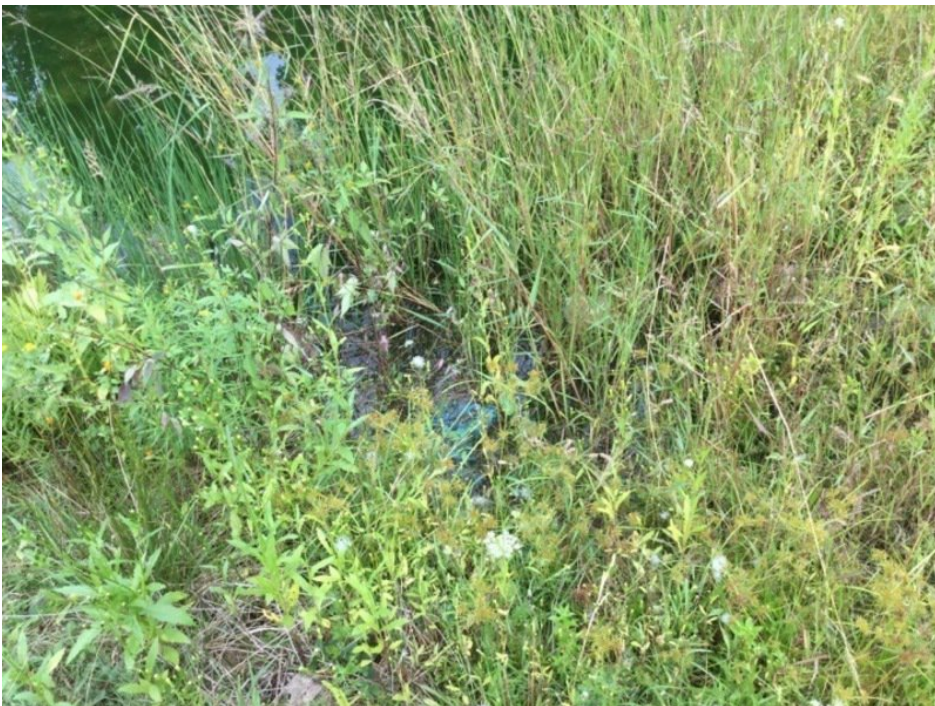
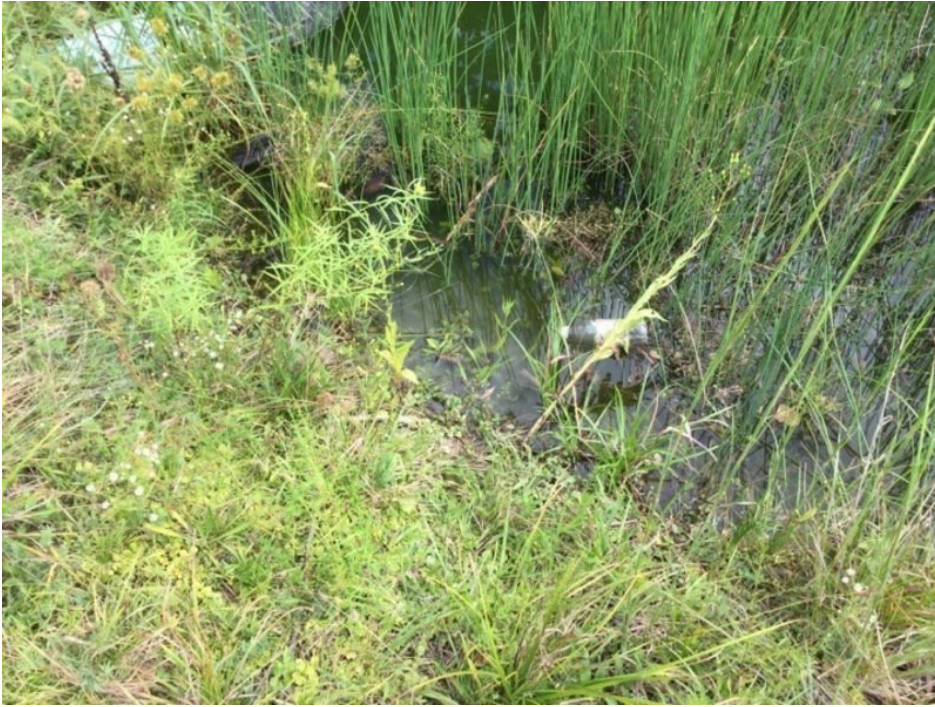
Additional view of trash within the basin.

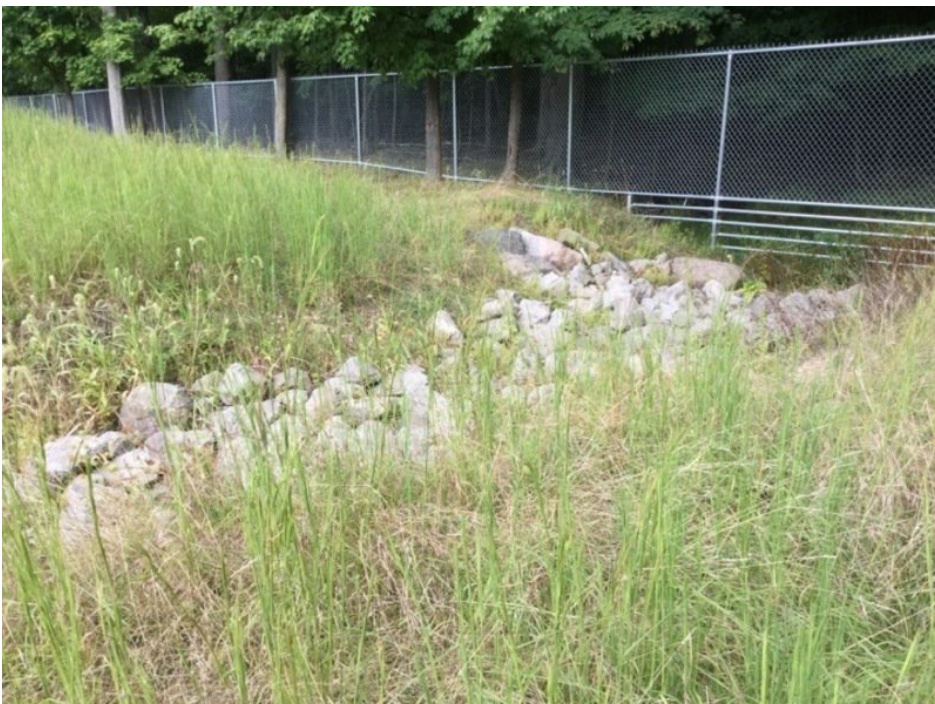
View of emergency spillway located in the northeastern portion of the basin.

Cut back vegetation annually to prevent the growth of woody vegetation (shrubs and trees) and ensure proper flow over the spillway during large storm events.
