Field Review

Technical Advisory Report

Site Name:	Chesapeake Drive - 036	Report Date:	2021-04-20
Location:	Facility 035, 036	Inspection Date:	2021-03-30
Permit Holder:	Chesapeake HOA	Reviewed By:	Jakob Hamlescher
Contact:	John Graven	Site NPDES Number:	N/A
Address:	18104 Heritage Trail Strongsville OH 44136	Application No:	N/A

Stormwater Control Measure Field Review of Conditions and Compliance Activities performed through a Memorandum of Understanding in accordance with Ohio Revised Code, Chapter 940 and North Royalton Codified Ordinances

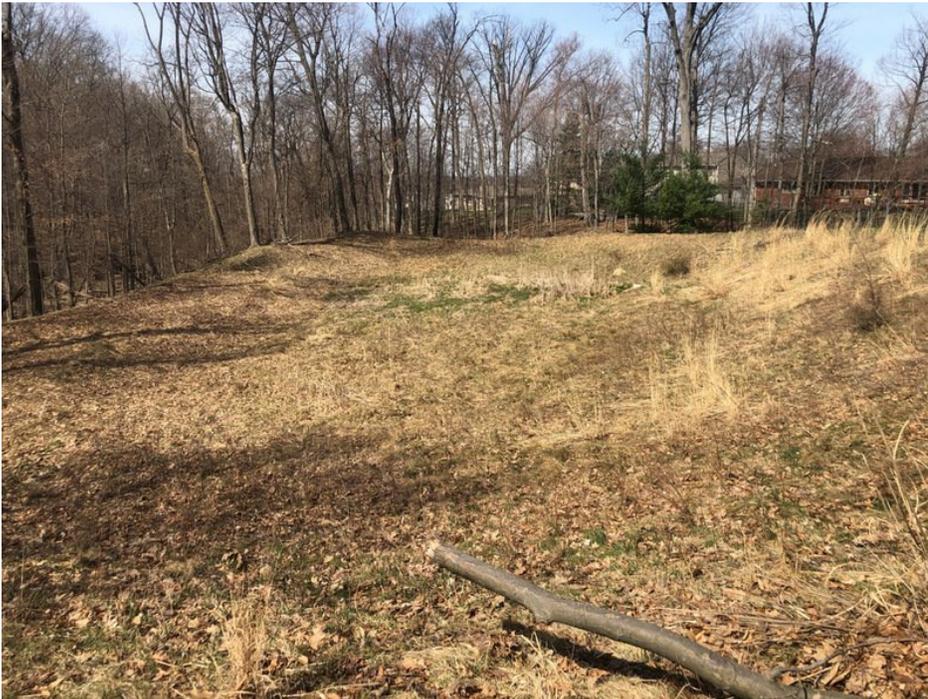
View of the basin.

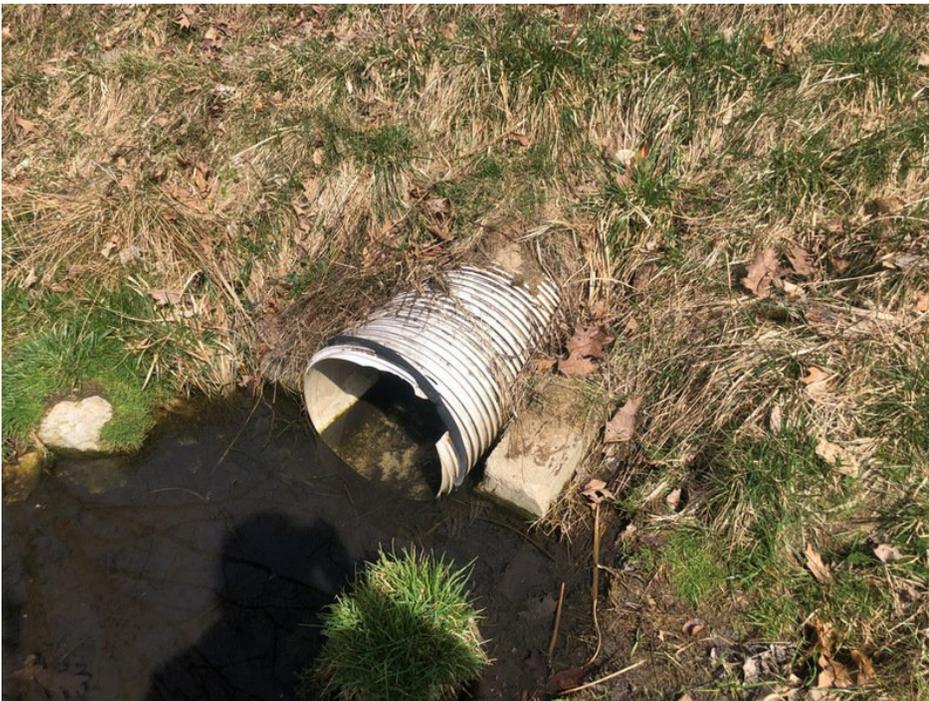
Inflow Structure

View of inlet structure. There is sediment accumulation in the pipe as well as some minor erosion/slumping. This sediment needs to be cleaned out.

Monitor and remove accumulated debris from the inflow structure on a regular basis to ensure proper function.

Monitor for erosion around the inflow structure, repair as needed to prevent failure of infrastructure and sedimentation of the stormwater control measure.

Ensure that inflow structures are kept clear of overgrown plants to minimize the blockage of flow.

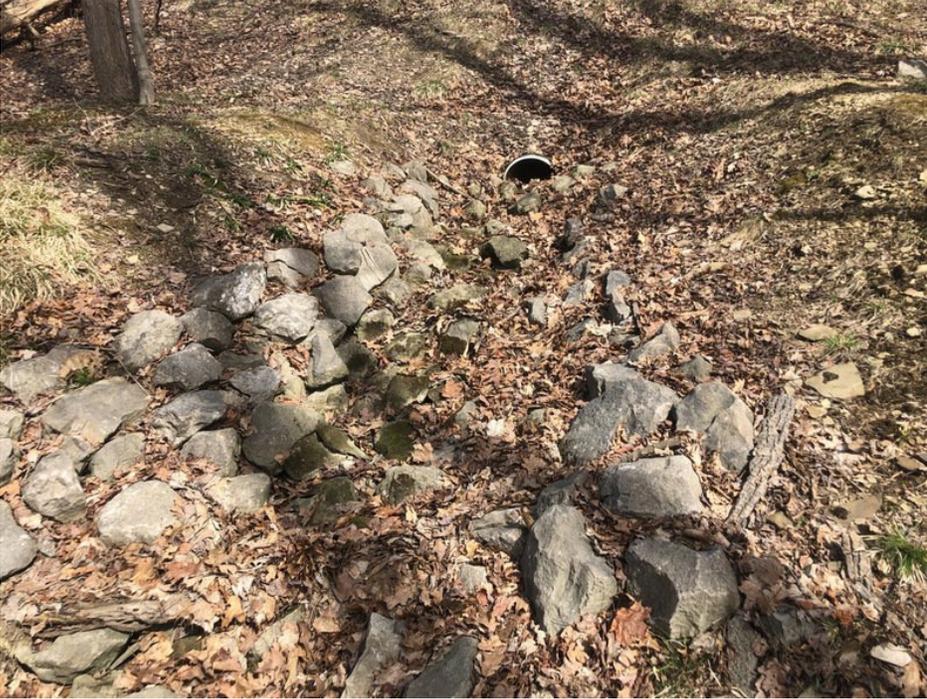
Outlet Structure

View of outlet structure covered with leaves. There was also minor erosion/slumping around the outlet structure.

Monitor and remove accumulated debris from the outlet structure on a regular basis to ensure proper function. Ensure that outlet structures are kept clear of overgrown plants to minimize the blockage of flow.

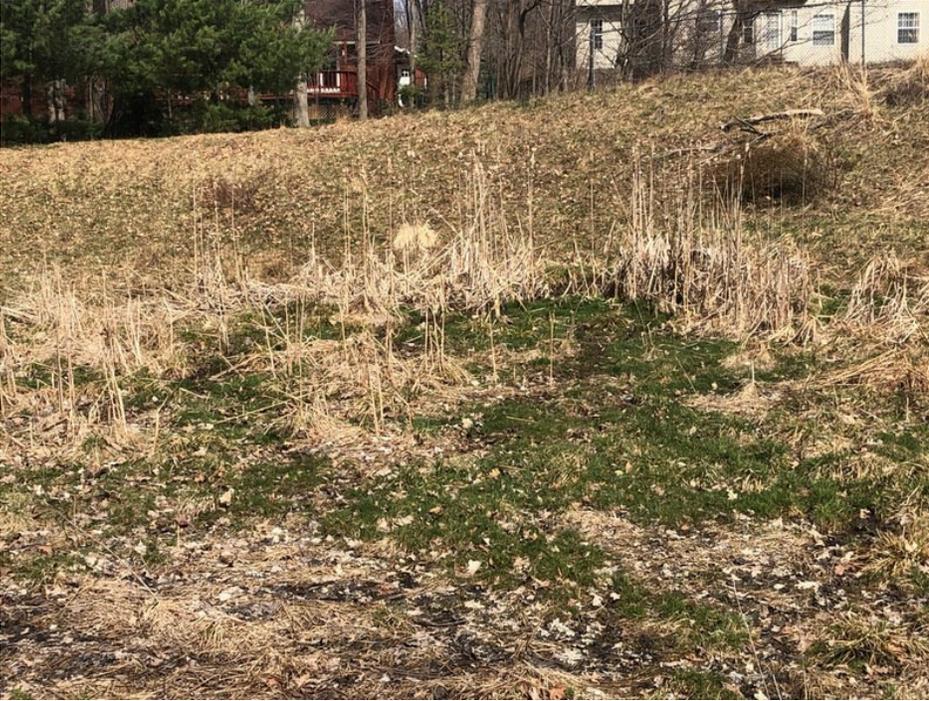
Invasive Aquatic Plants

View of cattails in the basin. These need to be treated and/or removed.

Cut back, remove, or treat narrowleaf cattails to prevent further growth. Use a contractor with a commercial pesticide license with aquatic endorsement for any chemical treatments. Planting turf or native species to compete with the invasive cattails will help stabilize and prevent future cattail establishment. Contact Cuyahoga SWCD for additional details about the proper management of narrowleaf cattail. Stabilize any areas that are disturbed during vegetation management.

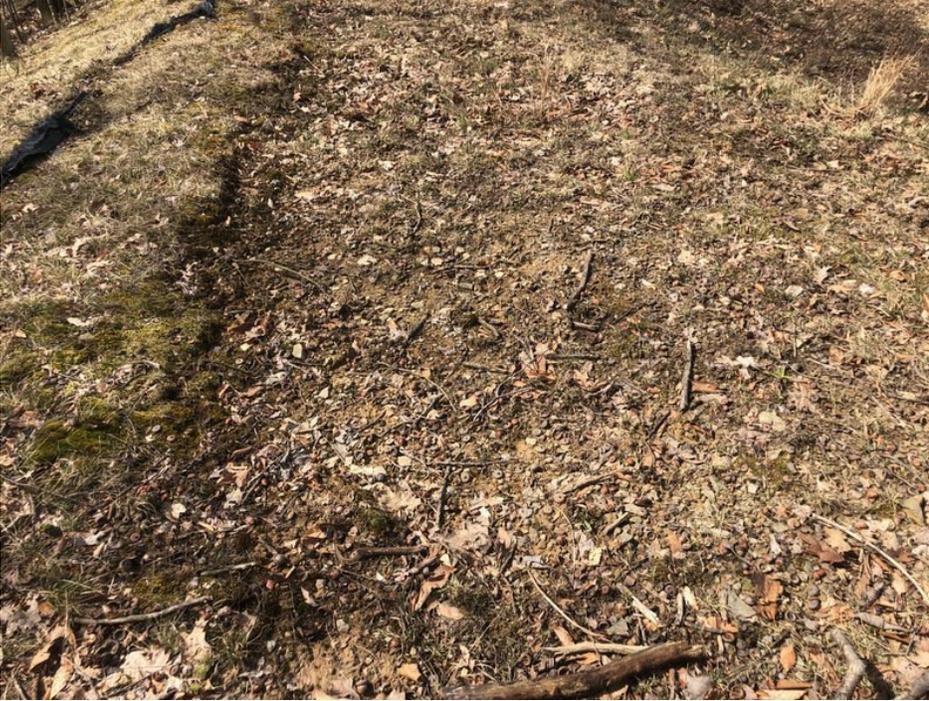
Permanent Stabilization

View of the bare area at the top of the berm. This needs to be re-seeded.

Stabilize all areas of exposed soil as quickly as possible.

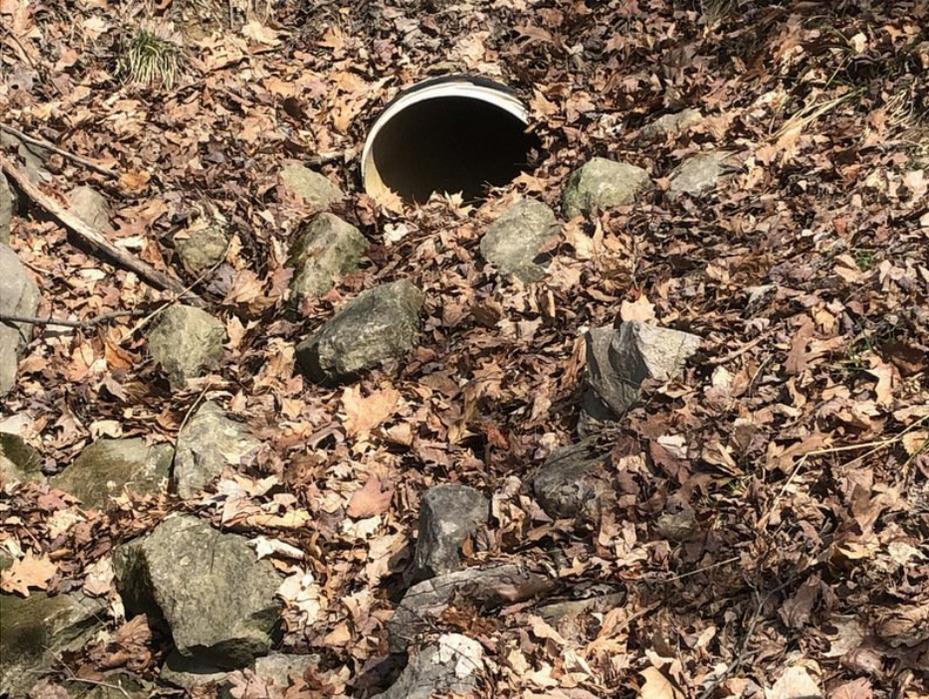
Trash and Debris

View of leaf litter near the outlet structure. This needs to be cleaned up to allow proper water flow and dissipation on the rocks below.

Remove plant debris from the stormwater control measure during routine maintenance to ensure proper function and aesthetic quality.

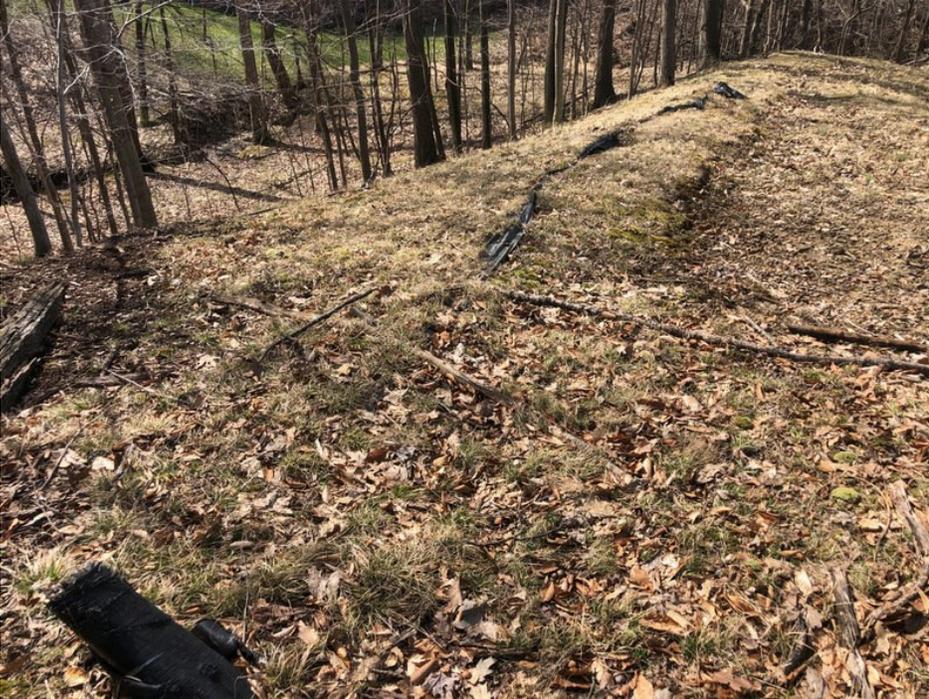
Other Observations

View of silt fence. This needs to be removed.

Temporary practices such as silt fence should have been removed at the end of construction. Please remove as soon as possible. There is a lower part of the embankment along the northern edge of the basin. It was difficult to determine if this area was at one time an emergency spillway or if the soil has settled in this area. Review engineering drawing for this basin and ensure the elevations of this embankment are correct.

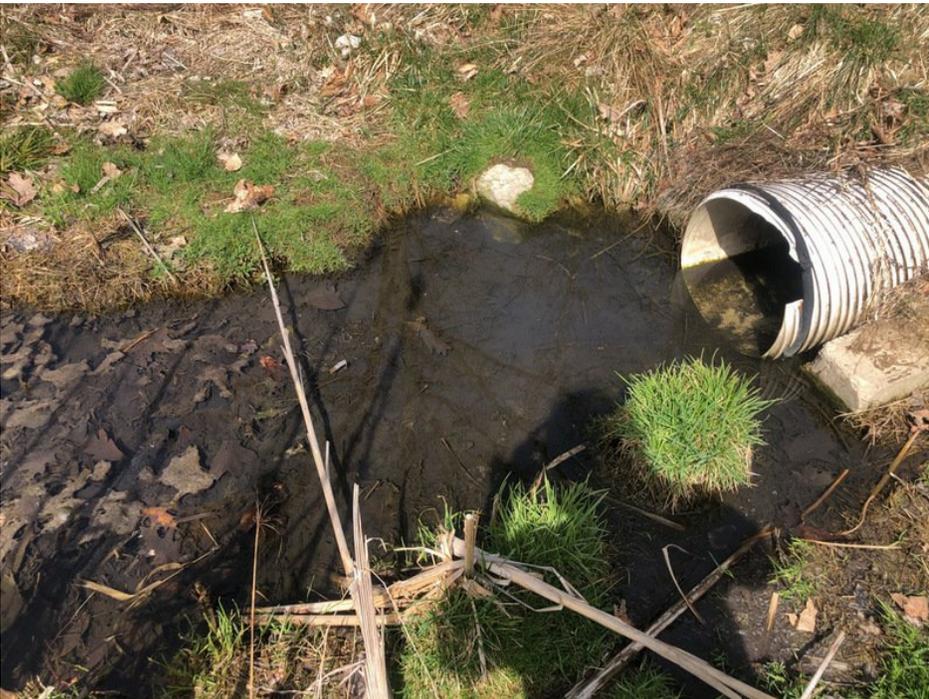
Sediment

View of sediment accumulation in the basin. This needs to be dredged soon.

Dry (detention) basins are designed to catch and settle sediment to prevent it from traveling into nearby streams/sewer systems. Owners should budget for eventual dredging which typically is needed every 15-20 years.
