Job Sheet

<div></div>	<div>Job Address</div> <div></div>	<div>Job Number</div> <div>UKJB00328</div>
<div></div>	<div>Reference</div> <div></div>

Gable Leak Investigation & Possible Repair

Dintgrade Limited
Estate Office
Gloucester Court,
Kew Road
Richmond
TW9 3DY

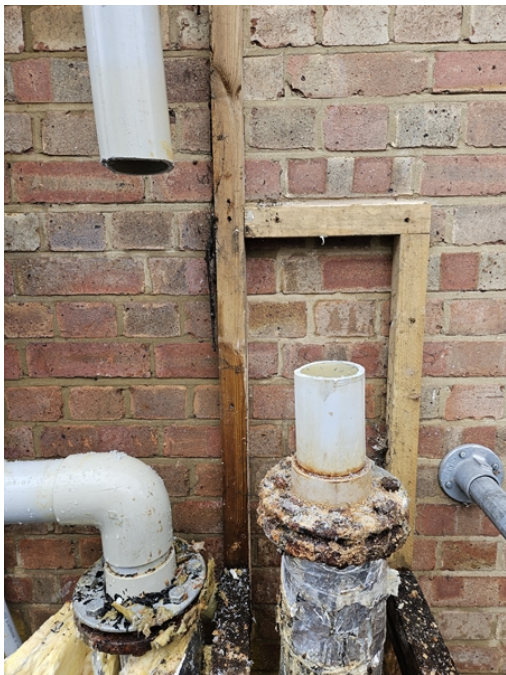
1st leak located on the hot water flow

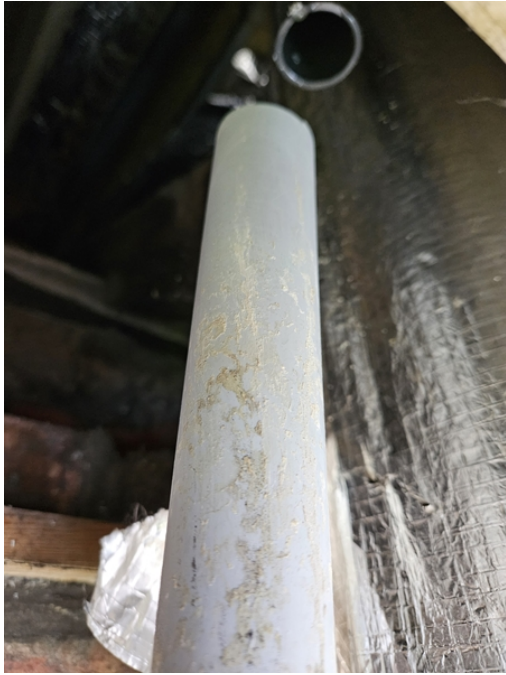
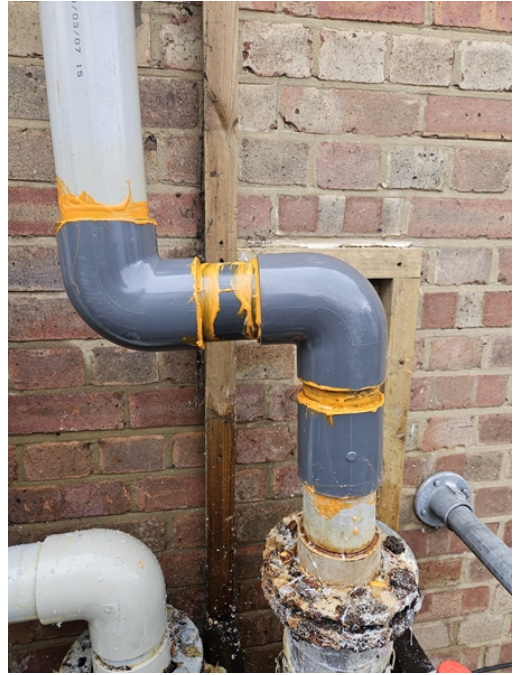
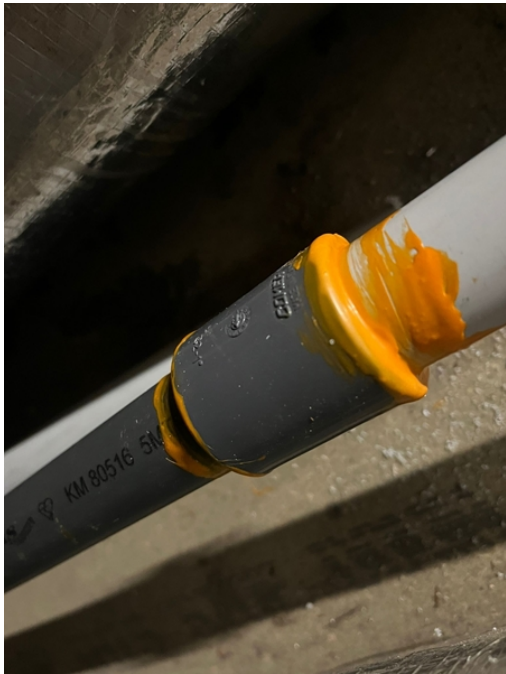
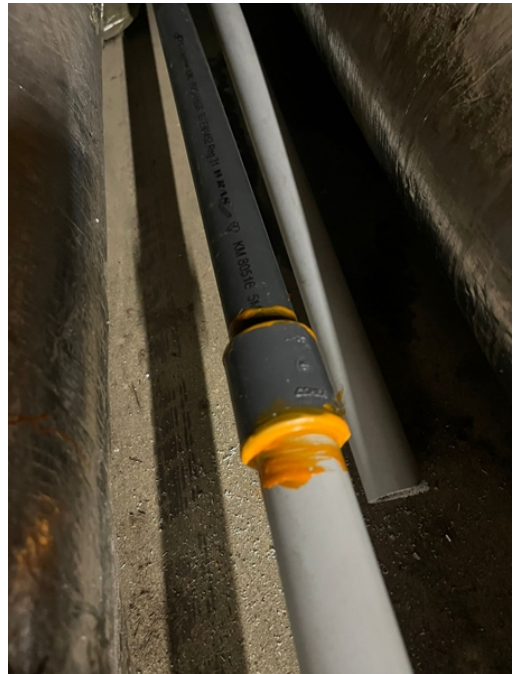
Leak located on return pipe at high level on Gable End under roof and at low level on the hot water flow

Failed pipe cut out and replaced with new and allowed to set for 2.5hrs prior to reinstatement
