# **HAERSES ROAD QUARRY BIODIVERSITY AND REHABILITATION MANAGEMENT PLAN**

Dixon Sands (No. 1) Pty Ltd

November 2020

Project Director: Luke Bettridge  
Project Manager: Trish McDonald  
Technical Director: Alison Riley  
Technical Manager: Chloe Parkins  
Report No. 4272/R06  
Date: November 2020

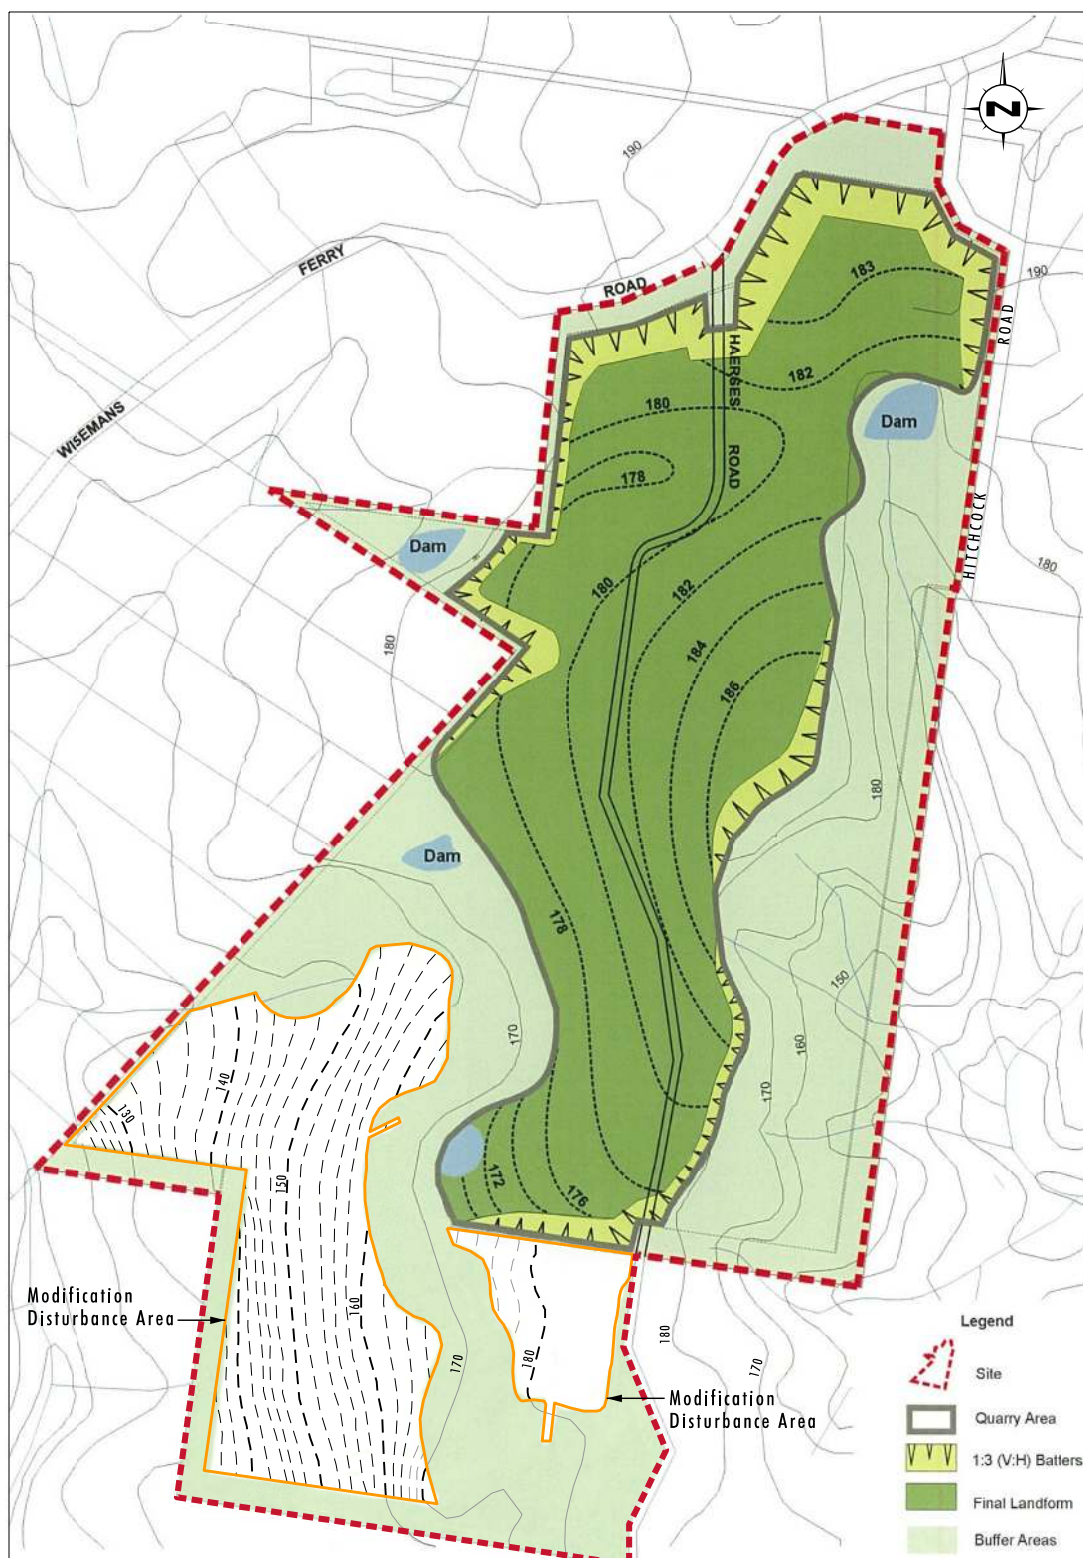
FIGURE 6.1

Proposed Final Landform
