# **Curlyleaf Pondweed in the Briggs Chain of Lakes: 2020**

Briggs Lake (#71-0146) Julia Lake (#71-0145) Rush Lake (#71-0147)

Surveyed May 4, 2020

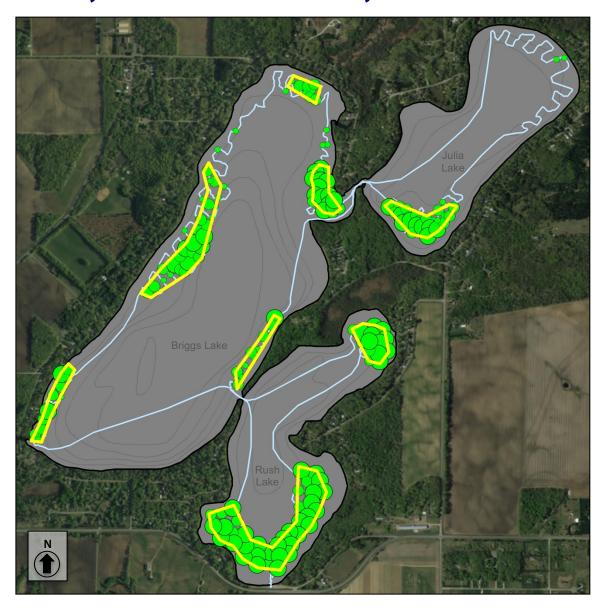
# **Briggs Chain of Lakes**2020 Curlyleaf Pondweeed Delineation Survey

Surveyed: May 4, 2020 Methods: Rake, Visual, Sonar Surveyor: JA Johnson

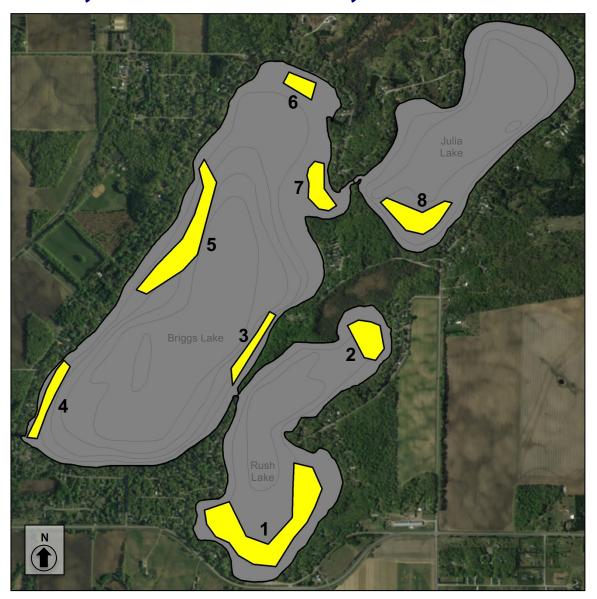
# **Briggs Chain of Lakes**2020 Curlyleaf Pondweed Delineation Survey

Surveyed: May 4, 2020 Methods: Rake, Visual, Sonar Surveyor: JA Johnson

### **Proposed 2020 Treatment Plots**

Plot	Acres	Mean Depth (ft)	Mean CLP (1-3)
1	25.2	3.6	2.8
2	6.2	2.8	2.6
3	3.9	3.5	1.7
4	4.9	3.0	2.0
5	15.4	4.2	2.0
6	3.0	4.7	1.6
7	5.3	3.4	2.7
8	8.0	5.3	2.2

**Total** 71.9
