## FIELD NOTES SUMMARY

**Customer:** City of Lynn (Goldfish Pond)

**Site Location:** Lynn, Massachusetts

**Date:** 4/21/22, 7:50 AM

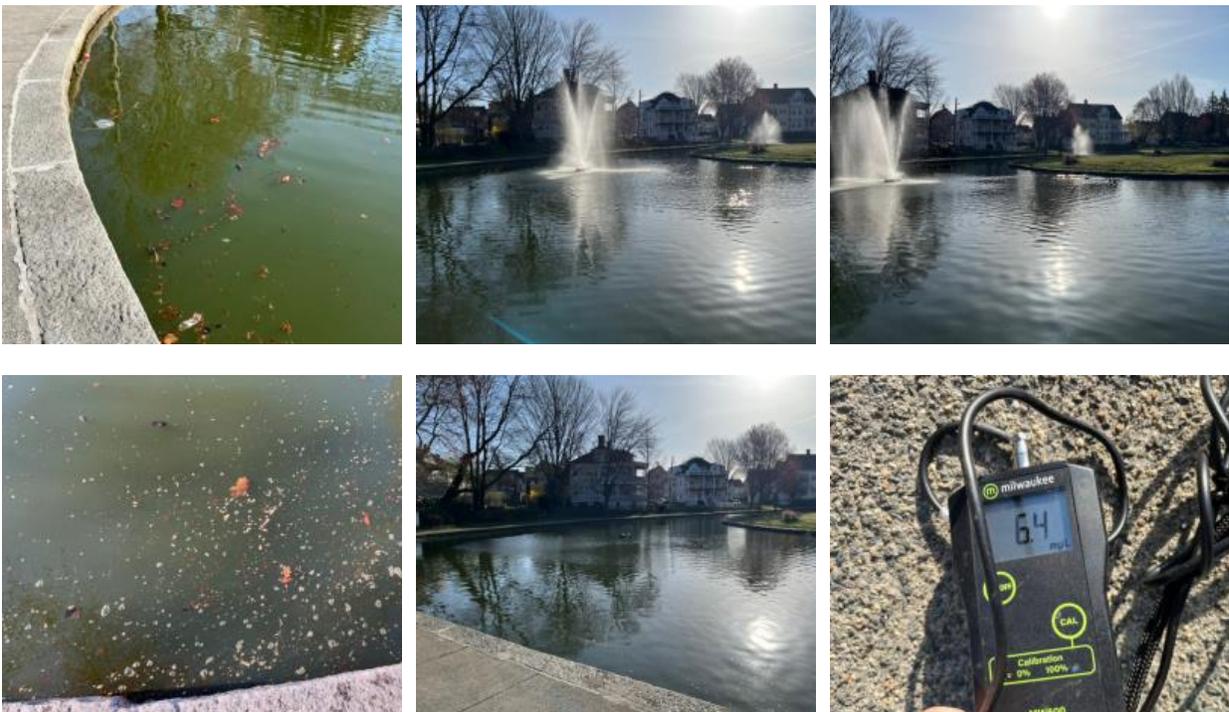
**Photos**

**Observations / Notes:** On April 21st, Senior Environmental Scientist, James Lacasse, completed the 2nd April pond maintenance visit to Goldfish Pond. Upon arrival, a survey of the pond was conducted using visual observation paired with a standard throw-rake. During the previous visit, a sample was collected and analyzed for algae ID and enumeration. The results showed significantly high blue-green algae species, which have the potential to be harmful. Given this, we had planned a treatment for the control of algae prior to this visit. Upon visual inspection, the pond did appear to be less green than during the previous visit. The cooler nighttime temperatures likely had some impacts on the microscopic algae. Despite this, there was still a moderate to dense microscopic algae bloom noticeable throughout the pond. Trash and debris were also documented scattered around the perimeter of the pond. Conditions during the visit were partly cloudy.

An algacide treatment was conducted using copper-based, EPA/MA approved algacide, EarthTec. EarthTec stays in solution much longer than traditional copper sulfate and will ideally be a better fit for Goldfish Pond than historically used copper algacides. There are no restrictions affiliated with this specific treatment. As indicated on the previous field notes, two out of three fountains were functioning as intended. We suggest checking/upgrading the relay in the fountain box, as this might be the reason why the third fountain is non-functional. Once this has been eliminated as a source for the malfunction, we could look into power units or potential replacement of the fountain. The submersed aeration system was inspected and was functioning properly. Bacteria/enzyme applications will begin during the next visit to target excess nutrients and to assist with the breakdown of muck/organic matter. These products require warmer water temperatures in order to work, so they are typically applied during the May through September window in New England.
